# Roof Rack Crossbar Interference With Roof Antenna

YEAR(S)	MODEL(S)	ADDITIONAL INFORMATION
2020	Tacoma	VDS(s): AX5GN, AZ5CN, BZ5DN, CZ5AN, DZ5BN, EZ5CN, GZ5AN Body Type(s): Double Cab

Some 2020 model year Tacoma double cab vehicles equipped with a Toyota genuine roof rack may exhibit a condition in which the cross bar interferes with the roof antenna. Follow the Repair Procedure in this bulletin to address this condition.

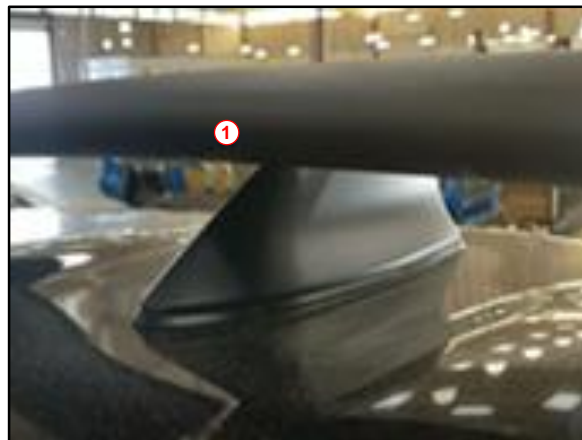
**Figure 1.**

1. Confirm the condition exists.  
Does the vehicle have a Toyota genuine roof rack and exhibit a condition in which the cross bar interferes with the roof antenna?
  - **YES** — Continue to step 2.
  - **NO** — This bulletin does NOT apply. Continue diagnosis using the applicable Repair Manual.

<b>1</b>	<b>Interference Condition</b>
----------	-------------------------------
