## STAR ONLINE PUBLICATION

**Case Number:** S2023000042

**Symptom/Vehicle Issue:** Wind Noise From Upper Corners Of Sliding Doors

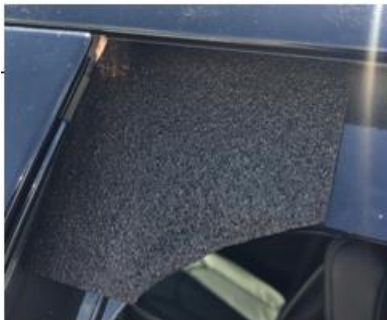
B PLR - Left Side Shown

### Foam applied to the B and C pillar door glass area

Install the foam(s) in the corner(s) covering the gap shown in the example below. Foam is to be used at the B pillar and C pillar corners. Remove any loose dirt or debris. If needed, wipe the area the foam will be applied to with isopropyl alcohol.
