# 7-SPEED DCT JUDDER INSPECTION AND DUAL CLUTCH ASSEMBLY REPLACEMENT

This bulletin provides the procedure to replace Dual Clutch Assembly and upgrade the TCU on some 2016-2020MY Kia vehicles listed on the table below, equipped with the 7 Speed Dual Clutch Transmission (DCT), which might exhibit clutch judder when accelerating from a stop. If the vehicle body vibrates without the steering wheel shuddering when performing creep driving test (driving the vehicle up to 3mph), the vehicle is exhibiting clutch judder. The creep test can be conducted by driving at a speed slower than 5 mph after releasing the brake. In order to remedy clutch judder, the Dual Clutch Assembly must be replaced and the TCU will need to be upgraded.

TSB: TRA083 Multiple Models December 2020

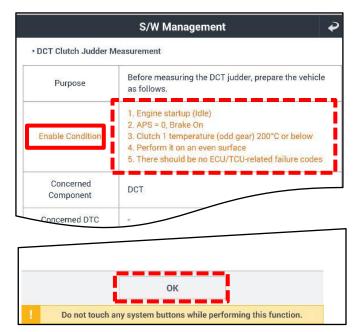
4a. Confirm the 'Enable Condition' list.

4b. Select 'OK'.

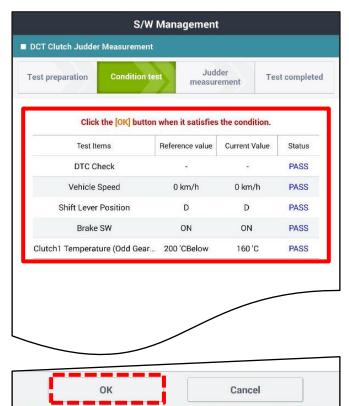
Under 'Condition test', satisfy the listed conditions on KDS. ■ DCT Clutch Judder Measurement Judder Test preparation Condition test Test completed measurement Before measuring the DCT judder, prepare the vehicle as follows. 1. Engine startup (Idle) 2. APS = 0, Brake On 3. Clutch 1 temperature (odd gear) 200°C or below 4. Perform it on an even surface. There should be no ECU/TCU-related failure codes. 6. Remove the floor mat, and then fix the diagnosis equipment on an even floor of the passenger seat. Diagnosis equipment position OK Cancel Do not touch any system buttons while performing this function.

6b. Select 'OK'.

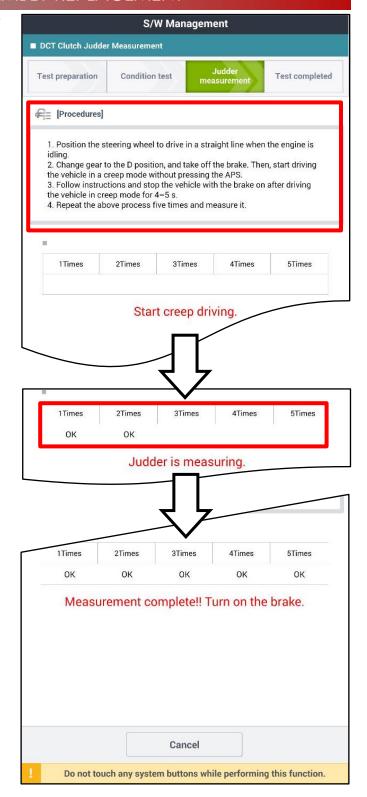
- 7a. Under 'Judder measurement' review the 'Procedures' outlined on KDS to measure DCT judder and follow the instructions on the screen to start creep driving.
- 7b. Release the brake and let the vehicle move forward without the pressing the pedal.

Note: Performed a total of five (5x) times.

8. After completing the measurement test, apply the brake as instructed on KDS screen.

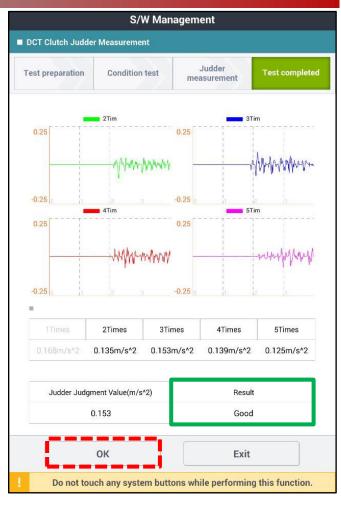
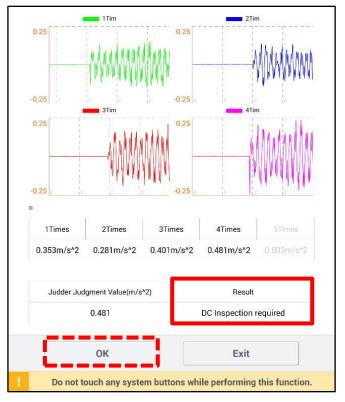
- Under 'Test completed', take the appropriate action based on the 'Result' as follows:
  - 1) If the result is "GOOD", no further action is required.

If the result is "DC Inspection required", replace the Double Clutch Set by referring to the DCT Replacement Procedure outlined on page 6.

4) Select 'OK' to complete.

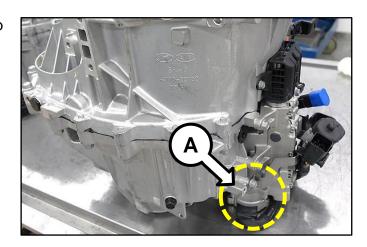
2. Place the DCT clutch housing facing up as shown.

When putting the DCT assembly down, be careful to not damage the clutch actuator motor connector (A).
