**SERVICE INFORMATION BULLETIN**

**APPLICABILITY:** All Models **NUMBER:** 07-186-20  
**SUBJECT:** Battery Leaks- Visual Guidelines to Assist with **DATE:** 12/08/20  
Determining Warranty Coverage

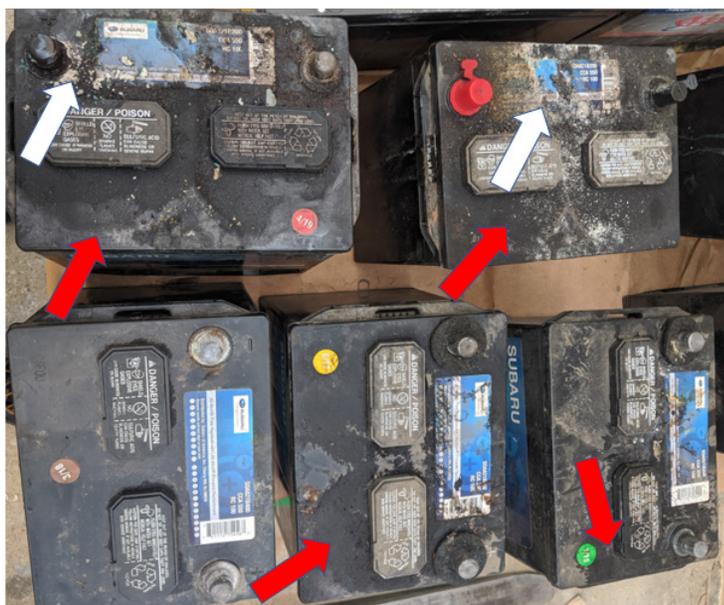
**FIGURE A:**

In this collection of returned batteries, the RED arrows point to moisture accumulations which has escaped from either the post seal(s) and / or the covers (fill caps) as a result of normal outgassing, a normal by-product of charging. The two WHITE arrows point to corrosion. Both are normal conditions and not to be considered defects.

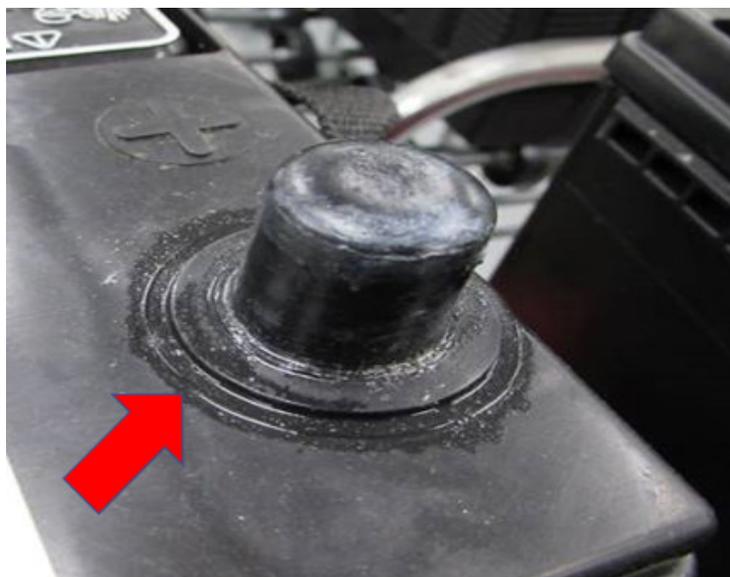
**FIGURE B:**

The RED arrow points to moisture seepage seen around the post seal. This photo depicts seepage which should be considered normal and would not be considered a warrantable defect requiring battery replacement.

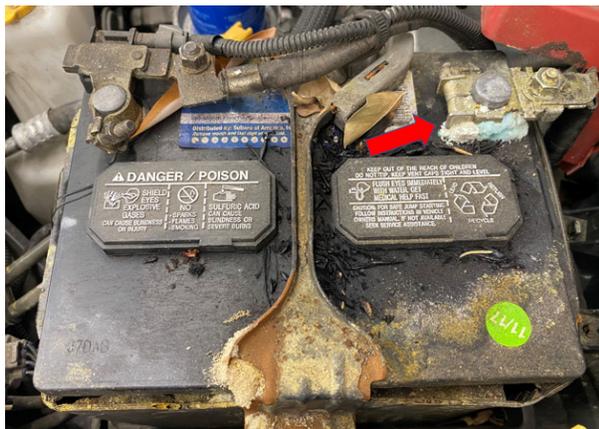
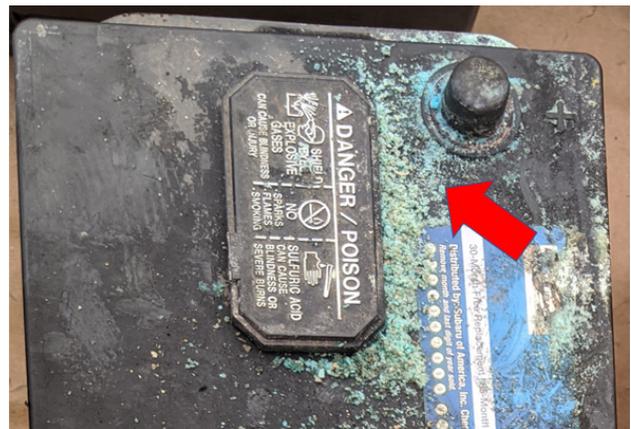
**FIGURES C and D:**

Both photos above show corrosion accumulations which have developed over time resulting from a lack of proper cleaning and / or maintenance. If corrosion develops on the hold-down, if the battery tray or hold-down parts become rusty or, whenever the battery becomes dirty, it is recommended to take the time to remove it from the vehicle and thoroughly clean these parts. Use a wire brush to remove dirt, corrosion and rust. A baking soda and water mixture (toothpaste consistency) or spray neutralizer is recommended for use on the battery cable ends and connectors along with a 2-way battery terminal brush as shown below to clean both the battery posts and inside the terminal ends. The solution also neutralizes the sulfuric acid content embedded in the metals creating the corrosion. A cloth dampened with ammonia or a baking soda/water solution can be used to remove dirt from the top of the battery followed by wiping clean with a damp cloth.

Once any rust and corrosion has been removed and all connectors are thoroughly cleaned, make sure the battery is completely dry. Reconnect the cables to the battery posts and torque the fasteners to their applicable specification. When complete, application of a thin coating of terminal protectant spray over the connectors and posts to retard corrosion is also recommended.

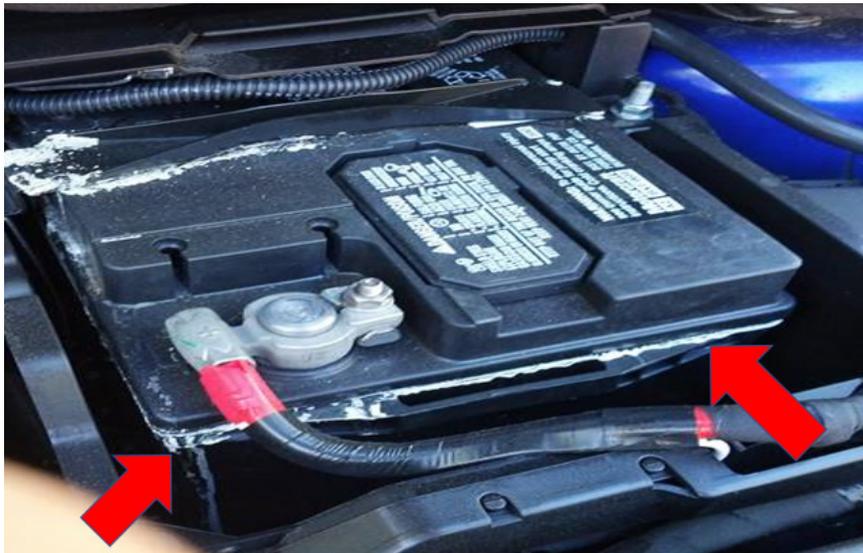
**FIGURE E:**

The RED arrows point to moisture seepage around the top cover seal and the start of an accumulation of corrosion. This photo depicts seepage which should be considered excessive and would be considered a warrantable defect requiring battery replacement.
