# AR880 2018-2019 SOI-F Drawn-Over-Mandrel (DOM) Tube Frame Reinforcement

**Complaint:** Drawn-over-mandrel (DOM) tube cracks in frame at rear spring, front frame brackets

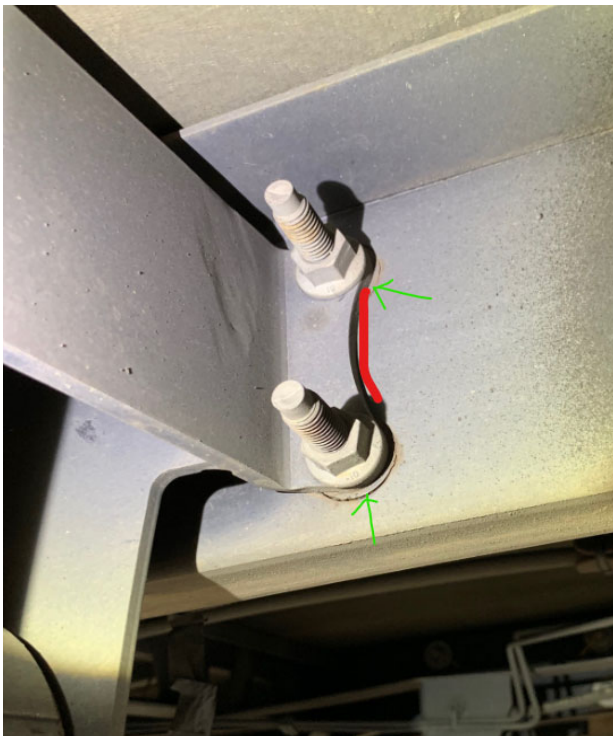
Step 3) Inspect rear spring, front frame DOM tubes for cracks (see picture below- green arrows )

Step 7) Weld frame bracket to frame ( see red line in picture below ). Using high quality undercoating or rust protective paint, coat repaired area

Step 5) If cracks are found, remove rear spring, front frame bracket. Grind cracked area of frame and DOM tubes

Step 6) Weld cracks and grind repaired cracks smooth. Reinstall rear spring, front frame bracket. Torque bracket to frame bolts to 66 ft-lbs and spring to bracket bolts 166 ft-lbs
