Technical Service Bulletin

51 Water sloshing sound is heard while driving

51 20 17 2061645/1 December 10, 2020.

Model(s)	Year	VIN Range	Vehicle-Specific Equipment
Q5, SQ5	2019 - 2021	All	Not Applicable

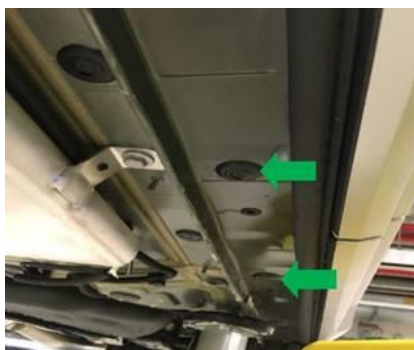
Figure 1. Body plugs in the outer floor to be removed.

1. Test drive the vehicle preferably with the customer and duplicate the symptom. If the symptom is duplicated, raise the vehicle on the hoist and remove the underbody trim. Then remove the outer body plugs indicated by the green arrows (Figure 1).

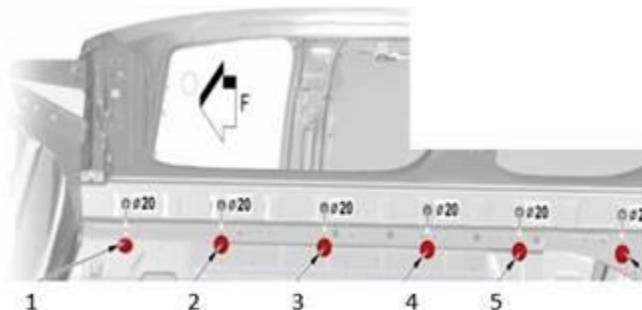
Figure 2. Outer side member body plugs number 3 and 4 from the front of the vehicle.

2. Plugs 3 and 4 on the outer side member from the front of the vehicle are to be removed (Figure 2).

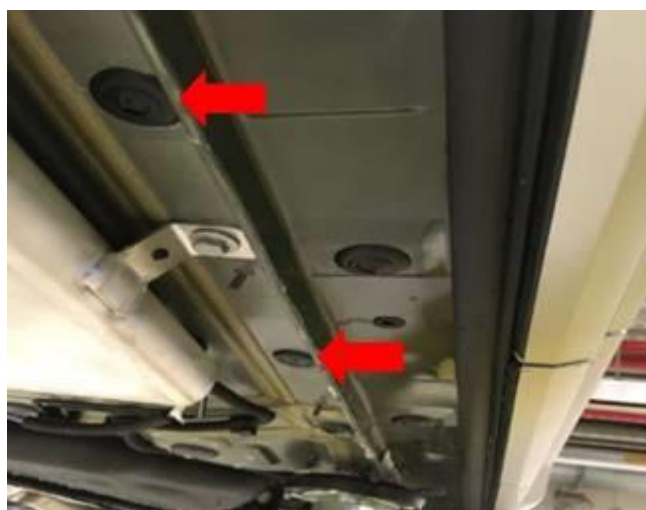
Figure 3. Inner side member body plugs in inner floor area to be removed.

3. To check for the presence of water that may already have entered the sill chamber remove the inner side member body plugs indicated by the red arrows (Figure 3).

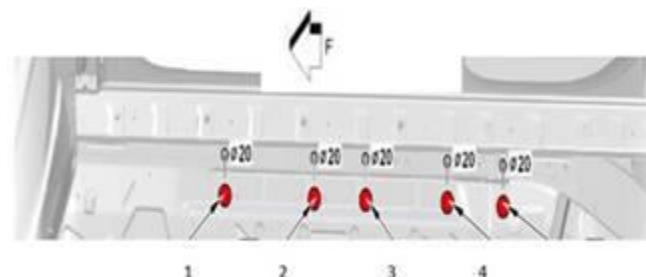
Figure 4. Inner body plugs number 2 and 3 from the front of the vehicle.

4. The inner side member body plugs 2 and 3 (Figure 4) from the front of the vehicle are to be removed just long enough to drain any accumulated water from the sill chambers. Reinstall after draining.

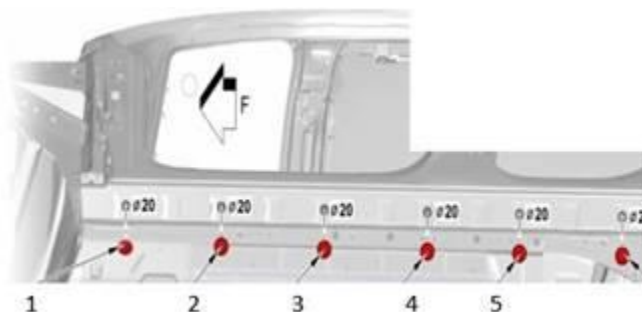
Figure 5. Plug number 3 of the outer side member to be replaced.

5. Body plug number 3 on the outer side member is to be replaced with body plug part number 8W0 899 188 (Figure 5). This plug incorporates a water drain to prevent water accumulation.

Reinstall the original body plug number 4.
