Technical Service Bulletin

60 Rattle noise near the central roof area

60 20 49 2054270/7 December 18, 2020. Supersedes Technical Service Bulletin Group 60 number 20-42 dated May 6, 2020 for reasons listed below.

Model(s)	Year	VIN Range	Vehicle-Specific Equipment
A6	2019 - 2020	All	Not Applicable

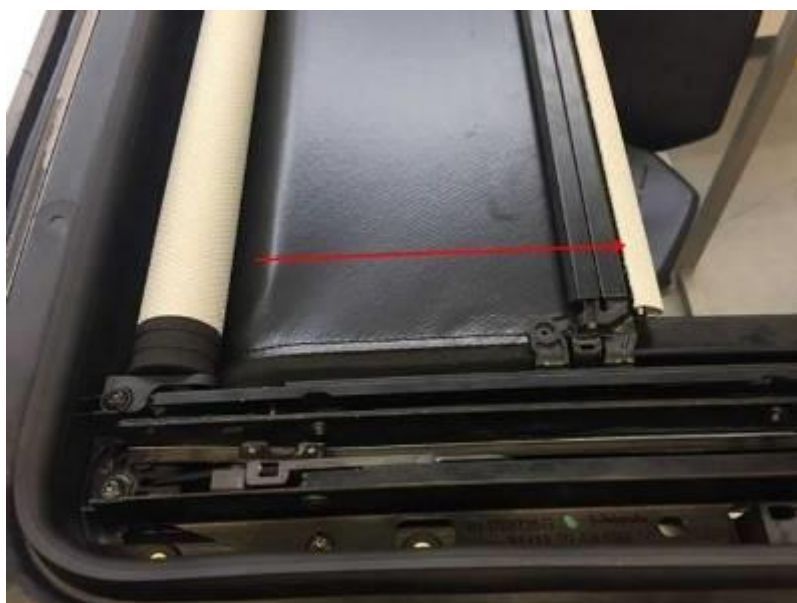
Figure 1. Closing the roller shade.

1. Remove the glass sunroof panel using the repair manual instructions.
2. Close the roller shade by about 20cm (Figure 1).

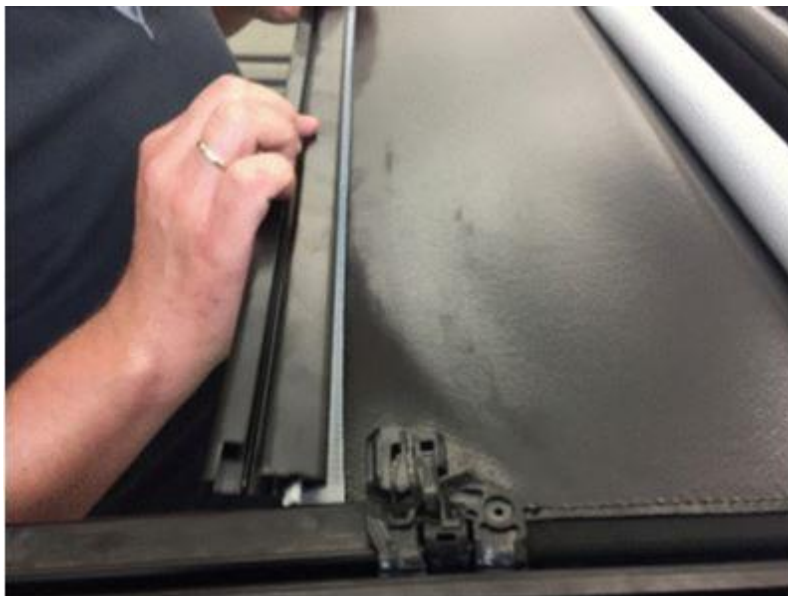
Figure 3. Beam removed from the drive.

3. Loosen the roller shade from the drive cable and push the material back until the bolts are exposed, then remove the bolts completely (Figures 2 -5).

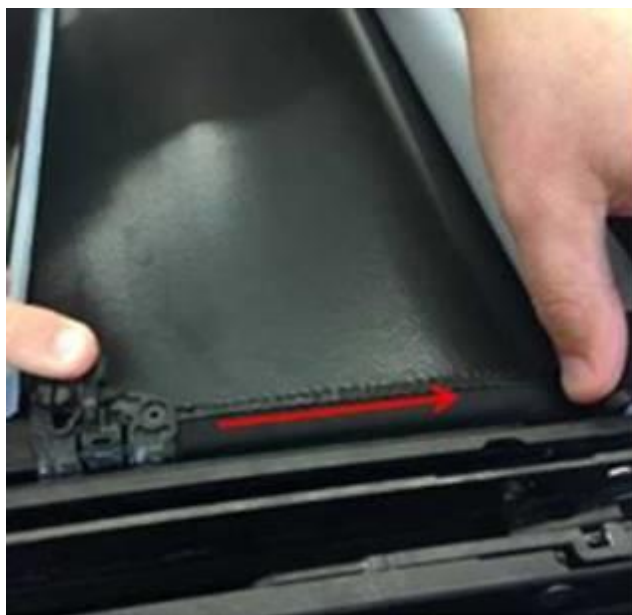
Figure 4. Push the material back to expose the bolts.

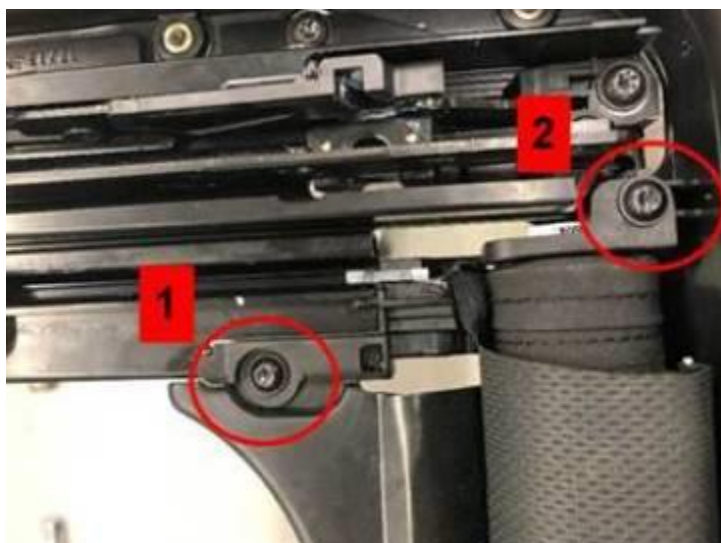
Figure 5. Remove the bolts.

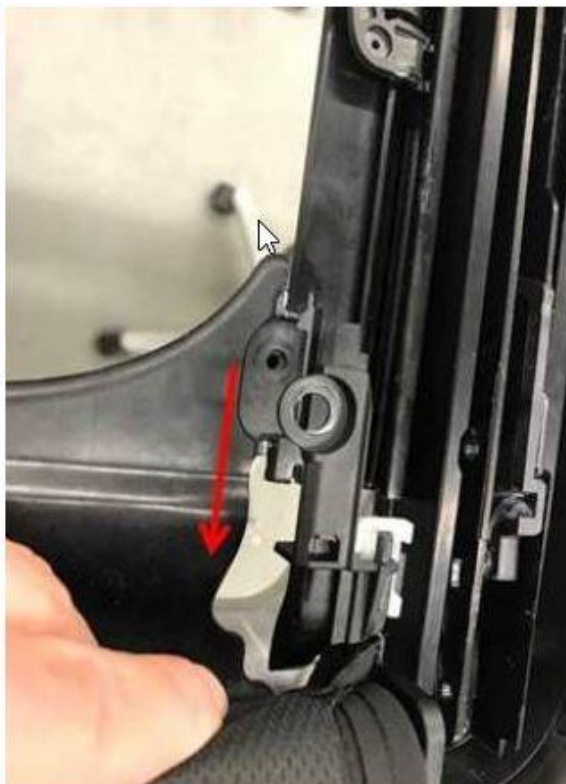
Figure 6. Slide roller shade backward.

4. Remove the roller shade by sliding it backward and clean the mounting points as shown in Figure 6 and 7. Use the cleaning solution D 009 401 04 or equivalent surface preparation solvent (e.g. isopropyl alcohol or adhesion promoter) to prepare the surfaces for adhesive backed felt strip material.

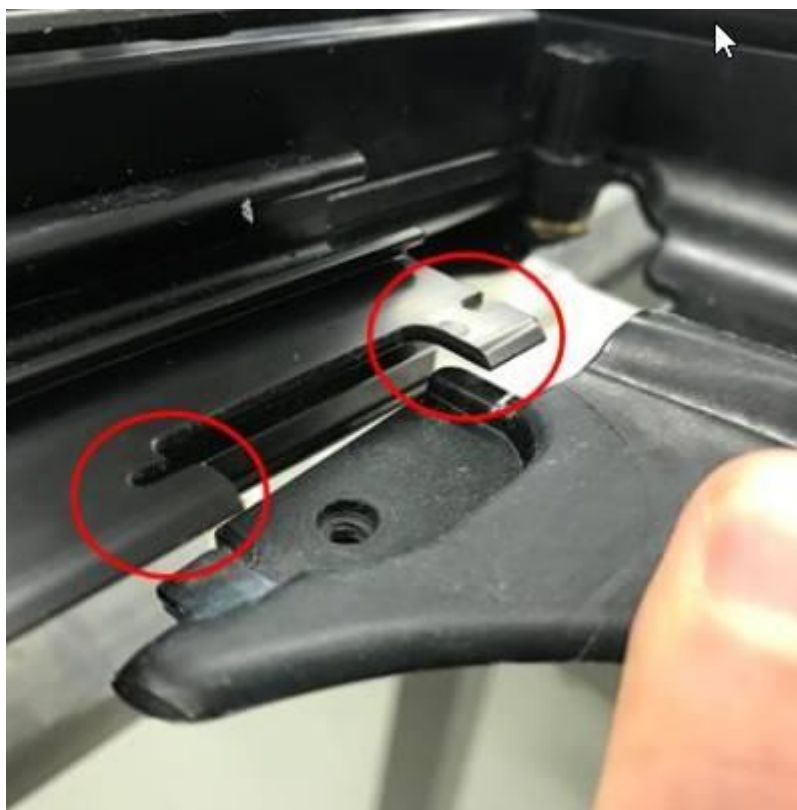
Figure 7. Areas to clean using cleaning solution D 009 401 04.

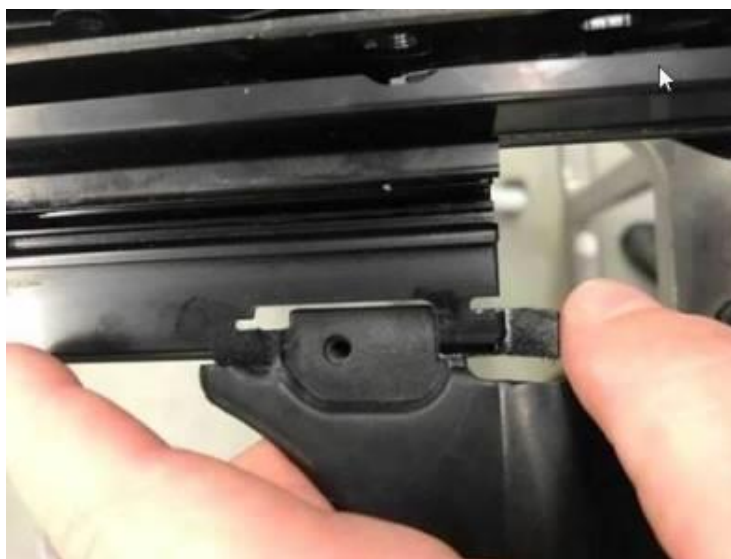
Figure 8. Applying felt tape.

5. Push down on the roller shade pan and starting from the bottom of the guide rail, wrap the areas shown in figure 8 with sections of felt tape 000 979 950 and fold them forward and over to the top of the guide rail such that both the top and bottom of the tabs are isolated (Figure 8 and 9).

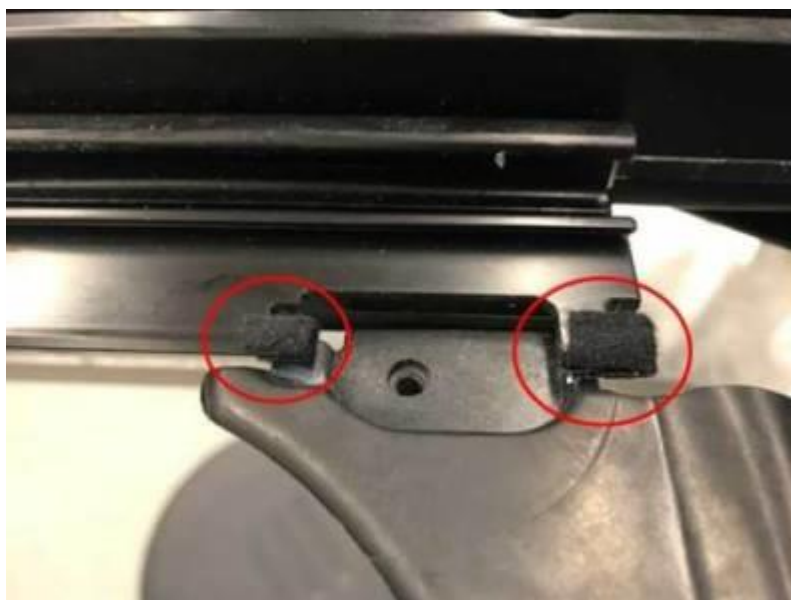
Figure 9. Apply felt tape on points shown. The tops and bottoms of the tabs must be isolated.

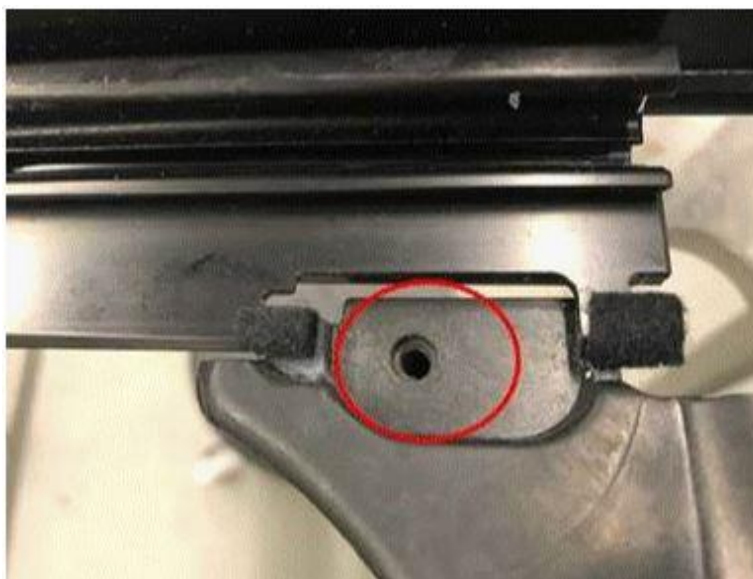
Figure 10. Apply thread locker in this area.

6. Apply thread locker to the screw hole shown in Figure 10. Reinstall the bolts to the roller shade and torque to 3Nm (Figure 11).

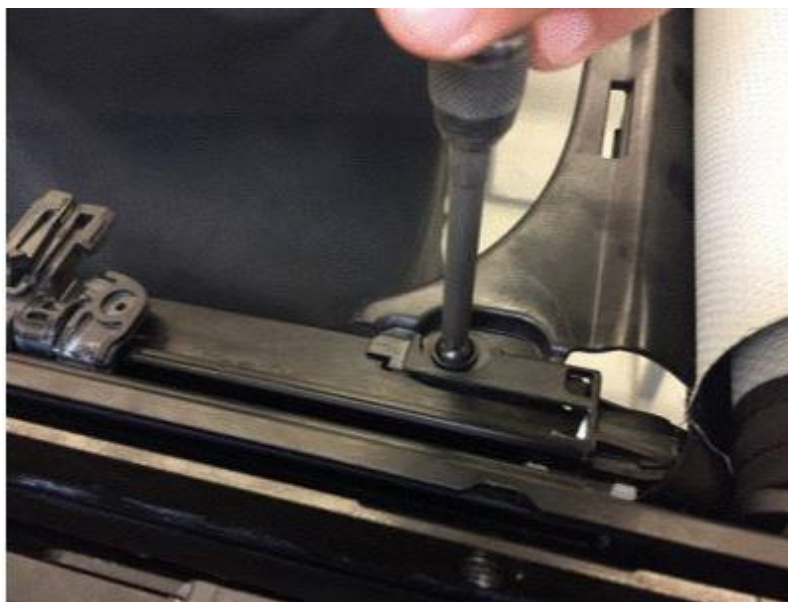
Figure 11. Torque screws to 3Nm.

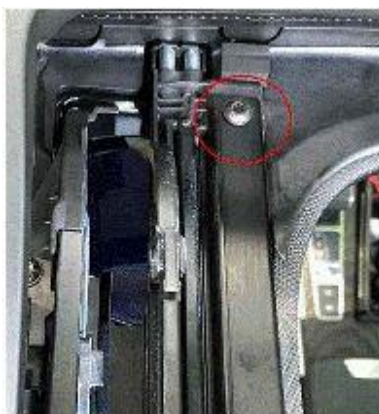
Figure 12. Loosen the bolt a few turns but do not remove the screw completely.

7. On the front of the sunroof guide rail, loosen that bolt a few turns but do not remove the screw completely (Figure 12).

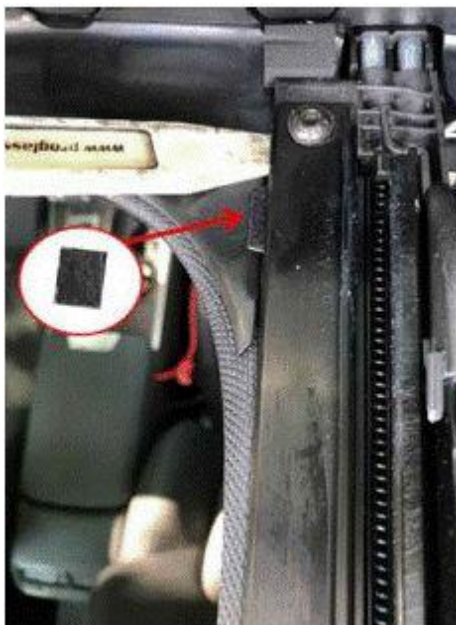
Figure 13. Isolation of guide rail and frame by the installation of a section of felt strip material.

8. Lift the guide rail slightly using a plastic wedge. Place a 20mm x 20mm section of felt strip material 533 867 910 A between the guide rail and the frame as shown in Figure 13. The backing for the adhesive side must be removed and the felt tape section adhered before the screw is tightened. Reinstall the screw and tighten to 5Nm (Figure 14).

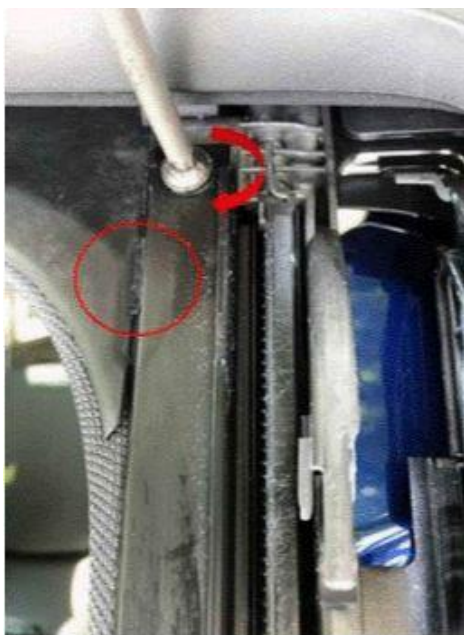
Figure 14. Tightening of the screw with the felt strip material isolating the guide rail and the frame.

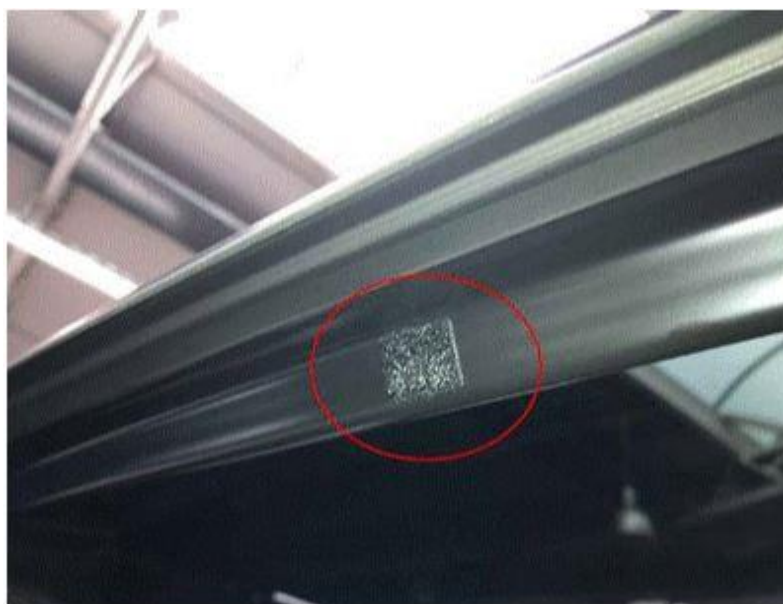
Figure 17. Adhesive felt strip material affixed to the center area of sunroof glass panel structure.

9. Measure and mark the center of the glass sunroof panel structure shown in Figure 15. Clean this area with cleaning solution D 009 401 04 or equivalent surface preparation solvent (e.g. isopropyl alcohol or adhesion promoter) to prepare the surfaces for adhesive backed felt strip material. Apply a 20mm x 20mm section of adhesive felt strip material 533 863 288 A to this central area of the glass sunroof panel structure as shown in Figures 16 and 17.
