Technical Service Bulletin

68 Noises from the dash panel around the MMI display

68 20 29 2056298/2 December 17, 2020. Supersedes Technical Service Bulletin Group 68 number 19-23 dated September 27, 2019 for reasons listed below.

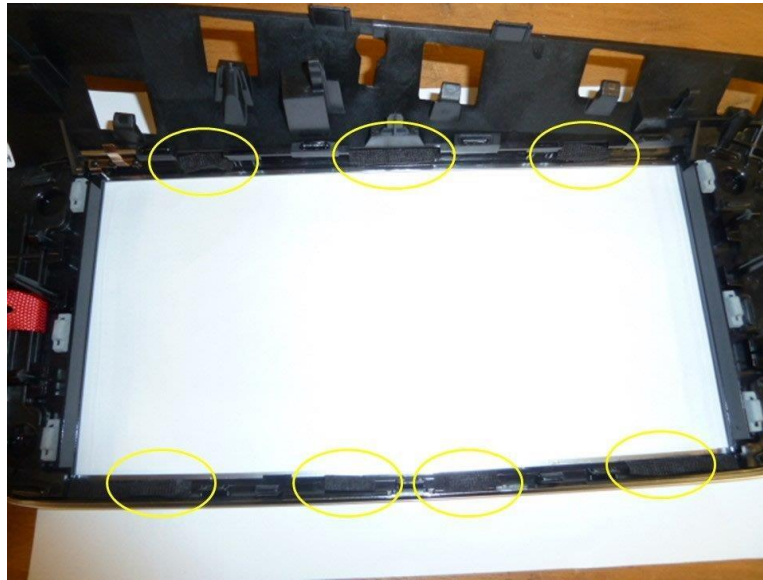
Figure 1. Apply felt strips to the circled areas.

- Felt strips 533867910A.
1. Remove the trim strip of the dash panel and stick the felt adhesive tape on the areas marked with yellow circles (Figure 1).

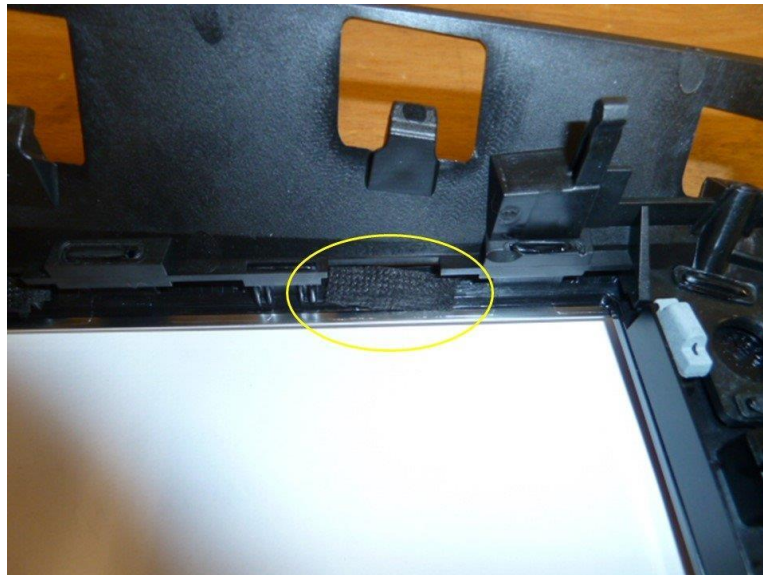
Figure 2. Close-up of Figure 1.

2. The felt strips shown in Figure 1 and 2 must be stuck on and folded back behind the clip (Figures 3 -4).

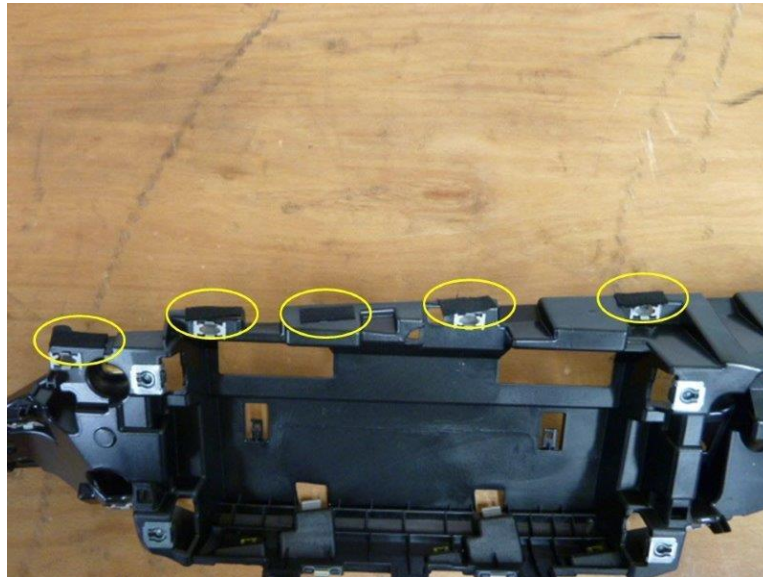
Figure 3. Apply felt strips to the circled areas.

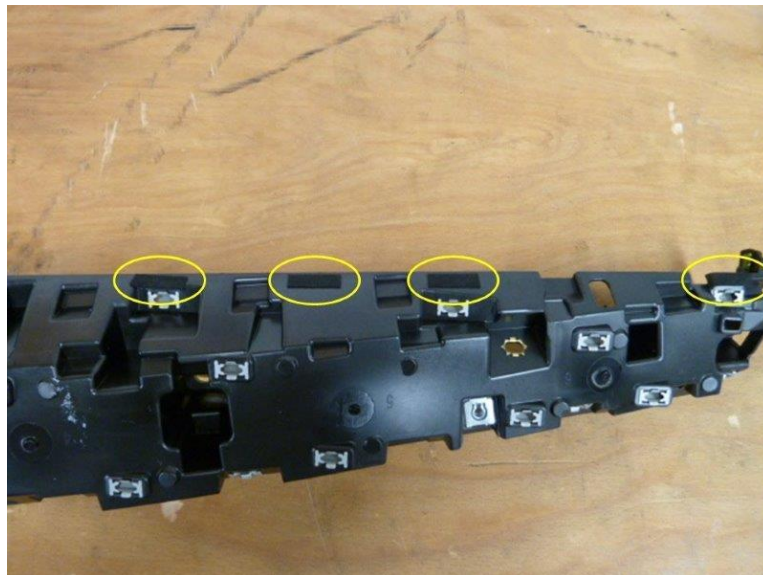
Figure 4. Apply felt strips to the circled areas.
