JTBO0585NAS3

TECHNICAL BULLETIN

Passive Entry System Slow To Unlock

MODEL:	MODEL YEAR:	VIN:	ASSEMBLY PLANT:
XF (X260)	2018	Y53259-Y53224	Castle Bromwich

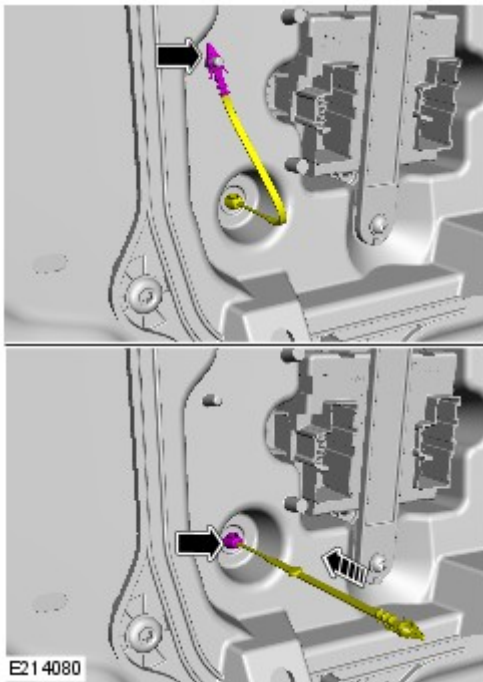
E214080

Remove the door window regulator retaining clip.

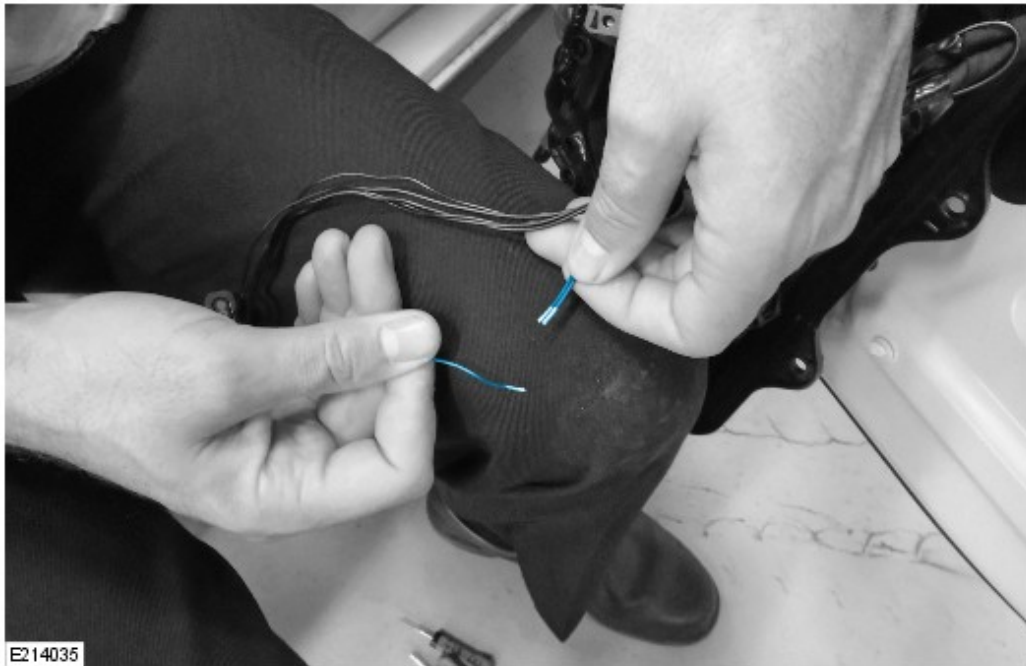
Cut the repair wire to a suitable length and prepare the front right door electrical wiring harness for a splice connector.

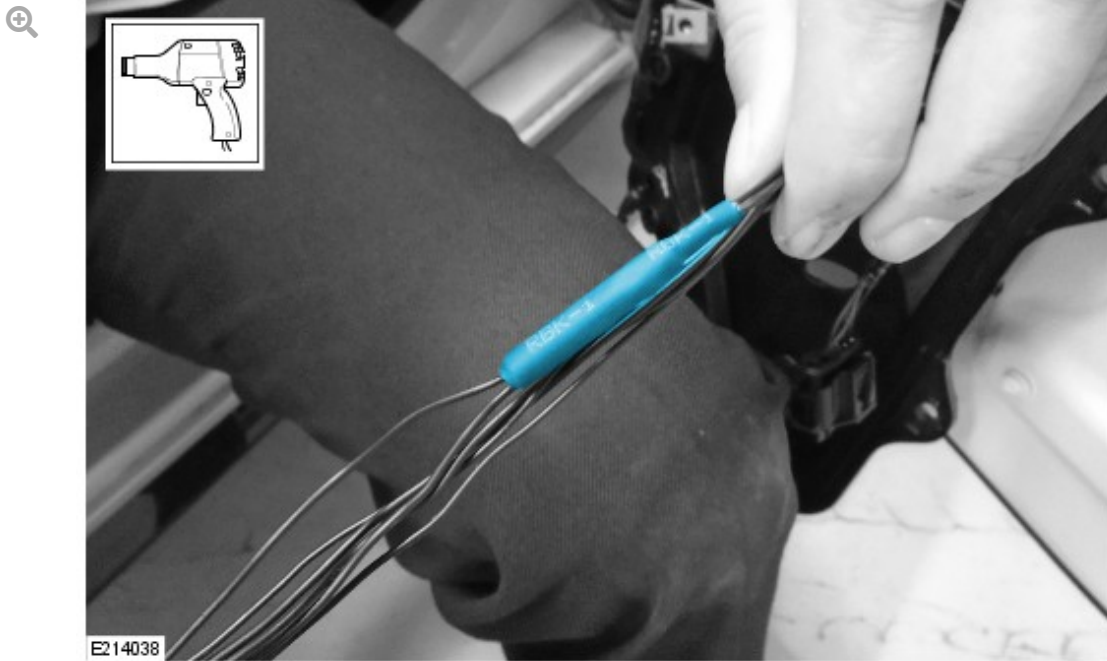
Position the heatshrink over the splice connector and apply heat to seal the splice connector.
