GROUP	NUMBER	
Campaign	20-01-047H	
DATE	MODEL(S)	
December, 2020	Elantra (AD/ADa)

TCU UPDATE AND IVT REPLACEMENT (SERVICE CAMPAIGN 963)

Description: Certain 20MY Elantra (AD/ADa) vehicles may experience an illuminated check engine warning light due to Diagnostic Trouble Codes (DTC) listed below. Perform the Transmission Control Unit (TCU) update, and, if necessary, replace the IVT (Intelligent Variable Transmission) to resolve this condition.

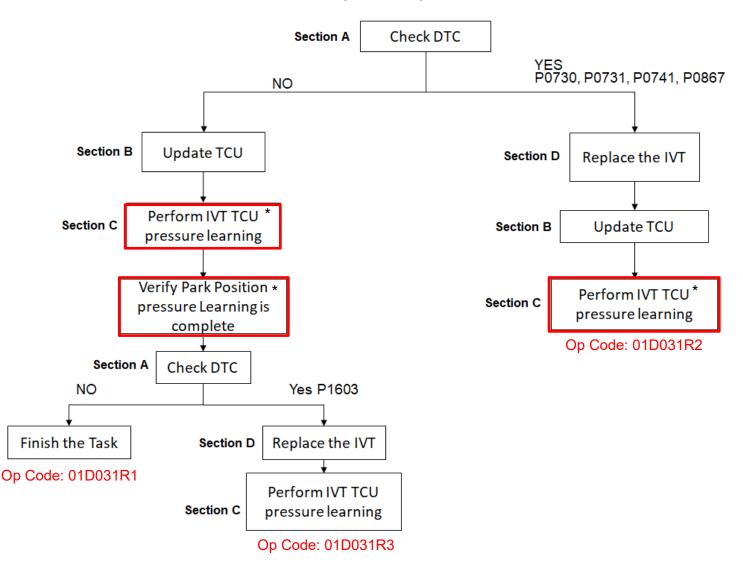
TCU Update Flow (AD/ADa with IVT)

1. Refer to the flowchart below to update the procedure.

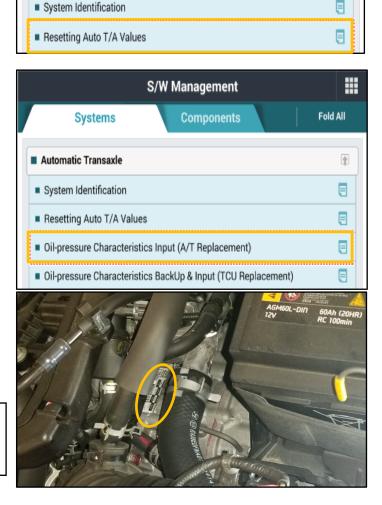
1. Perform IVT Resetting Auto T/A Values and Oil-pressure Characteristics Input procedures using the GDS-M.

IVT oil pressure characteristics label is located on the IVT bell housing.

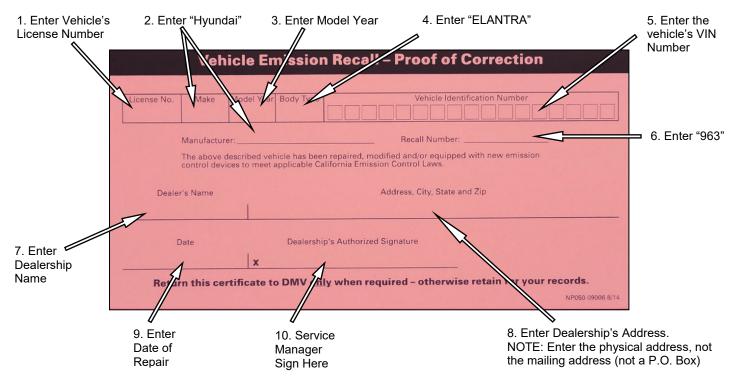
The copy of the card shown below indicates the areas to be filled in. Each area must be filled in.

The Vehicle Emission Recall - Proof of Correction card <u>must</u> be completed by the Dealership's Service Manager using a permanent ink pen. A fine point pen is recommended. When filling in the information, copy the information directly from the vehicle, <u>not</u> from the repair order. <u>ALL</u> <u>INFORMATION MUST BE PRINTED AND NEAT.</u>
