SERVICE BULLETIN

Classification: EC20-024	Reference: NTB20-086	Date: December 1, 2020
-----------------------------	-------------------------	---------------------------

PERMANENT DTC SET IN TCM AND WILL NOT ERASE

APPLIED VEHICLES: 2019 Sentra (B17)
2019 Versa Note (E12)
2019 Versa Sedan (N17)

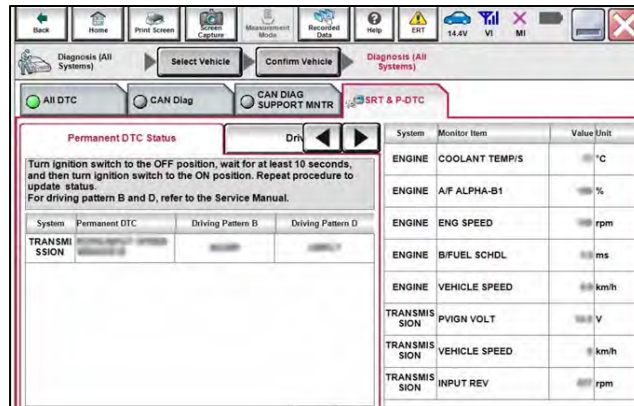
Figure 1

One or more of the following DTCs are stored in the permanent DTC screen (Figure 1):

P1890, P2768, P17F3, P17F4, P188F

The DTCs will not erase when following the ESM procedure.

Replace the TCM.

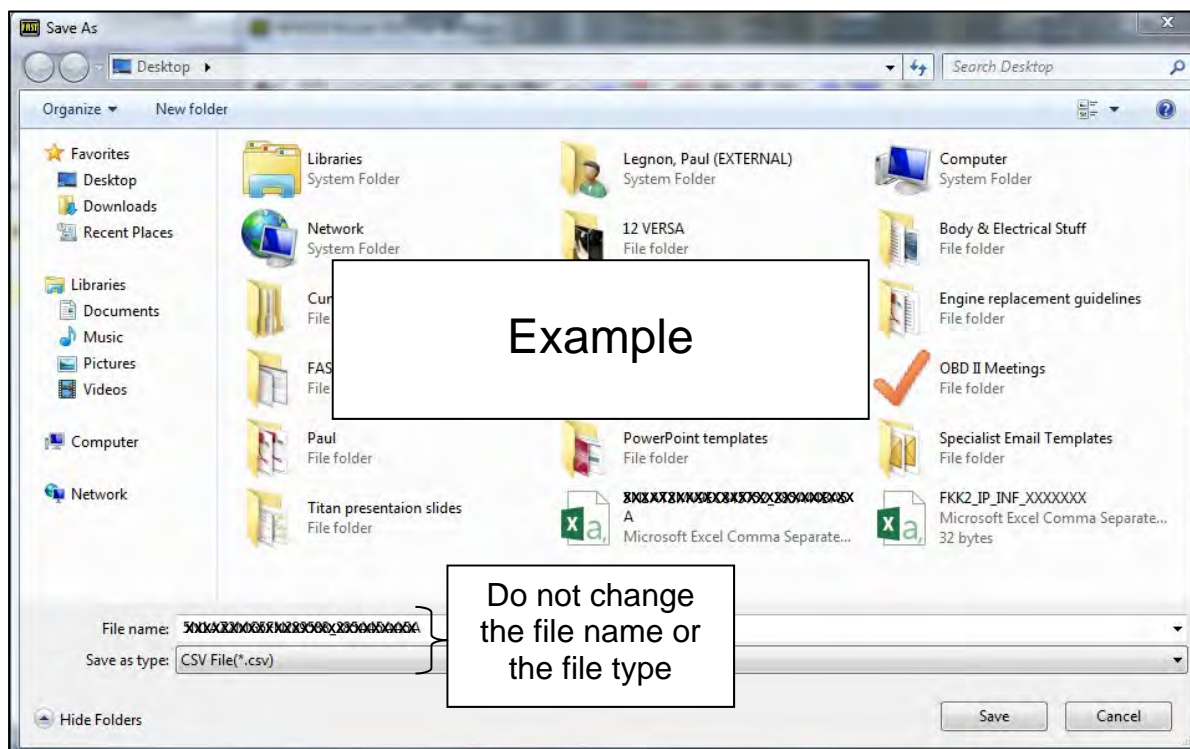
Figure 6

- 7. Load the CSV file onto a thumb drive.
 - After selecting the blue CONSULT button in step 6, a screen showing your computer’s desktop with the CSV file should display (see Figure 6, this is the VIN specific configuration file).
 - Do not change the file name or the file type.
 - Load/save this CSV file onto a thumb drive.

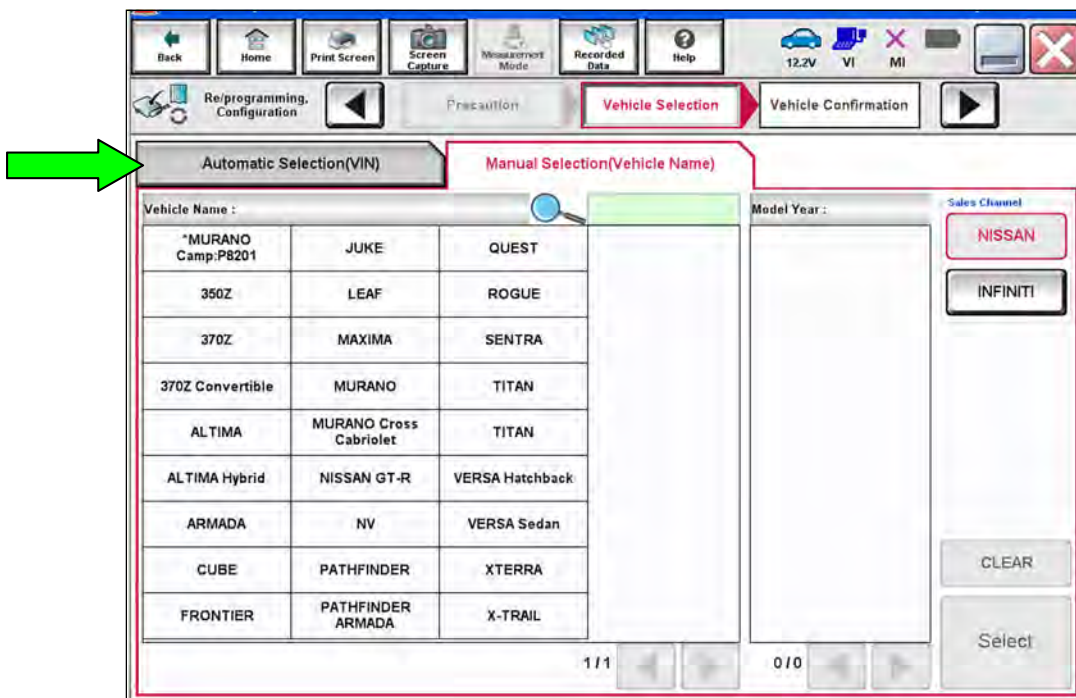
- If the screen in Figure 10 displays, select **Automatic Selection(VIN)**.

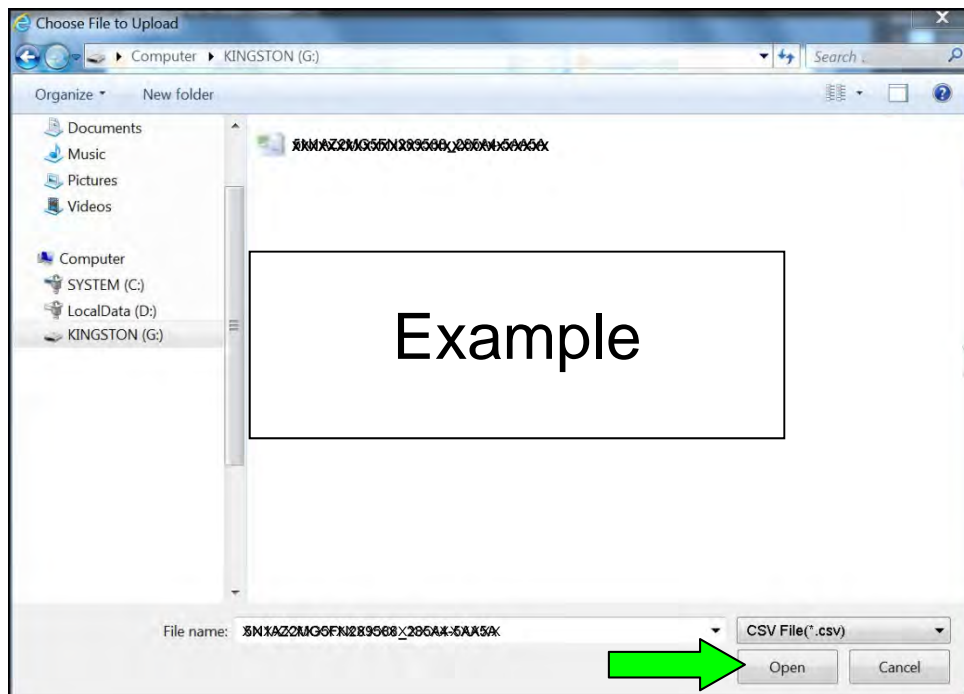
Figure 17

23. Navigate your CONSULT PC to the thumb drive and select the configuration file (see example in Figure 17).

- This will be the file that was loaded onto the thumb drive in step 7 on page 4.

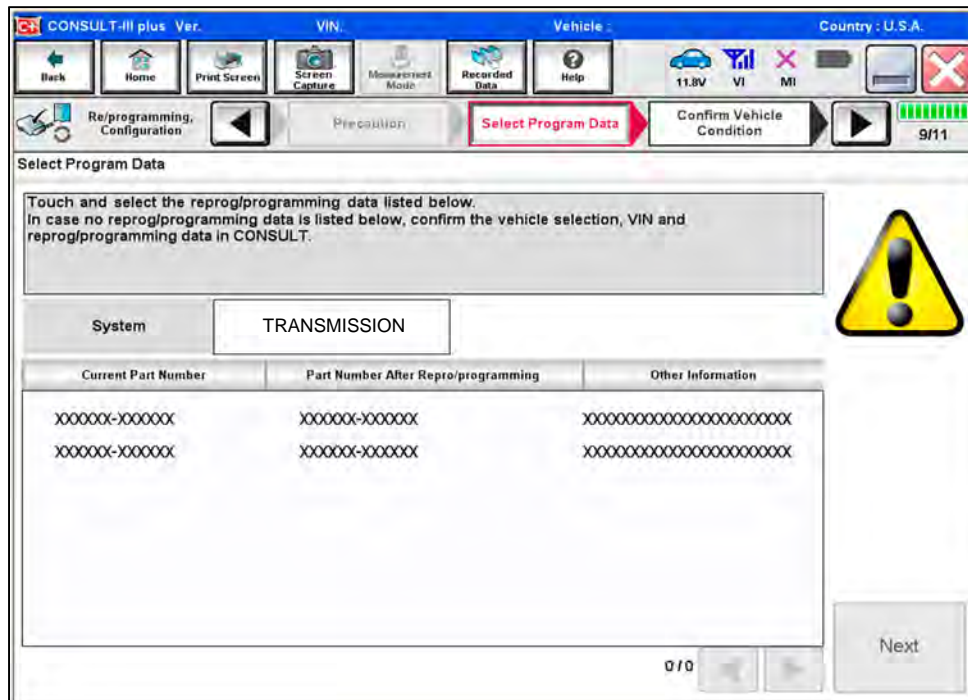
32. Follow the on-screen instructions to navigate C-III plus to the screen shown in Figure 23 and reprogram the TCM.

- In some cases, more than one new P/N for reprogramming is available.
 - If more than one new P/N is available, the screen in Figure 23 displays.
 - Select and use the reprogramming option that does **not** have the message “Caution! Use ONLY with NTBXX-XXX”.
- If you get this screen and it is blank (no reprogramming listed), it means there is no reprogramming available for this vehicle. The repair is complete. Proceed to the claims information on page 19.

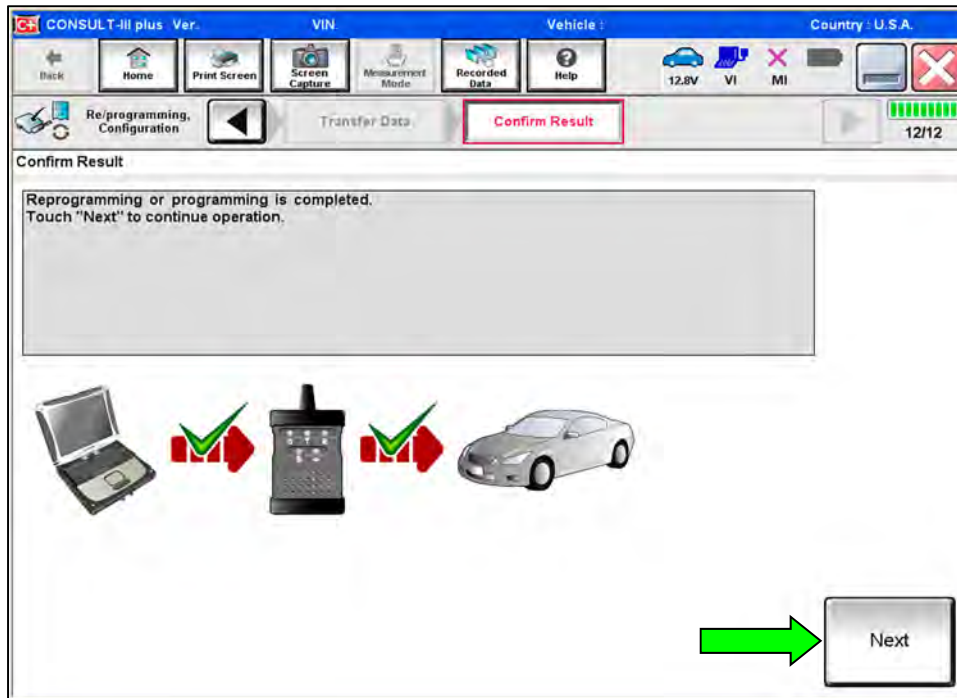
33. When the screen in Figure 24 displays, reprogramming is complete. Disconnect the battery maintainer/smart charger from the vehicle.

HINT: If the screen in Figure 24 does not display (indicating that reprogramming did not complete), refer to the information on the next page.

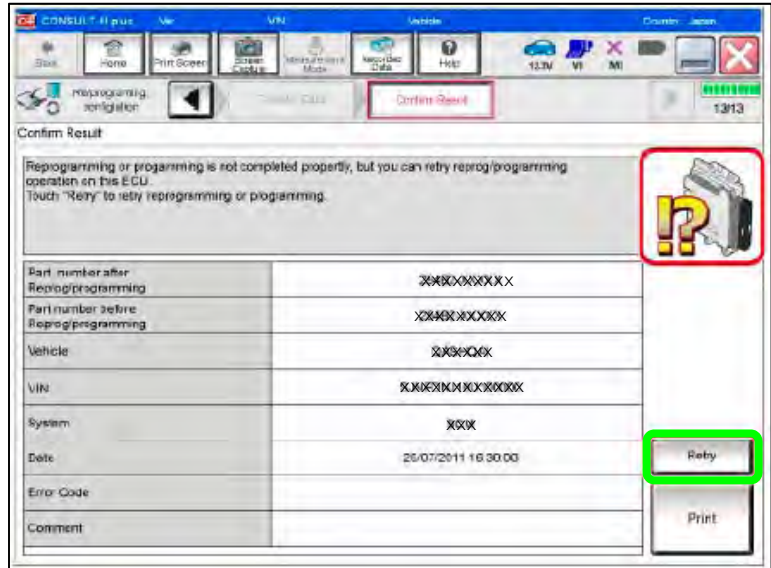
Figure 25

If reprogramming does not complete and the “!” icon displays as shown in Figure 25:

- Check battery voltage (12.0–15.5 V).
- Ignition is ON, engine OFF.
- External Bluetooth® devices are OFF.
- All electrical loads are OFF.
- Select retry and follow the on screen instructions.
- “Retry” may not go through on first attempt and can be selected more than once.

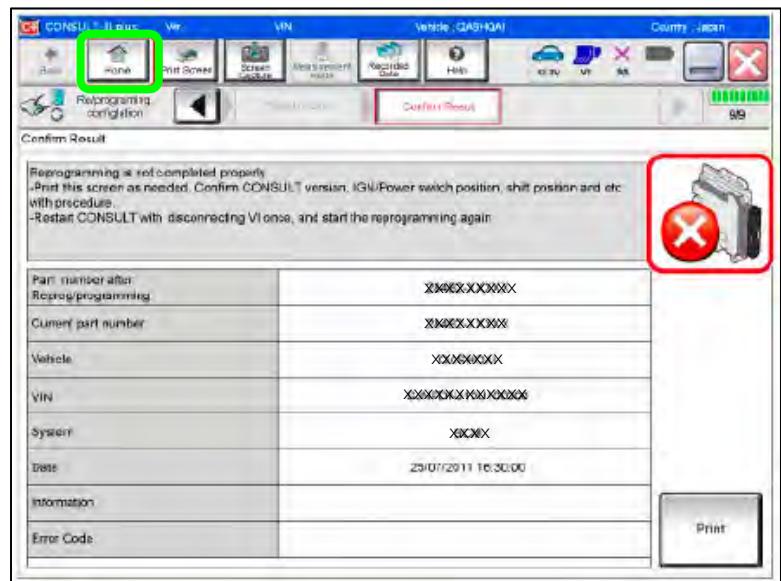
Figure 26

If reprogramming does not complete and the “X” icon displays as shown in Figure 26:

- Check battery voltage (12.0 – 15.5 V).
- CONSULT A/C adapter is plugged in.
- Ignition is ON, engine OFF.
- Transmission is in Park.
- All C-III plus / VI cables are securely connected.
- All C-III plus updates are installed.
- Select Home, and restart the reprogram procedure from the beginning.

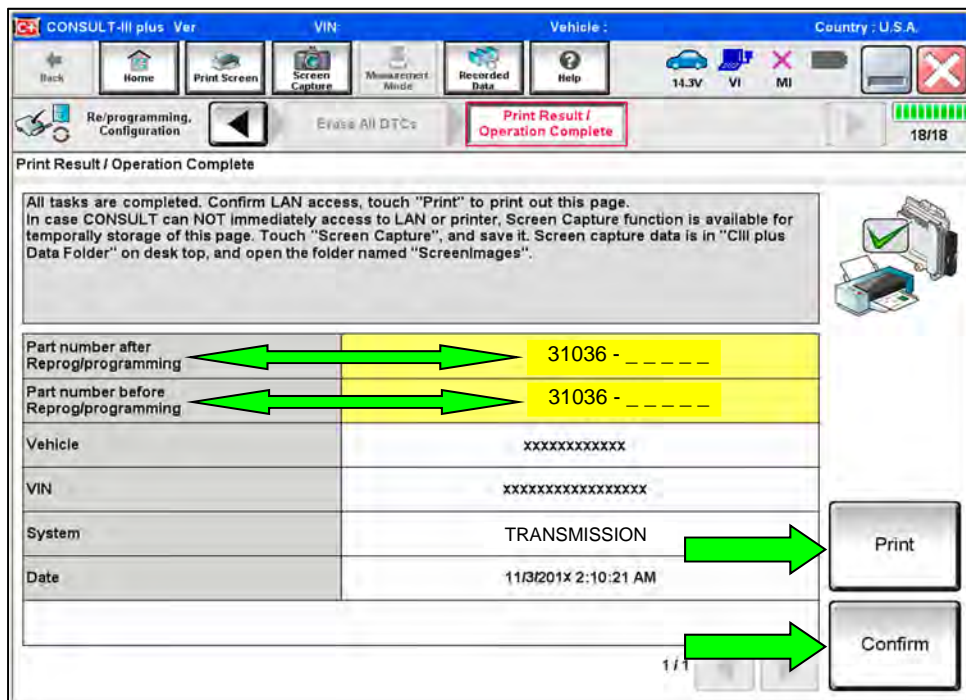
35. Follow the on-screen instructions to **Erase All DTCs**.
 - When the entire reprogramming process is complete, the screen in Figure 27 will display.
36. Verify the before and after part numbers are different.
37. Print a copy of the screen shown in Figure 27 and attach it to the repair order for warranty documentation.
38. Select **Confirm**.
