# TECHNICAL SERVICE BULLETIN

Technical Service Bulletin: 205-1264

Forest River is alerting you to an issue involving certain 2021 – Coachmen Catalina ACAT293QBCKLE travel trailer recreational vehicles. Please see the information below which describes the issue and provides you with details on the steps you should take to have your vehicle repaired.

# TECHNICAL SERVICE BULLETIN 205-1264 REMEDY INSTRUCTIONS

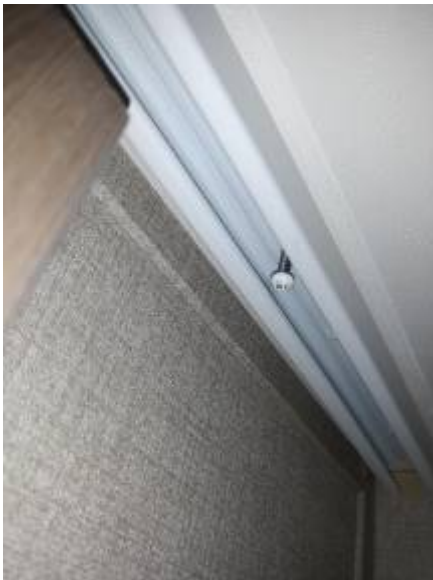
FIGURE 1

- STEP 1: SLIDE ROLLERS ONTO DOOR TRACK AND THEN SECURE TRACK TO CEILING WITH SCREWS (FIG. 1);
- STEP 2: HANG DOOR ONTO ROLLERS AND ADJUST AS NEEDED, CLOSE CLIPS (FIG. 2);
- STEP 3: INSTALL BOTTOM GUIDE ONTO WALL TOWARDS FRONT OF DOOR, ADJUST AS NEEDED (FIG. 3);
- STEP 4: ADJUST DOOR EVEN WITH WALL IN CLOSED POSITION; INSTALL STOP SCREW INTO TRACK TO STOP DOOR FROM OPENING TOO FAR.
- STEP 5: DOOR HUNG INSTALLED AS DESIGNED/INTENDED (FIG. 4)
