# Service Bulletin

Bulletin No.: 20-NA-225

**Subject: Low Battery Charge After Vehicle Sits for Short Period of Time**

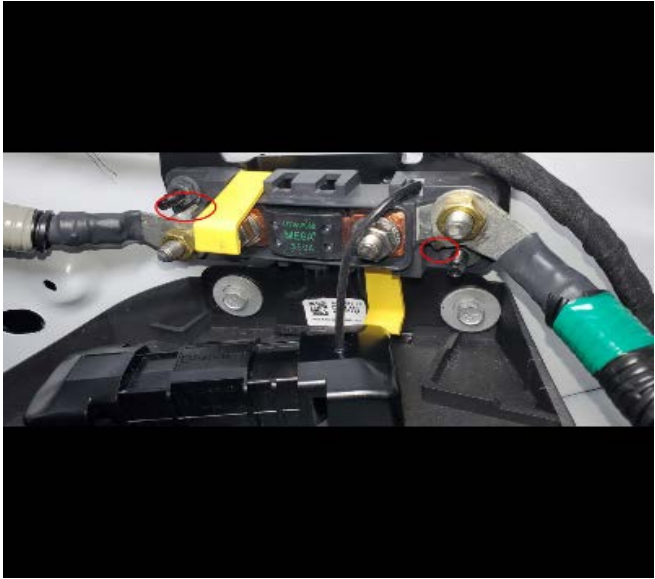
<p style="text-align: right;">5693951</p> <p>– The anti-rotation tabs on the positive side cables, located at the mega fuse, may contact the mega fuse mounting stud nuts.</p>
<b>Correction</b>	Trim the anti-rotation tabs on the positive battery cables located at Mega fuse.

<b>Involved Region or Country</b>	North America, Israel
<b>Condition</b>	Some customers may comment on a low battery charge after sitting for a short period of time.
<b>Cause</b>	<p>This condition may be caused by a voltage draw.</p>
