SPECIAL SERVICE CAMPAIGN 20LC02

FRONT INSIDE DOOR HANDLE MAY BECOME INOPERATIVE

CERTAIN 2016-2019 MODEL YEAR RX350 and RX450h

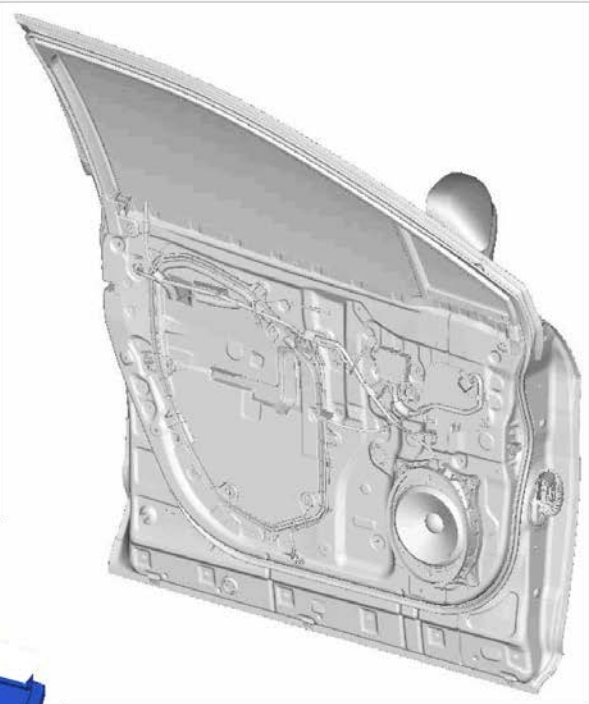
R190729000

PIN

SPRING

INSIDE DOOR HANDLE

FRONT DOOR AIR DUCT

MULTIPLEX NETWORK MASTER
SWITCH ASSEMBLY WITH FRONT
DOOR UPPER ARMREST BASE PANEL

POWER WINDOW REGULATOR
SWITCH ASSEMBLY

FRONT DOOR UPPER
ARMREST BASE PANEL

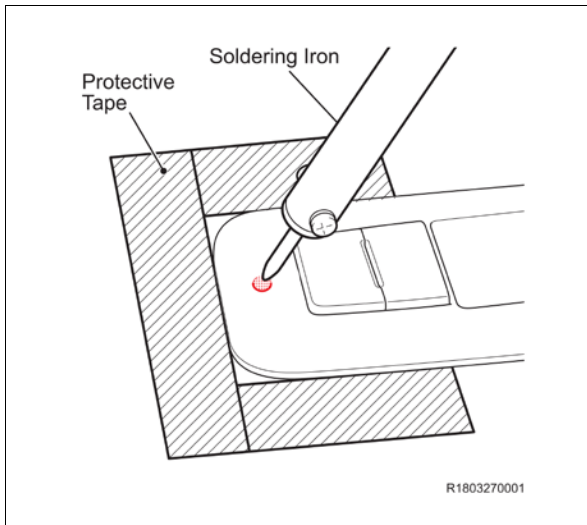
Remove the power window regulator switch assembly with front door upper armrest base panel on the passenger side following the instructions below.

The following procedure is designed to reduce the risk of door panel damage during window switch removal. Do not deviate from the procedure below.

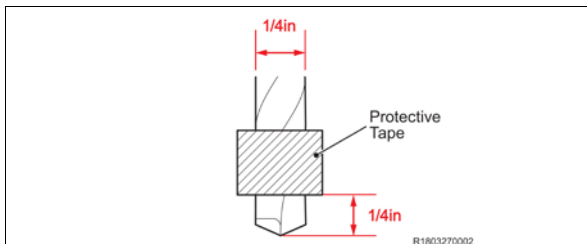
To prevent the drill to go through the hole and damage the part, wrap protective tape around the drill bit at 1/4in from its point.

Be careful not to damage the door panel

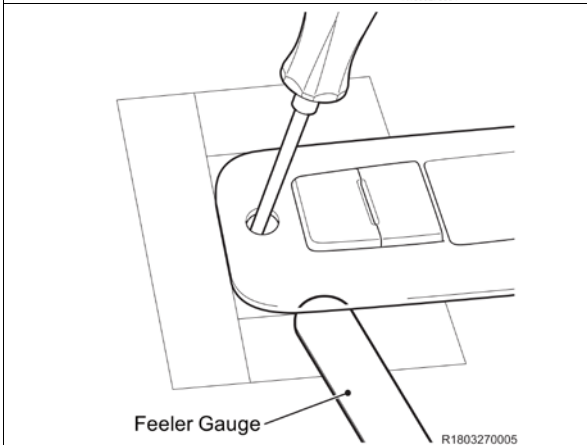
- e) Using a small screwdriver, release the locking tab by inserting the screwdriver into the hole and prying the tab back.

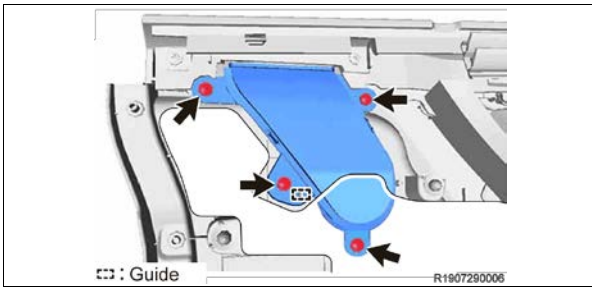
3. REMOVE FRONT DOOR AIR DUCT

- Remove the 4 screws.
- Disengage the guide to remove the front door air duct.

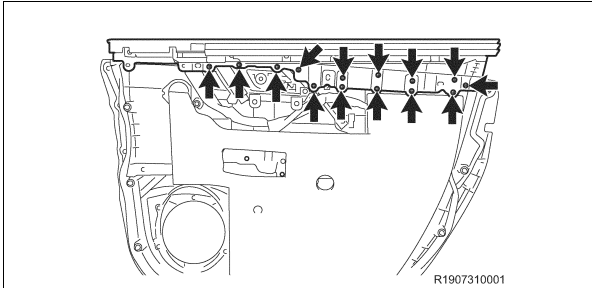
4. REMOVE DOOR TRIM BOARD SUB-ASSEMBLY

- Remove the 14 screws and door trim board sub-assembly.

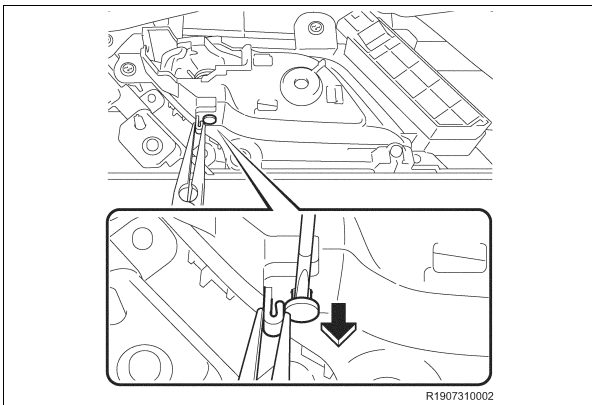
5. REMOVE INSIDE DOOR HANDLE

- Using a screwdriver and needle nose plier, remove the pin.

Cover the spring with a shop towel before removing the pin to prevent it from flying off the door trim board

- Remove the inside door handle and spring.
- Put a mark on the removed inside door handle and store it in a separate container.

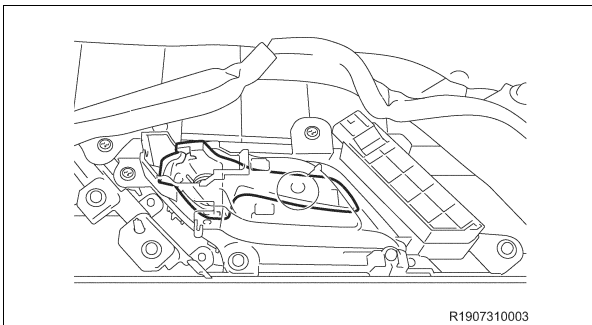
6. INSTALL INSIDE DOOR HANDLE

- Install the **NEW** inside door handle.

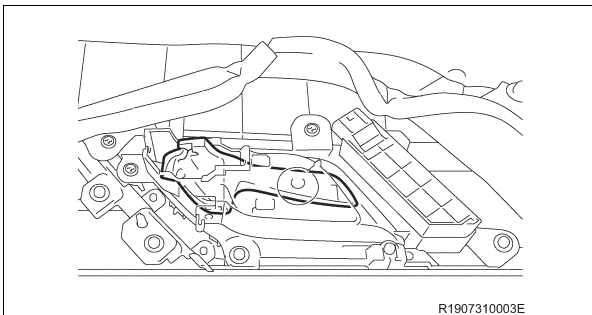
Place the shorter side of the spring end to the groove of the lever

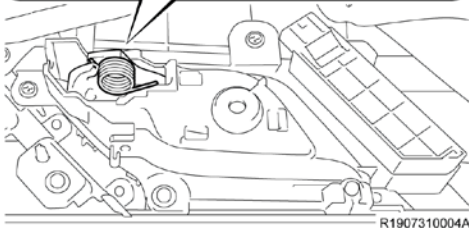
R1907310004A

b) Place the spring as shown in the illustration.

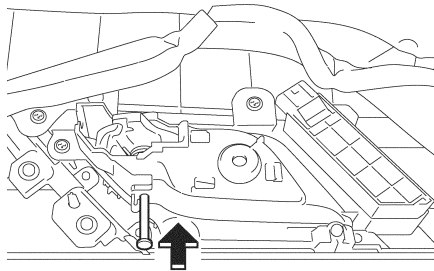
R1907310006

c) While supporting the inside door handle from the bottom, push the spring straight in from the top.

d) Insert the pin.

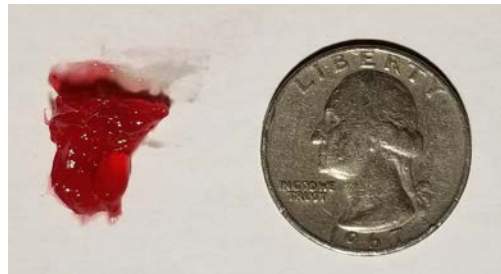
R1907310007

e) Apply the grease (Plus guard SG) to the positions shown in the illustration.

The amount of grease needed for one side is extremely small (0.5g) Below an example of the amount of grease needed per side (2 per vehicle)
