## Service Campaign 70-77

**AFFECTED:** 2021 View & Navion

**SUBJECT:** 2021 Entry Door Strut R&R

## 2021 View & Navion Entry Door Strut

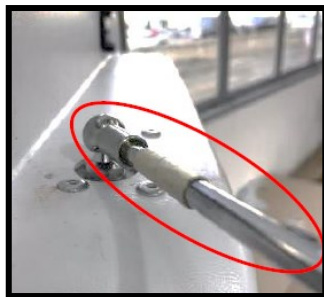
Figure 1

1. Remove the existing gas spring and the screw with spherical head (Figures 1-3). **Retain screw with spherical head (Figure 2) as it is reused.** Insert plastic cap from kit by applying pressure from above and rotating it clockwise (Figure 4).
