# Service Campaign 70-78

**AFFECTED:** 2021 View & Navion

**SUBJECT:** Front Cap Clearance Lights

### Front Cap Clearance Lights

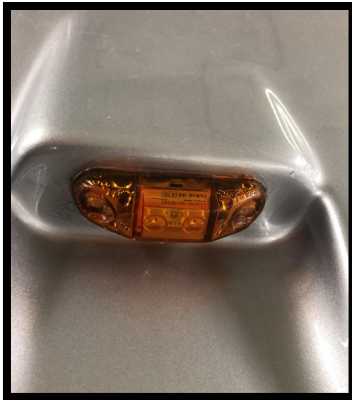
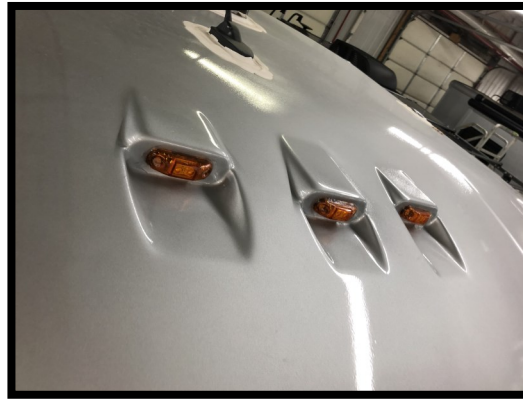
**Overview:** This campaign is to ensure the clearance lights are adequately sealed.

1. Trim any of the gasket that may be bulging around the front cap clearance lights. Cap seal lights using clear sealant around the tops, sides and bottom of the lights. Tool sealant to ensure no gaps or voids exist.
