BULLETIN

Subject: Installation of Galvanic Barrier

No.: B20008

Re.: Installation of Galvanic Barrier to the Aeroskirt Spring Posts Type: Technical

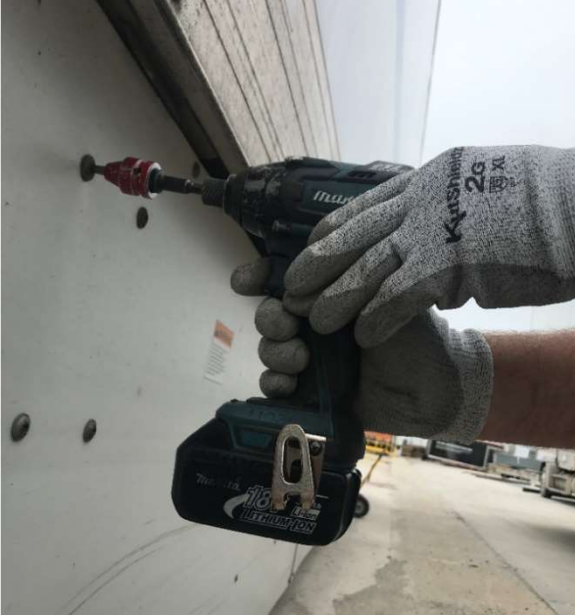
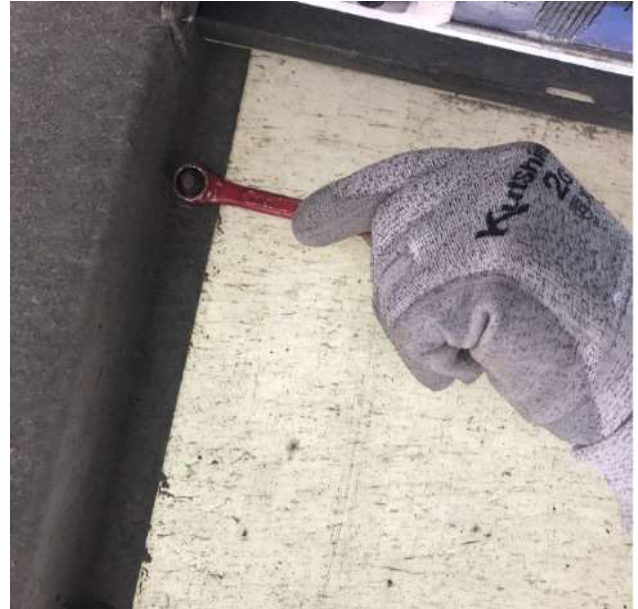
1. Remove all fasteners connecting the Aeroskirt panels to the four Spring Posts.

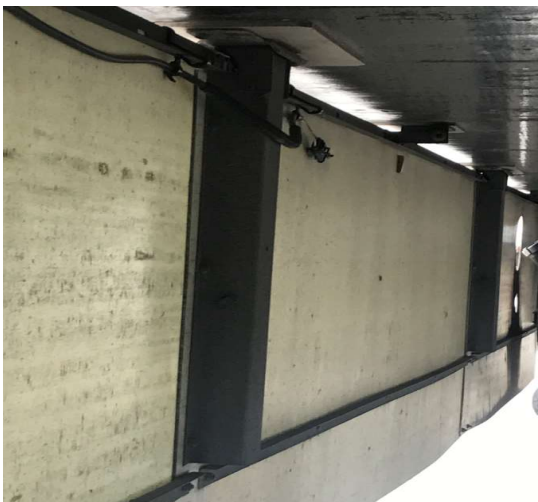
Before

2. Once all screws attaching the panels to the posts have been removed, flex the Spring Post inwards and push / pull the skirt panels away from the post allowing the skirt panels to hang from the tethers. There will be one factory installed tether per panel for the skirt to hang from.

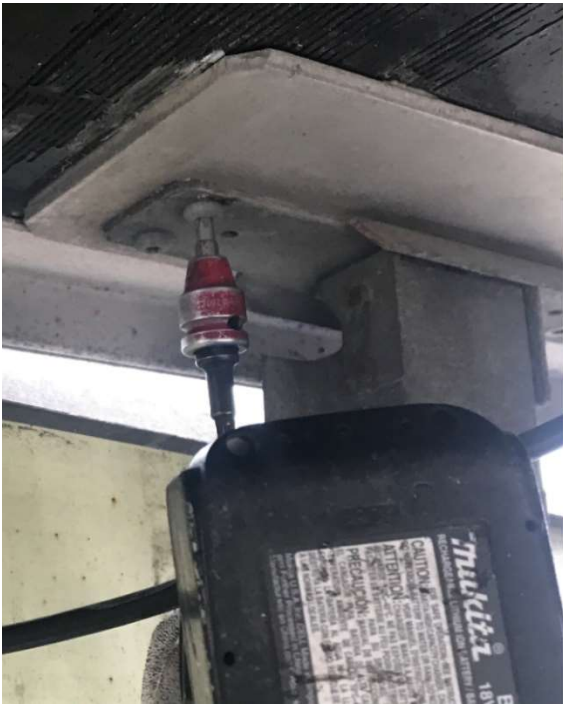
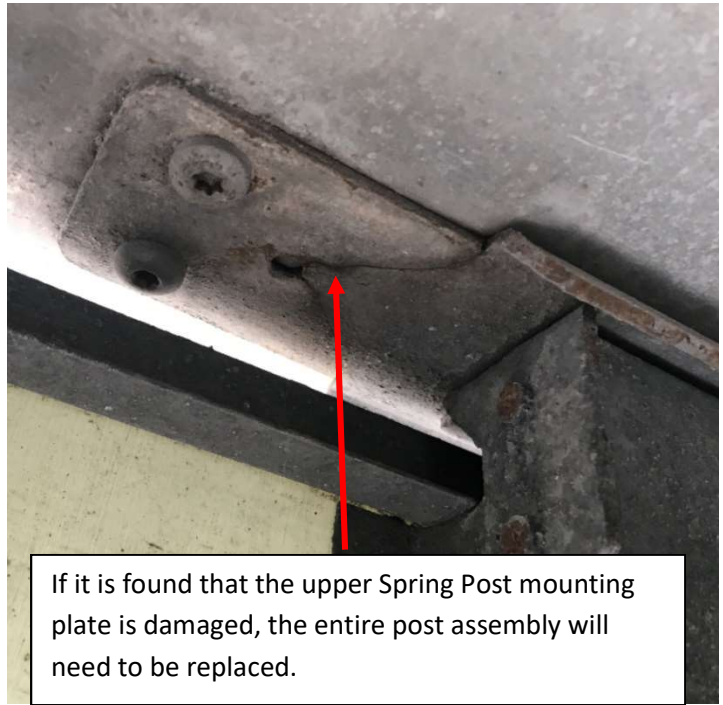
3. Remove the bolts securing the Spring Posts to aluminum mounting plates.

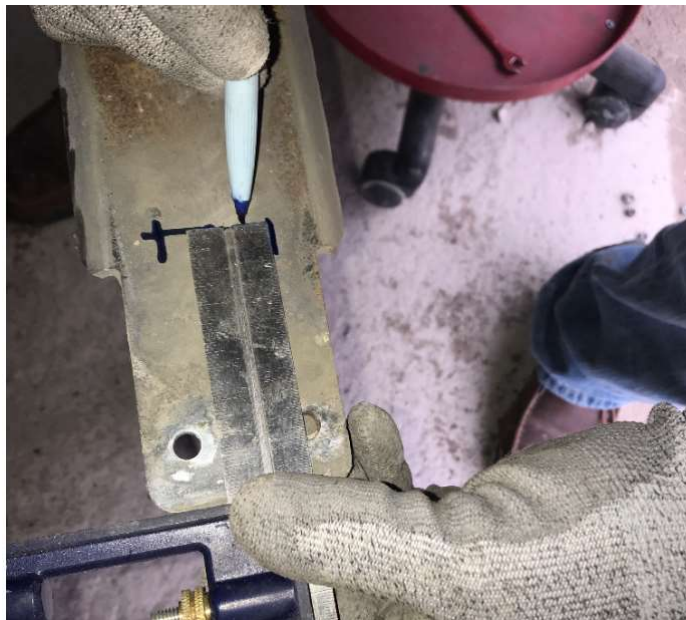
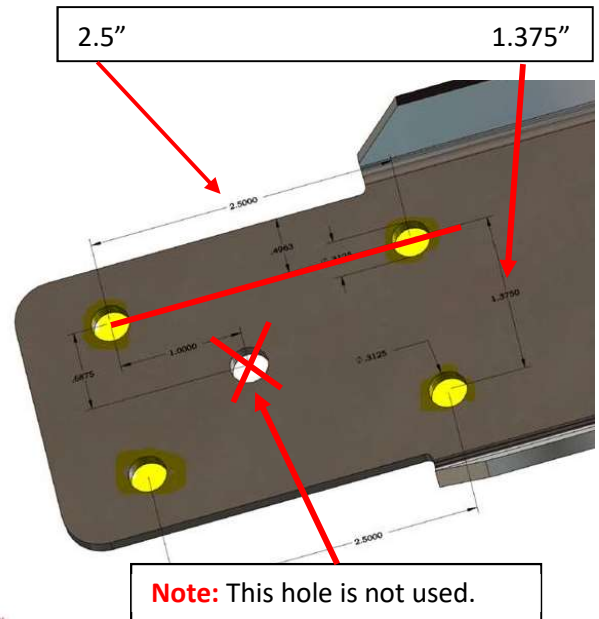
4. Once the Spring Posts have been removed locate the drilling locations for adding the additional bolts.

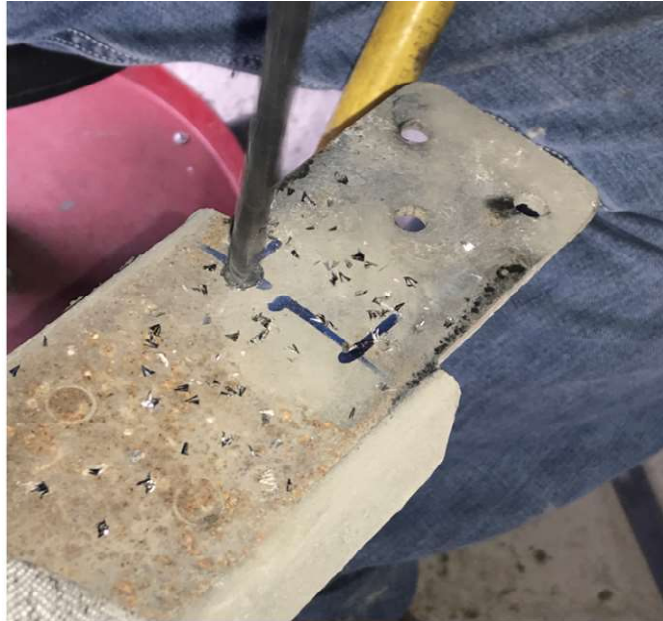
5. Once the posts have been marked for drilling, drill from the top down using a 5/16" drill bit. You will need to drill four additional holes per post assembly.

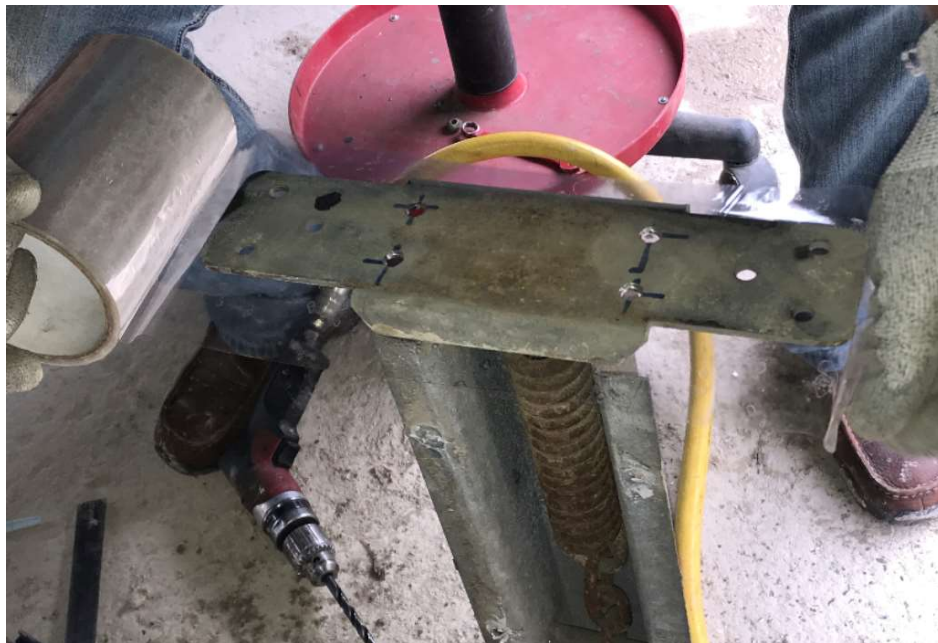
6. Once all four holes have been drilled, apply the 21100015 Barrier tape to the topside of the Spring Post assemblies.

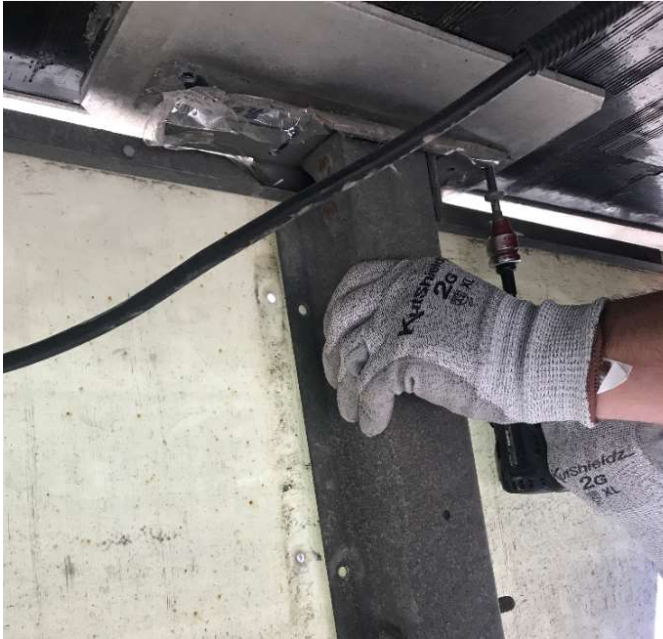
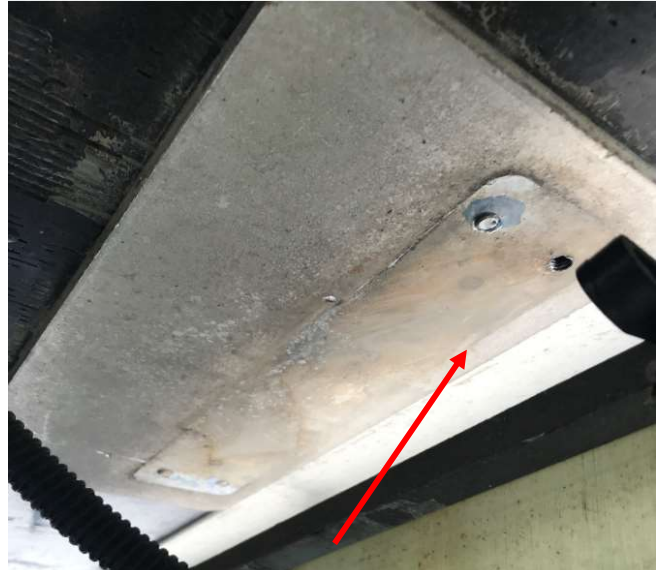
7. Once all holes have been drilled, and the barrier tape applied to the topside of each post assembly, reinstall the post assemblies using the original mounting holes. When running the bolts in with the impact stop short of tight, as these will be torqued to 15 ft. lbs. later in step 9

If a mounting screw broke off during the removal of the Spring Post assembly, no action is required. The additional 4 screws were added for this reason.

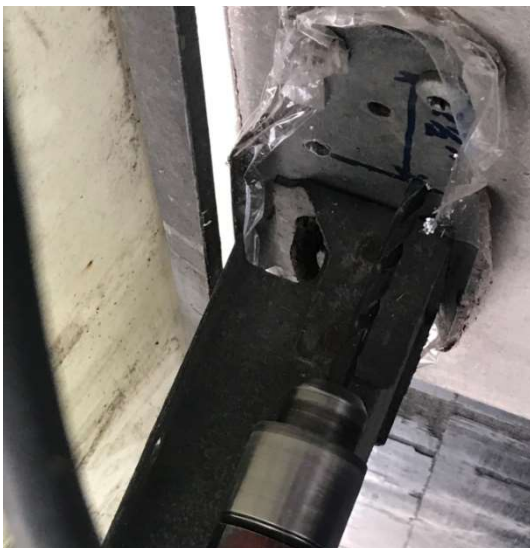
8. Once the Spring Posts are in place, using the newly pre-drilled holes as a guide, drill up through the aluminum mounting plate and into the bottom of the MSC floor using a 9/32" drill bit.

Note: When drilling through the aluminum plate it vey important to drill the hole as straight as possible so that the entire circumfrance of the bolt head seats flat against the mounting plate.

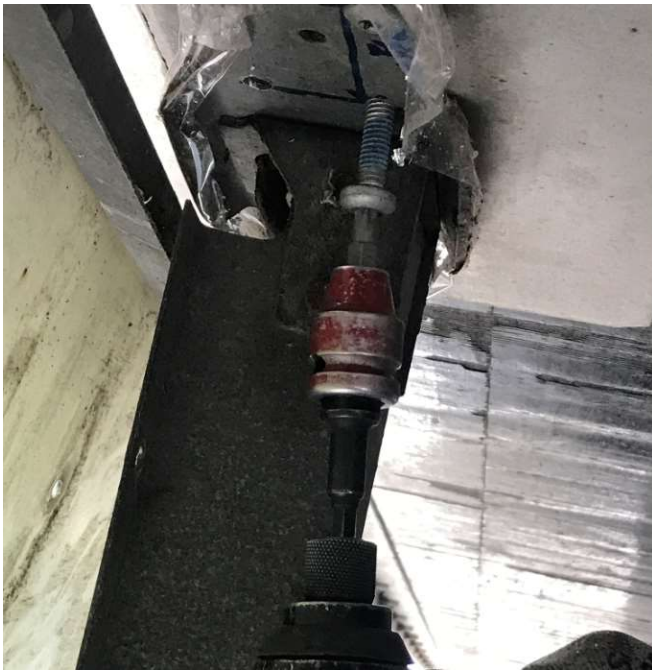
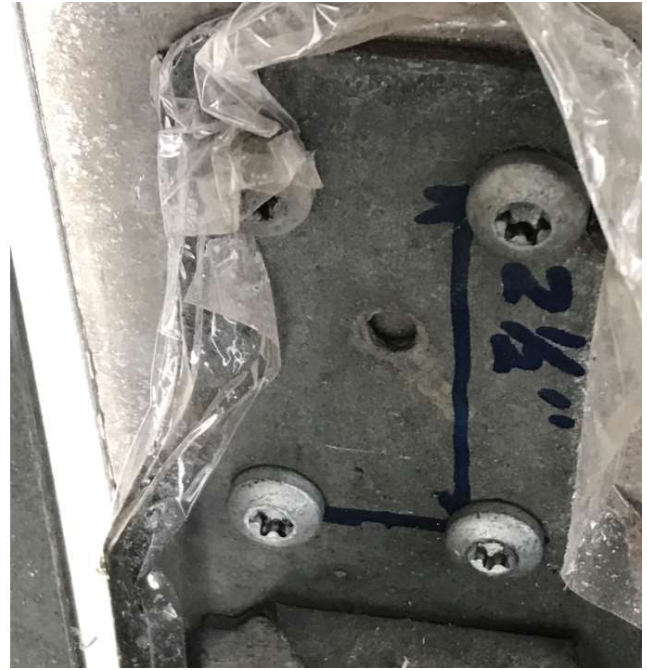
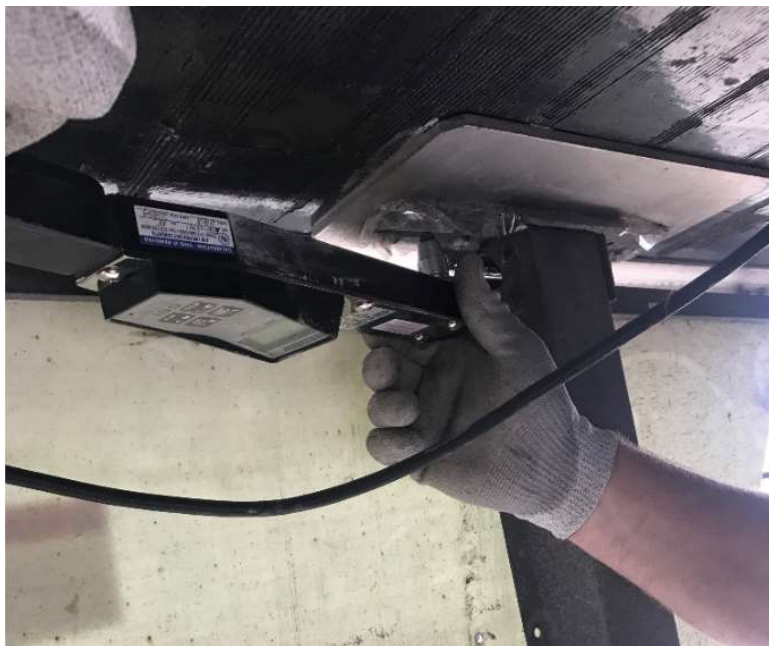
9. Once the holes have been drilled, install the 4 additional bolts in each of the four spring posts. When running the bolts in with the impact stop short of tight so you may finish the installation with a torque wrench. To prevent damage to the bolt and the aluminum plate, torque all installed spring post mounting fasteners to 15 ft. lbs. +or- 1 ft. lbs..

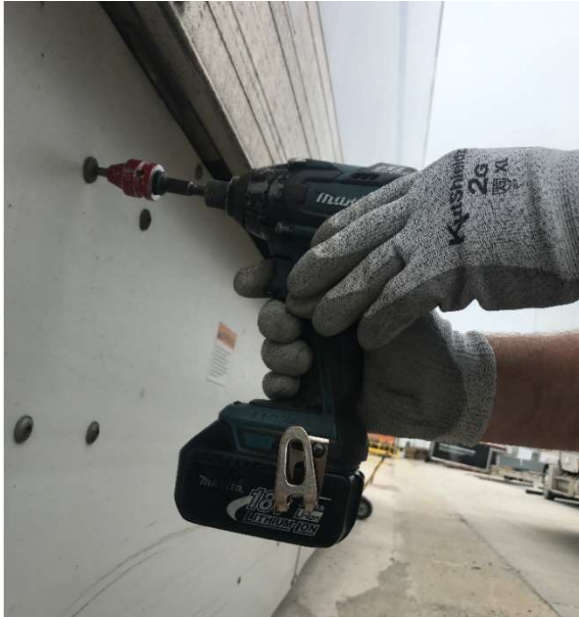
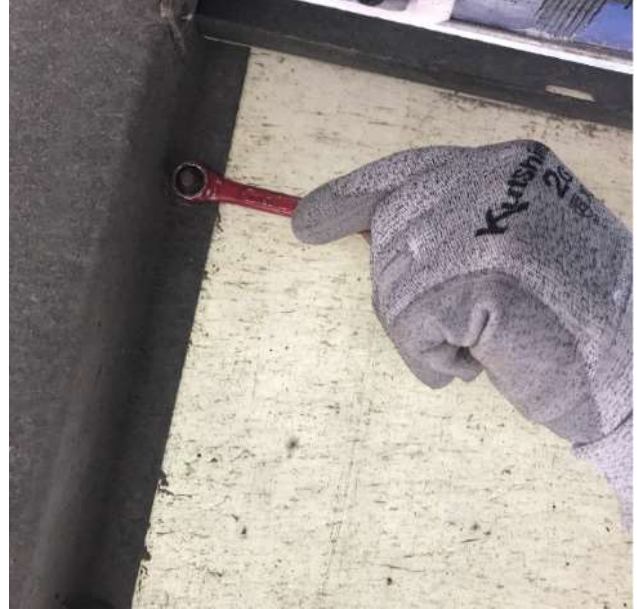
10. Once the additional bolts have been secured into all 4 Spring Posts, re-attach the skirt panels to the posts, re-using the pre-existing hardware.

Repeat steps 1 thru 10 on the opposing side of the unit.
