| S.A.T. | 245 MV |

# Service Bulletin

Subject: Tire pressure label

Product: Brutale 1000 Serie Oro - RR from vin ... LV000011 to vin ... MV000294

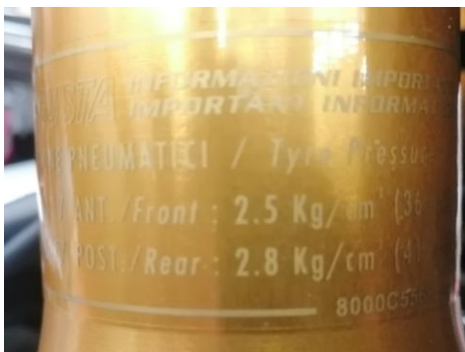
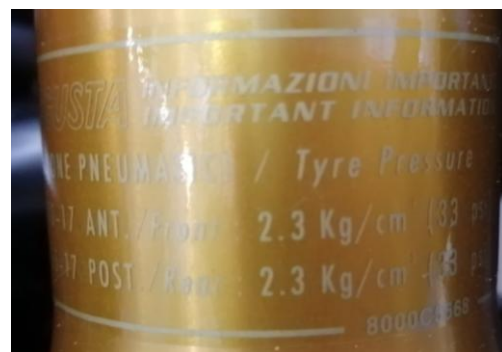
It will be possible to identify the part that needs to be replaced by observing the pressure values shown on the label placed on the right fork leg and identified by the cod. 8000C5568;

The correct tire pressure values for the B4 1000 Serie Oro and RR are the following:

**Front tire: 2.3 bar (cold condition)**

**Rear tire: 2.3 bar (cold condition)**

**All labels showing values other than those listed above must be replaced.**

We kindly ask you to replace the label BEFORE delivering the vehicle to the end customer. For the bikes already sold, we ask you to replace the label on the first useful occasion.

**We ask you to check and, if necessary, replace the label during the pre-delivery phase, during a maintenance service or at the first useful opportunity at your workshop.**

After the validation of the warranty claim by the MV Agusta Technical Assistance Service, you will automatically receive the replacement part no. 8000C5568 for the replacement of the tire pressure indication label.
