## **Customer Satisfaction Notification W60 Rear Axle Hub Nut**

**2020 (VF) Ram ProMaster**

The rear axle hub nut on about 300 of the above vehicles may not have been properly crimped.

Verify proper axle nut torque, and crimp to prevent loosening.

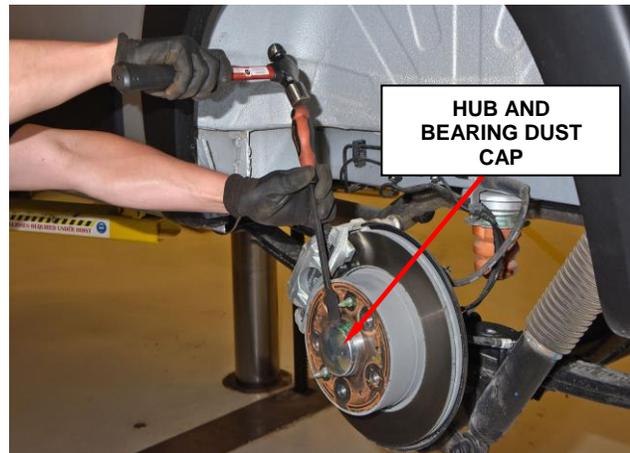
Figure 1 - Hub and Bearing Dust Cap

1. Raise and support the vehicle.
2. Remove the wheel mounting bolts, then the rear tire and wheel assembly.
3. Remove the hub and bearing dust cap (Figure 1).

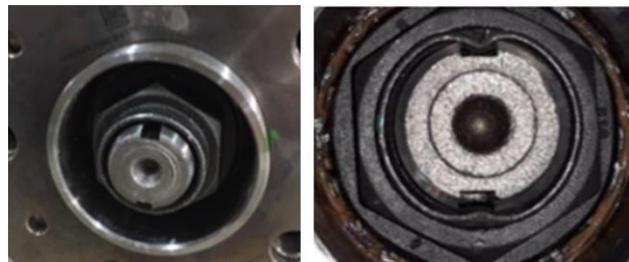
Figure 2 – Un-Crimped and Crimped Nut

4. Is the nut crimped (Figure 2)?
  - If the nut is not crimped, proceed to step 5.
  - If the nut has been crimped, proceed to step 8.

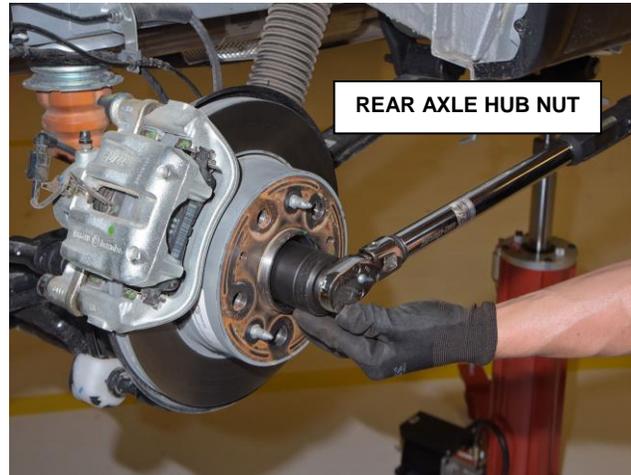
**Figure 3 – Rear Axle Hub Nut**

5. While a helper applies the brakes, tighten the nut to 408 N·m (301 ft. lbs.) (Figure 3).

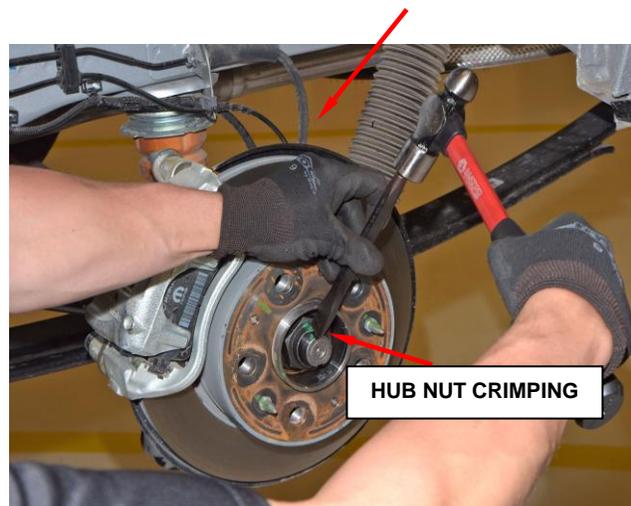
**Figure 4 – Hub Nut Crimping**

6. Using the chisels leading cutting edge, crimp the hub nut (Figure 4).

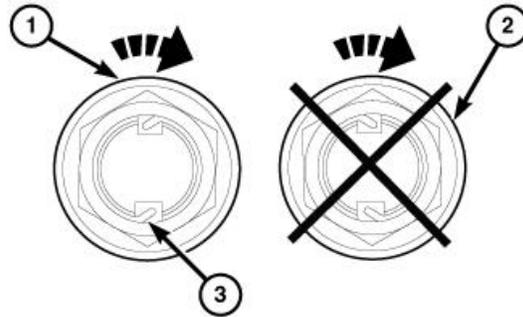
**Figure 5 – Hub Nut Crimping**

7. The hub nut must be staked so that it looks similar to (1) in Figure 5. Both edges must be split and bent into the shape shown (3). The staking must be in the opposite direction from the forward rotation of the wheel.

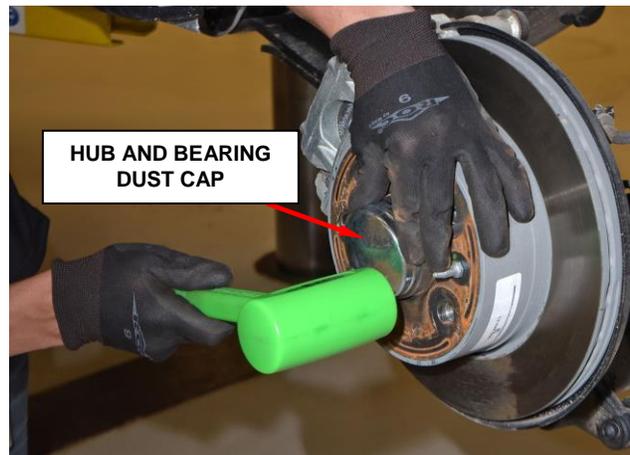
**Figure 6 – Hub and Bearing Dust Cap**

8. Install the hub and bearing dust cap (Figure 6).

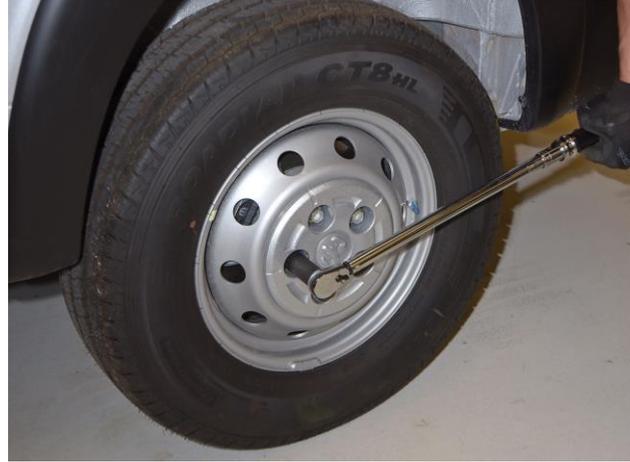
**Figure 7 – Torque Wheel Bolts**

9. Install the tire and wheel assembly. Progressively tighten all five wheel mounting (lug) bolts in a star pattern. Tighten wheel (lug) bolts to 197 N·m (145 ft. lbs.) (Figure 7).
