STAR ONLINE PUBLICATION

Case Number: S2021000003

Symptom/Vehicle Issue: Check Engine Light Is On, Vehicle Speed May Be Limited, Shifting May Be Erratic

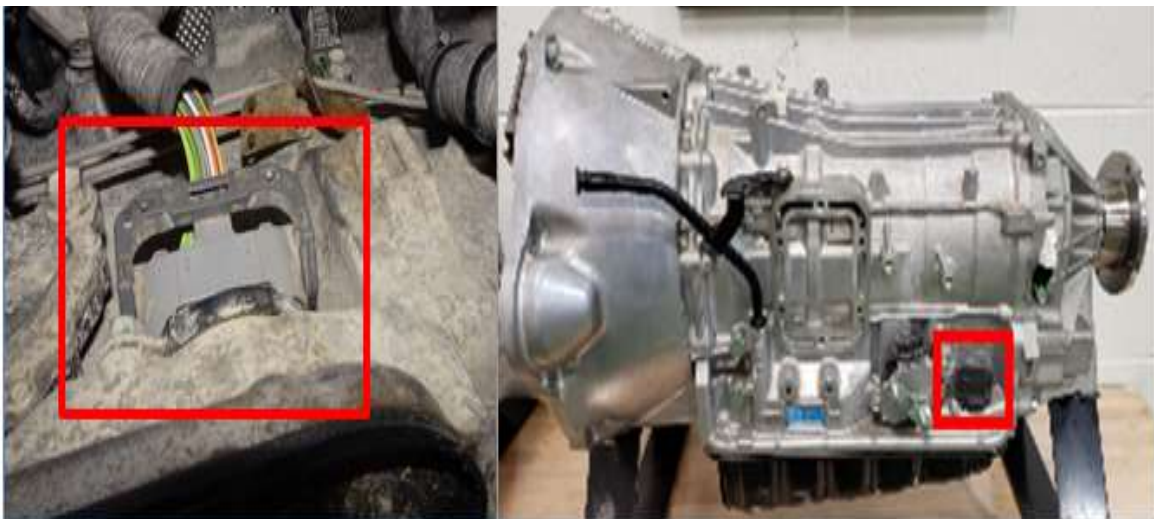
Fig 1-1

Repair Procedure: Inspect the transmission housing main connector on the left side of the transmission housing located toward the rear of the transmission case. Inspect the connector for any signs of loose or pushed out terminals or poorly secured connectors Fig 1, 2, 3.

Clean, repair or replace any affected transmission case connectors using the FCA approved connector and circuit repair guidelines. Secure any pushed out terminals or weather seals to ensure no water entry. If no transmission case connector or terminal damage is located at the transmission case connector, inspect the inline harness connector XY107A – 34-way black connector at the location shown below for any potential suspect circuit terminal issues and repair as needed.
