NUMBER: 25-003-20

Evaporative Emission Control System (EVAP) Purge Line Kinked

2020	(LA)	Dodge Challenger
2020	(LD)	Dodge Charger
2020	(LX)	Chrysler 300

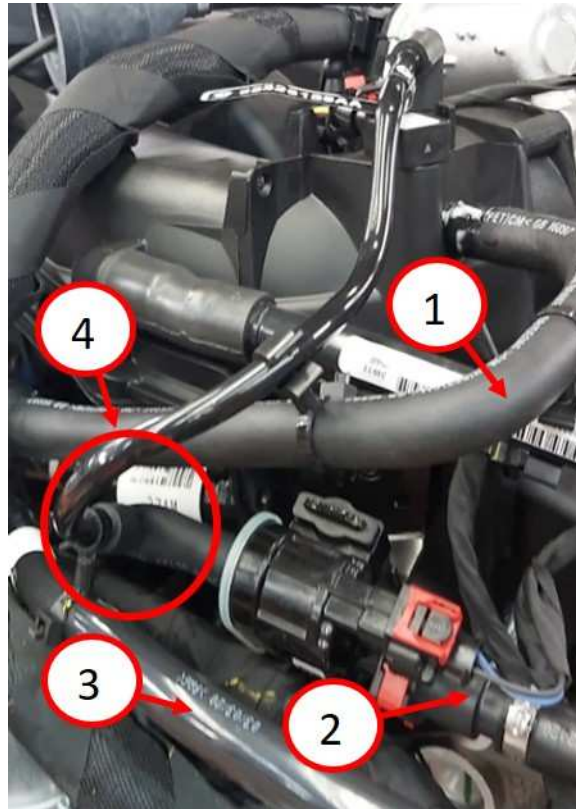
Fig. 1
Kinked Purge Line Elbow

Customers may experience a Malfunction Indicator Lamp (MIL) illumination. Upon further investigation the technician may find that one or more of the following Diagnostic Trouble Codes (DTCs) has been set:

- P0441 - EVAP Purge System Performance.
- P0452 - EVAP Pressure Switch Stuck Closed.

1. Open hood.
2. Inspect for kinked and/or improperly routed purge line (Fig. 1) .

- 1 - Brake Booster Hose
- 2 - Purge Line
- 3 - Make-up Air Hose
- 4 - Kinked/Pinched Purge Line Elbow

3. Is P0441 or P0452 active and the purge line elbow kinked?
 - YES>>> Proceed to [Step 1](#) of the Repair Procedure.
 - NO>>> This bulletin has been completed, use inspect LOP (25-01-17-9E) to close the active RRT. Normal diagnosis should be performed.

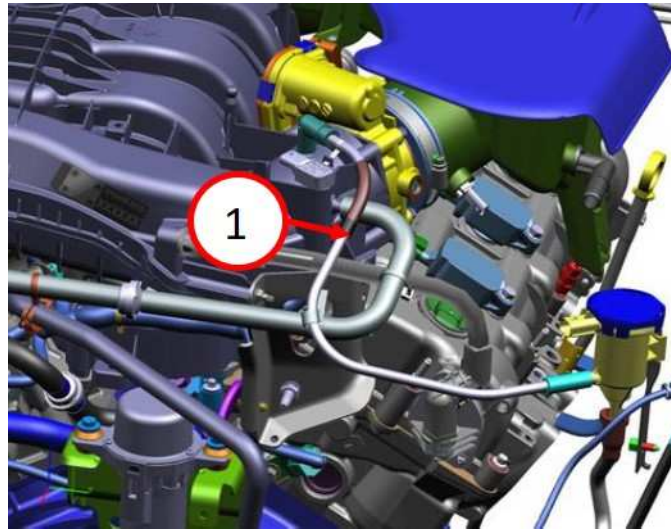
**Fig. 2
Purge Line Routing**

1 - Purge Line

1. Remove purge line from brake boost tube.

2. Install the new purge valve assembly. Re-route purge line behind brake boost tube (Fig. 2) .

NOTE: Remove the original clip that held the purge line to the brake booster line and discard.

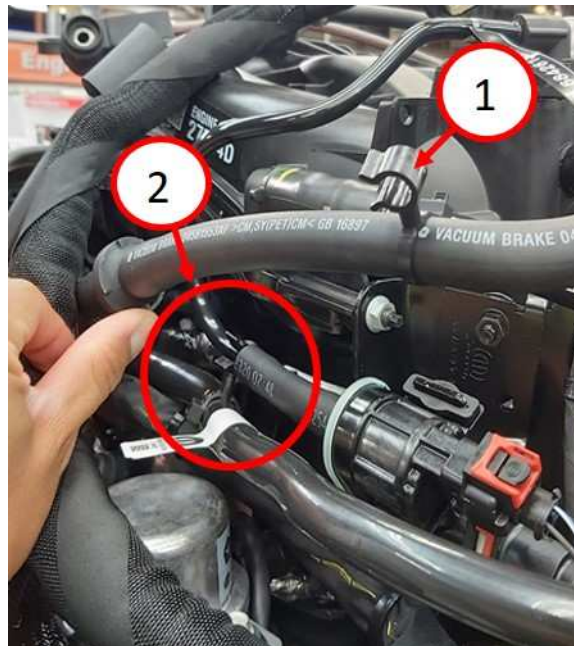
**Fig. 3
Correct EVAP Purge Line Elbow**

1 - Brake Boost Tube Clip
2 - Non-pinched Purge Line Elbow

3. Remove clip from brake boost tube (Fig. 3) .
