| INTERIOR | 20-BD-003G |
| February 2020 | G80 (DH) |

Technical Service Bulletin

SUBJECT: SEAT BACKBOARD CLIP REPLACEMENT

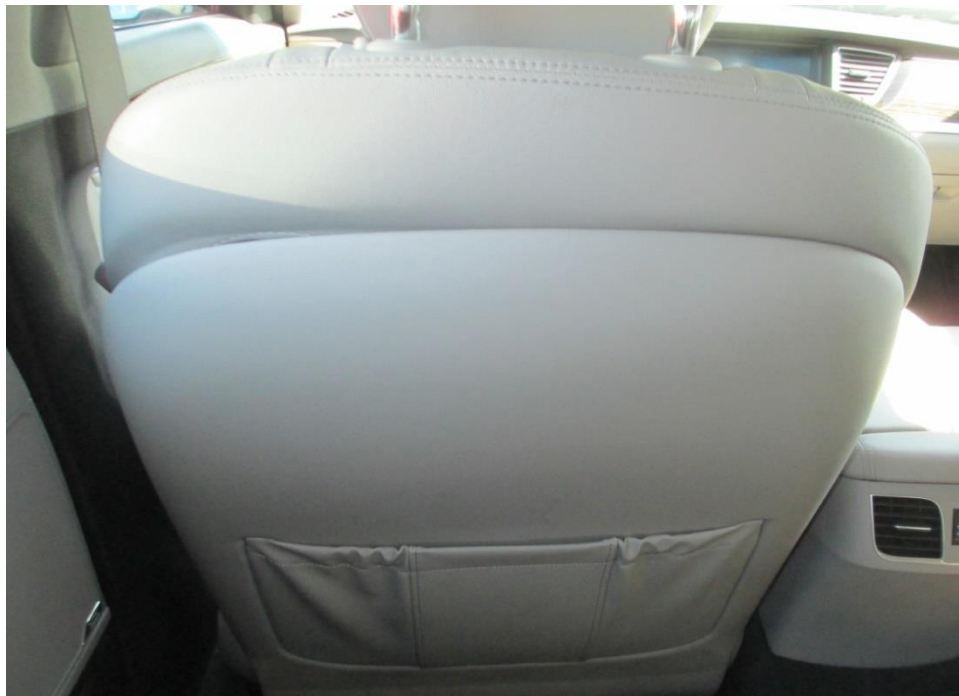
Description: Certain 2019-2020 G80 (DH) vehicles may have a condition where the seat backboard comes loose. This bulletin describes the procedure to replace the seat backboard clip.

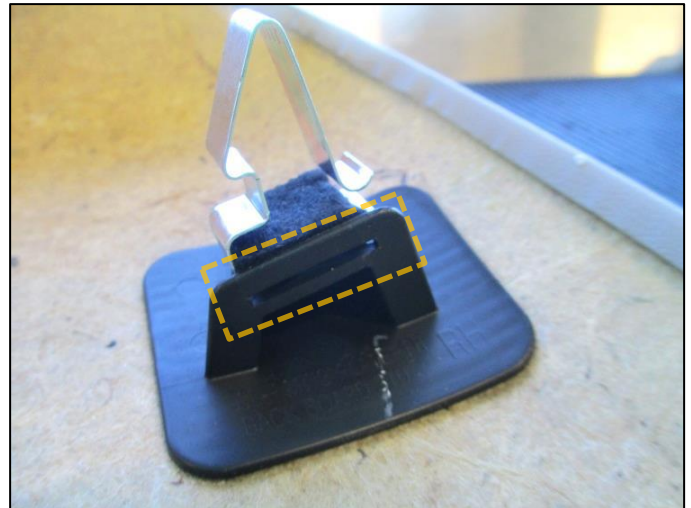
The base clip is normal.

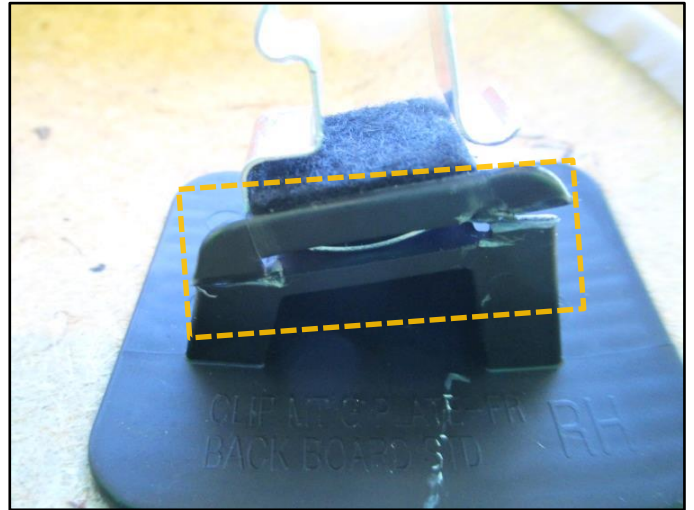
The base clip is broken.
