Technical Service Bulletin

68 Glove box door is binding when opened or close

68 21 30 2060899/3 January 14, 2021. Supersedes Technical Service Bulletin Group 68 number 20-26 dated December 2, 2020 for reasons listed below.

Model(s)	Year	VIN Range	Vehicle-Specific Equipment
Q5, SQ5	2019 - 2020	All	Not Applicable
Q5, SQ5	2021	000001 - 006020	Not Applicable

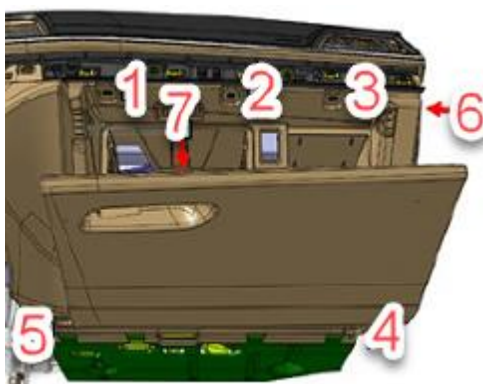
Figure 1. Glove box bolt tightening sequence

1. Loosen all 7 glove box bolts (Figure 1).

2. While pulling the glove box door outward in direction of the A-Pillar, tighten the glove box bolts according to the sequence outlined in this TSB (Figures 1 - 2).

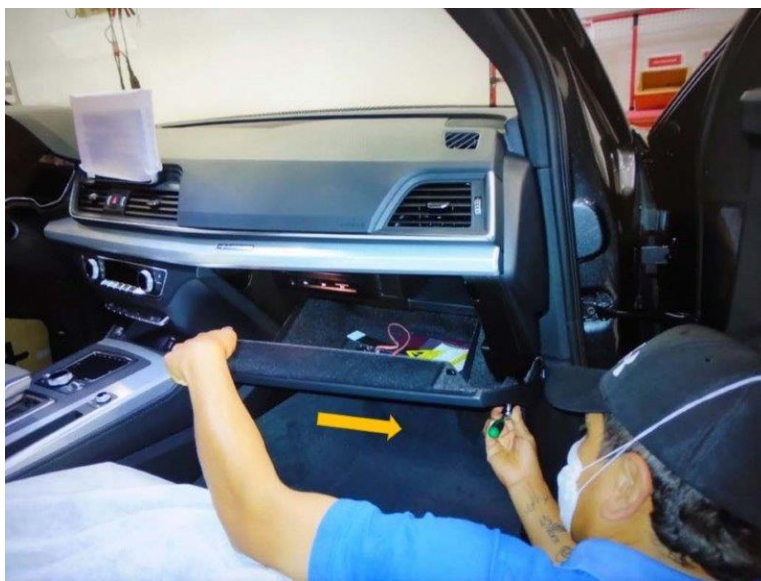
Figure 2. Adjusting the glove box to increase clearances.

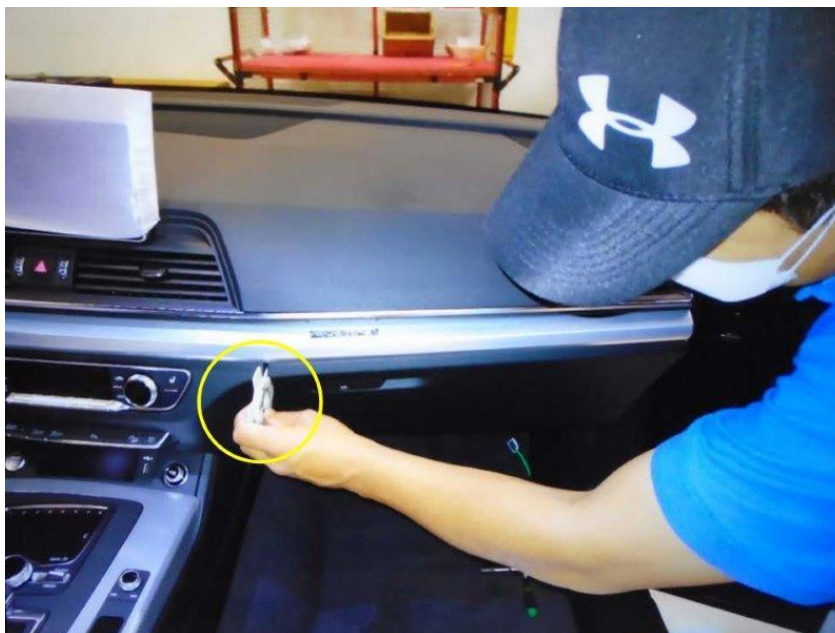
Figure 3. Checking the gap between the glove box door and the center console.

3. Check the gap between the center console and the glove box door to ensure adequate clearance (Figure 3).
