## A/C Leaks Due to Bulkhead Insulator Fibers

Year	Model	Trim
2017-20	CR-V	ALL

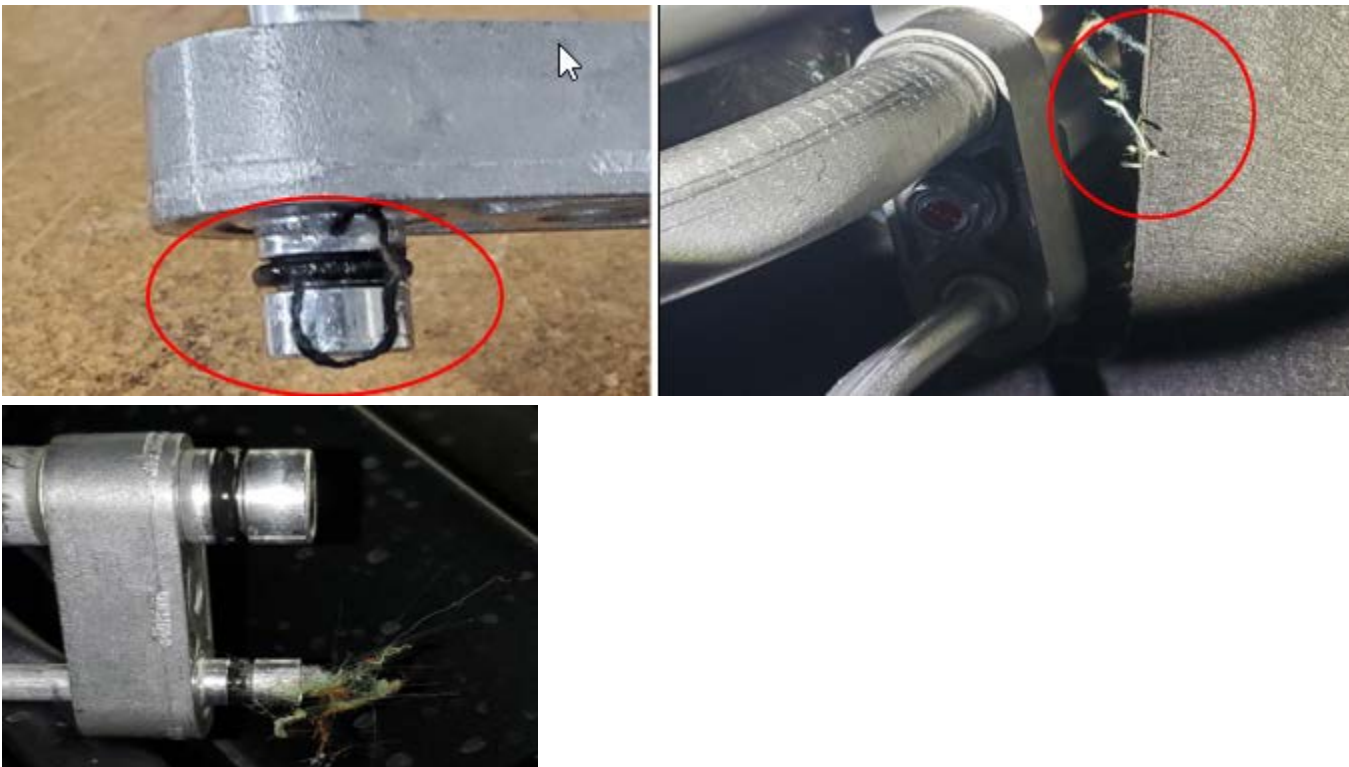
Before replacing a compressor or discharge hose for pressure leaks or not blowing cold, verify that no fibers are found on the O-rings section of the hose at the bulkhead of the vehicle.

If found, remove the fibers and replace the O-rings, then recharge the A/C system.
