2021MY  
K5 (DL3a)

PS684

SUBJECT: FUEL DOOR STUCK CLOSED - ACTUATOR REMOVAL

This Pitstop provides information to show an alternative way to access and remove the fuel door actuator on 2021MY K5 (DL3a) vehicles, to help minimize breaking of the fuel door lid when the fuel door has a stuck closed condition. Follow the steps outlined in this Pitstop to remove the fuel door actuator.

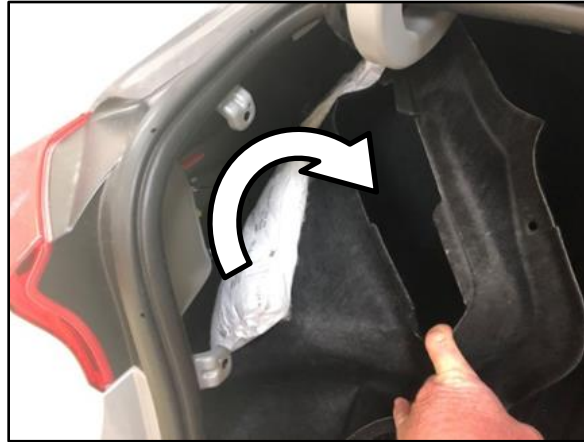
3. Fold back the left side trunk liner and be careful not to cause damage when folding.

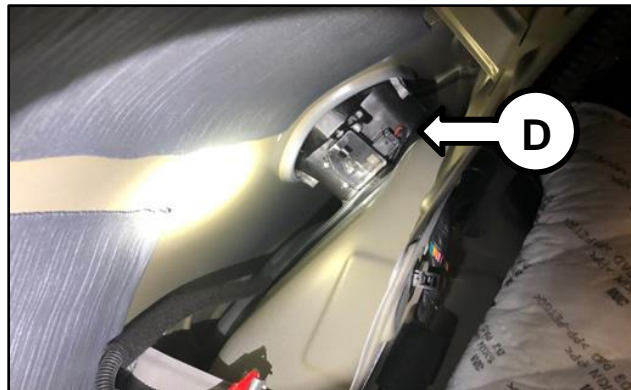
7. Install the new fuel door actuator in the reverse order of removal and confirm normal operation of the fuel door. Re-install all removed parts in the reverse order of removal.
