RECREATIONAL VEHICLE SERVICE CAMPAIGN

SERVICE ADVISORY 21-396

SERVICE ADVISORY # 21-396

Voltage-Yukon Self-Leveling Roof Sealant

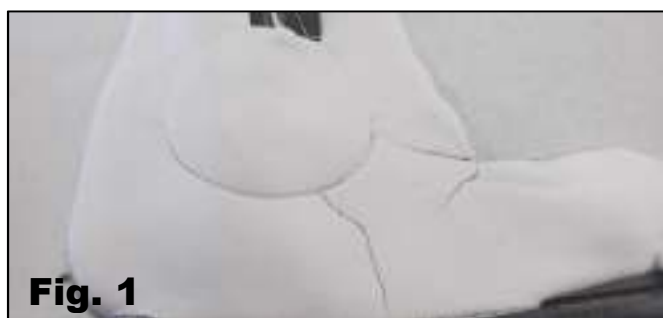
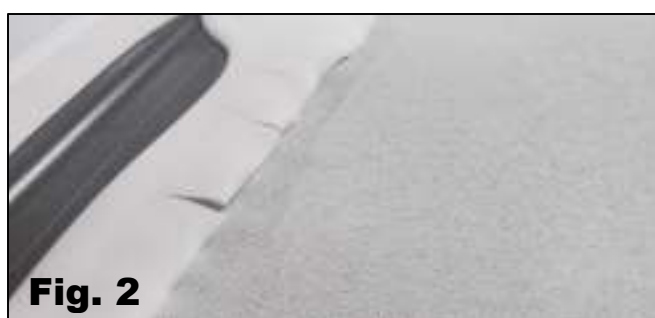
It has been determined certain Voltage-Yukon trailers may have defective self-leveling roof sealant that exhibits a hard, cracked appearance. The defective sealant exhibits poor adhesion and cracking within 96 hours of application and can be easily removed from the roof by pulling it up by hand. A visual inspection will reveal the defective sealant lifting from the roof due to poor adhesion properties. The following procedure describes how to correct the issue. Campaign closes May 30, 2021.

The remedy is to inspect the self-leveling roof sealant and replace if cracked and lifting. See Figure 1 and 2.

Step 1. Test the adhesion properties by pulling the sealant by hand.

Step 2. If it is not easily removable by hand then it is adhered properly and will be left in place. In these cases, touch up or reseal any void at the base edges of the existing bead seal and reseal any surface cracks as necessary.

Step 3. If the sealant can be easily removed by hand, remove it and apply new self-leveling roof sealant per the instructions on the caulk tube. The roof must be clean and dry when applying sealant.
