165/20enu WLK3

WLK3 - Checking Electric Plug Connection for Rear Seat-Belt Buckles and Plugging it in Correctly if Necessary (Workshop Campaign)

Vehicle Type:	Taycan 4S (Y1A)/Taycan Turbo (Y1A)/Taycan Turbo S (Y1A)		
Model Year:	As of 2020 up to 2021		
Concerns:	Electric plug connection for rear seat-belt buckles		
Information:	There is a possibility that some electric plug connections for the rear seat-belt buckles were not plugged in correctly on the affected vehicles.		
	As a result, there is no guarantee that the relevant seat belt warning lights for the rear seats will be displayed correctly.		
Action Required:	 Check function of the seat belt warning lights for the rear seats Depending on the result of the check, plug in the electric plug connections for the rear seat-belt buckles correctly 		
Affected Vehicles:	Only vehicles assigned to the campaign (see also PCSS Vehicle Information). This campaign affects 5 MY20 vehicles.

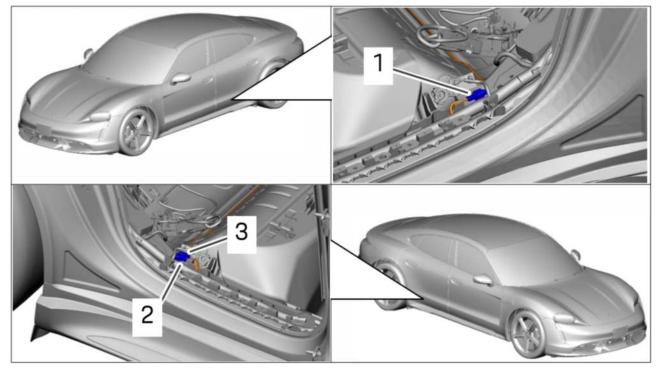
Installation position of electric plug connection for rear seat-belt buckles

- 1 Electric plug connection for left rear seat-belt buckle (plug in correctly if necessary)
- 2 Electric plug connection for right rear seat-belt buckle (plug in correctly if necessary)
- 3 (Depending on equipment) Electric plug connection for center rear seat-belt buckle (**plug in correctly if necessary**)
