## Field campaign

<b>Topic</b>	Replacement of veneered parts due to incorrect specification (SC 21/01)
<b>Market area</b>	China 796 VW Import Comp. Ltd (Vico), Beijing (6796),United States E05 Bentley USA and rest America (6E05)
<b>Brand</b>	Bentley
<b>Transaction No.</b>	2061944/1
<b>Campaign number</b>	EB82
<b>Note</b>	
<b>Type</b>	
<b>US code</b>

### New Flying Spur

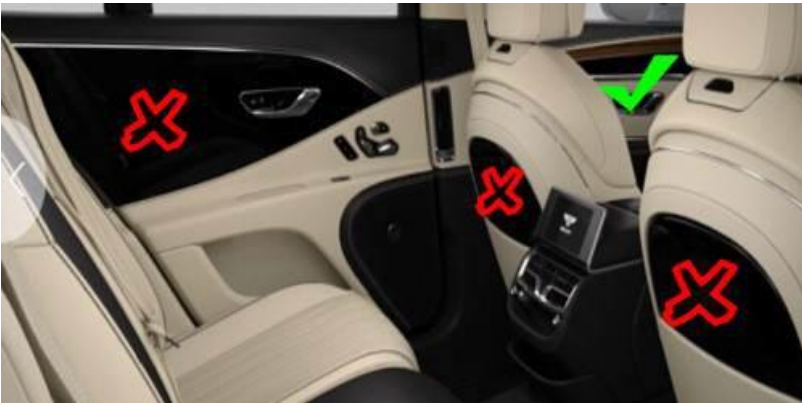
Incorrect veneer infills fitted to the following components: (Depending on VIN)

- Right and left picnic table veneer infills

- Right and left rear door pad veneer infills

Referring to the Figure 1, the rear door infills and/or picnic table veneers are incorrect as they do not match the dual option colour specification (Refer to the front door infill shown in Figure 1 as an example)

### Remedy

Refer to the work section

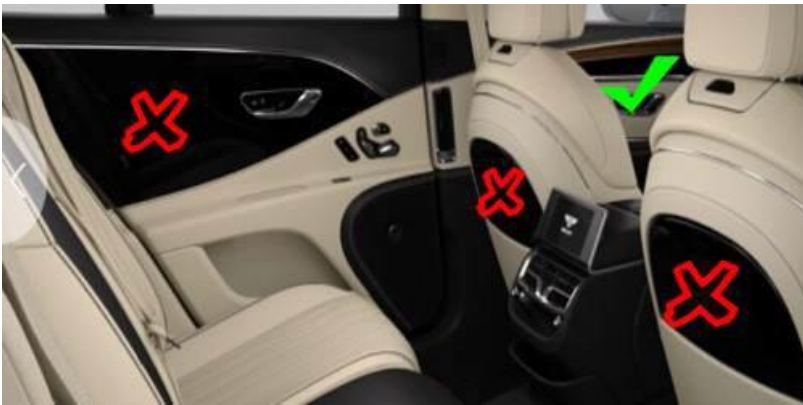
Incorrect veneer infills fitted to the following components: (Depending on VIN)

- Right and left picnic table veneer infills

- Right and left rear door pad veneer infills

Referring to the Figure 1, the rear door infills and/or picnic table veneers are incorrect as they do not match the dual option colour specification (Refer to the front door infill shown in Figure 1 as an example)

Rear door and picnic table veneer replacement VIN's - SCBBB6ZG7MC085304 - SCBBB6ZG1MC085380

- 1) Replace the right and left rear door parts as received
- 2) Replace the right and left hand picnic table veneered parts (Refer to the attached PDF as guidance)

Picnic table veneer replacement VIN - SCBBZ 53S7MC085435

- 1) Replace the right and left hand picnic table veneered parts (Refer to the attached PDF as guidance)
