JLRTB02070NAS1

**TECHNICAL BULLETIN**

Cloth Seat Staining - Cleaning Procedure

MODEL:	MODEL YEAR:	VIN:	ASSEMBLY PLANT:
Defender (LE)	2020 Onwards	000002 Onwards	Nitra (Slovakia)

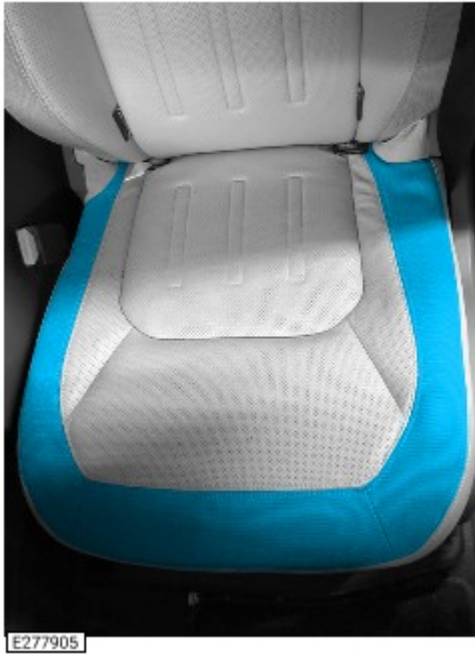
2.

Front cushion cover.

Only complete the Service Instruction on the area of the seats highlighted blue in the Service Information illustrations.

Using a suitable sized wet vacuum nozzle attachment, clean the cloth areas of the backrest and cushion seat covers.

- **1.** Soak the area with clean water using the wet vacuum nozzle attachment.
- **2.** Apply enough pressure with the nozzle attachment to depress the seat cover cloth.
- **3.** Slowly pull the nozzle attachment across the seat cover cloth, while constantly applying a jet of clean water.

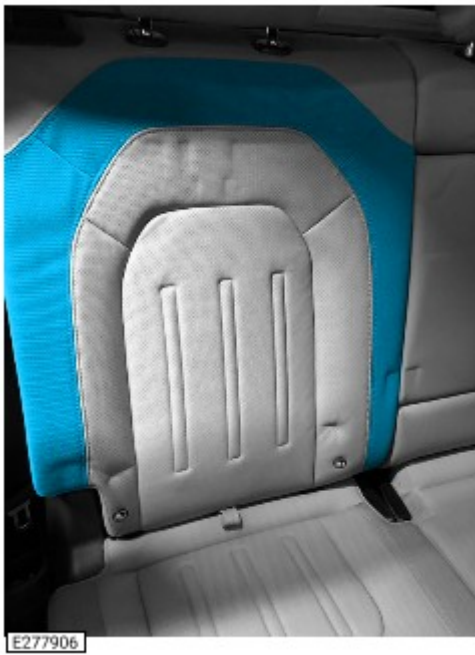
3.

Second row backrest cover.

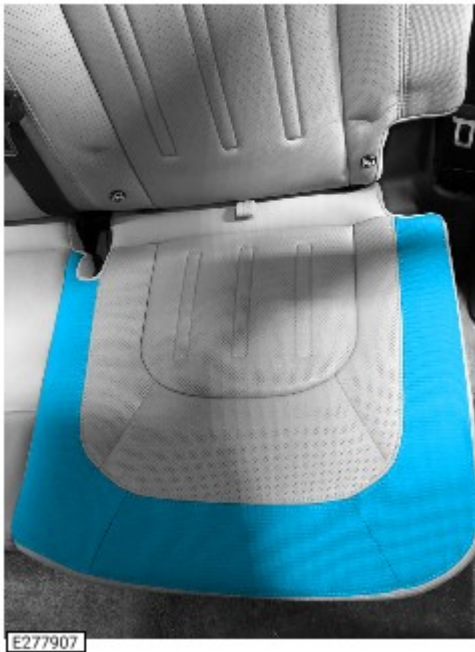
4.

Second row cushion cover.
