<b>Subject:</b> <b>SEAT WARMER TURNS OFF AFTER 10 MINUTES AND DTC B1030:13 IS STORED</b>	<b>Service Alert No.:</b> SA-009/21
	<b>Last Issued:</b> 01/28/2021

2019 Mazda3 Japan built before December 17, 2018  
2019 Mazda3 Mexico built before March 19, 2019

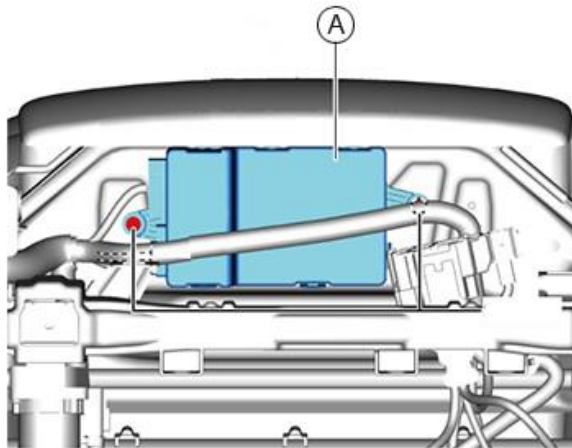
Some customers may complain that the seat warmer turns off after 10 minutes in manual mode and will not turn back on until the vehicle is restarted. DTC B1030:13 (Seat warmer unit (LH) circuit malfunction (heater side)) may also be stored. This may be caused by a faulty seat warmer control unit (A).

1. Verify customer concern.
2. Is DTC B1030:13 stored?
  - Yes - Replace the Seat Warmer Control Unit according to the instructions on MGSS ([SEAT WARMER CONTROL UNIT REMOVAL/INSTALLATION \[\(US\)\]](#))
  - No - This service information does not apply. Go to MGSS for normal diagnosis.
3. Verify repair.

Parts Number	Description	Qty.	Note
BCKA-67-5J0B	Power Unit, Front Seat	1	Part Number suffix "B" or higher

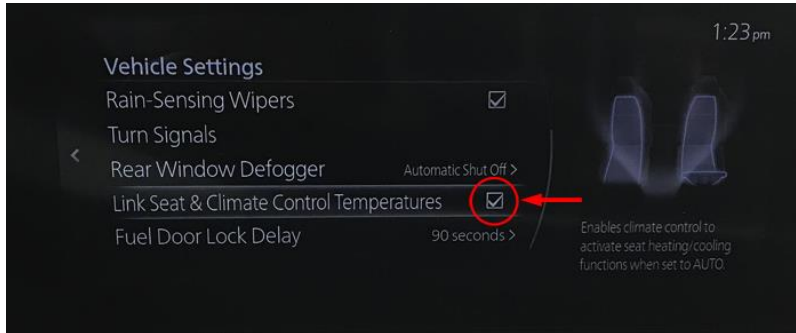
**NOTE:** Confirm that the seat warmers are NOT linked to the climate control system before verifying customer concern.
