QUALITY ACTION

CAMPAIGN BULLETIN

Right Side Wheel Nut Inspection Dealer Inventory

Reference: PC790

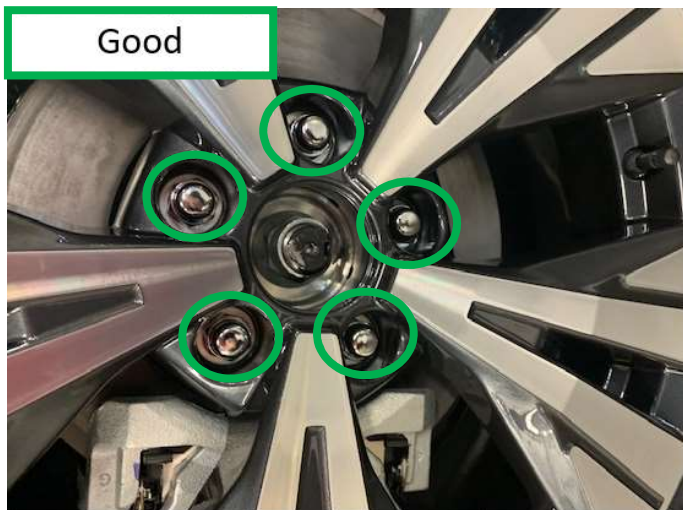
1. Inspect both RH front and rear wheel and tire assembly wheel nuts.
 - Vehicle should be equipped with wheel nuts shown in Figure 1 and Figure 3

2. Are the RH side front and rear wheels equipped with the wheel nuts shown in Figure 1 and Figure 3?
 - If the RH wheels are equipped with the correct wheel nuts, no further action is needed.
 - If the vehicle is found to have the wheel nuts shown in Figure 2 and Figure 4, continue to Step 3 for wheel nut replacement.
