## TECHNICAL SERVICE BULLETIN 84-1285 REMEDY INSTRUCTIONS

| | Make(s): Champion Bus<br>Model(s): Challenger, Crusader, Impulse & LF Transport on E-450 chassis<br>Model Year(s): 2021 | Repair Code: SB-386-22-00-003974<br>Allotted Time: 0.5 hrs.<br>Inspection Code: N/A<br>Allotted Time: N/A |
| | Concern: InPower Fast Idle does not function properly due to the OEM tie-in harness is either incorrectly pinned, has a lack of +12V power supply, or both. | Photo(s) Required: No<br>Prior Authorization Required: No<br>Part(s) Number: N/A<br>Part(s) Return: N/A |

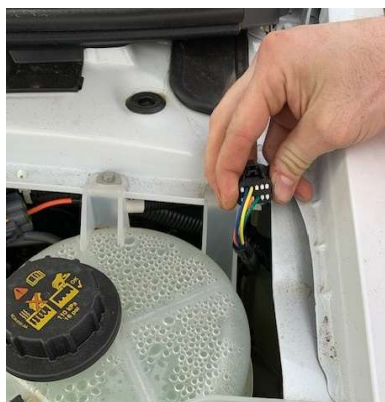
1. Customer Access connector can be located behind the engine Coolant reservoir.

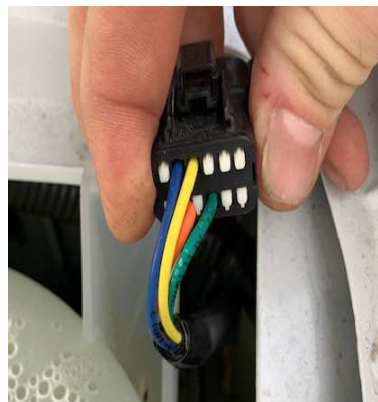
2. Locate the green wire on the 12-position harness connector that runs through the firewall.

3. If the green wire is seated at Pin #10 instead of Pin #11, this may be the reason for an inoperable Fast Idle. Separate the connector and use a de-pinner tool to remove the green wire from Pin #10. Move the green wire over to the next position, Pin #11.

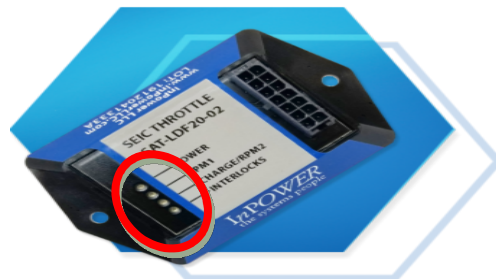
1. The InPower Fast Idle Module is located underneath the steering column. Locate the module and check for power. If you do not see any lights on the module, then it is missing a +12V ignition power source.

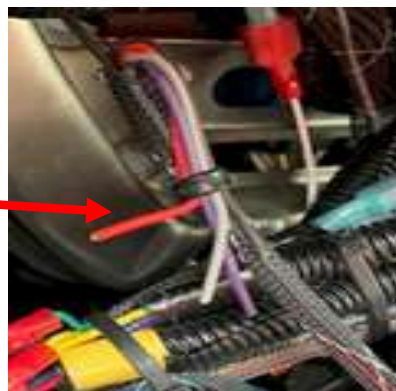
2. The Red wire from the InPower Idle harness must see +12V ignition power. The Red wire will be located with the zip-tie along with the Purple and Gray wires. If the Red wire is not connected to anything, this may be the reason no lights are showing on the module.
