## **RECREATIONAL VEHICLE SERVICE CAMPAIGN**

### **SERVICE ADVISORY 21-401**

## SERVICE ADVISORY # 21-401

### Zinger Thermostat Wiring

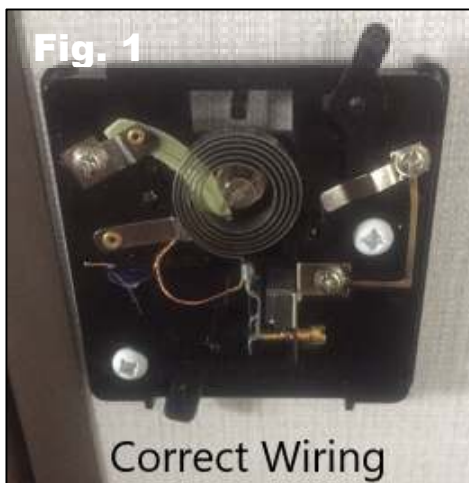
Locate and remove the cover on the heat only thermostat. Inspect the mounting location of the thermostat wires. See Figure 1 and Figure 2.

If the thermostat wiring is not visible because it is attached to the back side of the thermostat, see Figure 1, reinstall the thermostat cover and proceed to warranty reimbursement. If the thermostat wiring is visible and connected to the front side of the thermostat, see Figure 2, proceed to step 4.

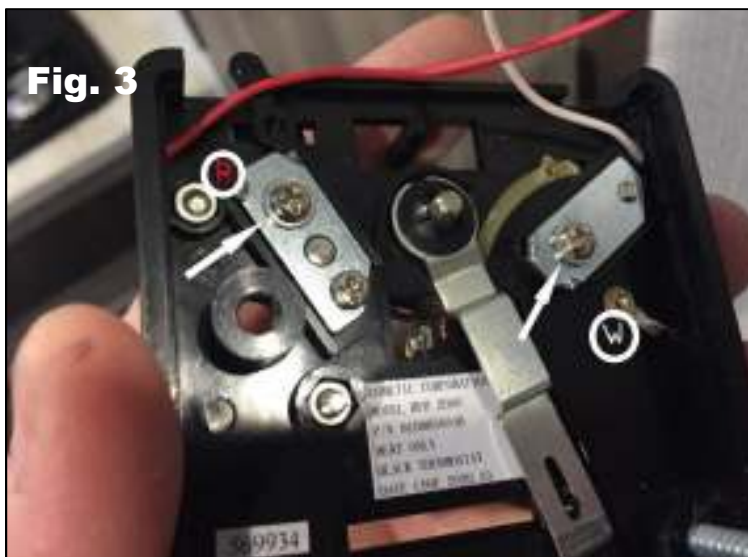
Remove the two mounting screws from the thermostat. Remove the wires and relocate them to the back of the thermostat as shown in figure 3. The wire connection screws have a washer type head and the thermostat base is embossed with a "R" and a "W" which corresponds to the white and red wire color.

Mount the thermostat back into the same location on the wall and test the furnace function. Proceed to warranty reimbursement.
