## Montana Fifth Wheel 3780/3781- Sidewall Crack Repair

**Models:** 2020-2021 Montana Fifth Wheels: 3780/3781

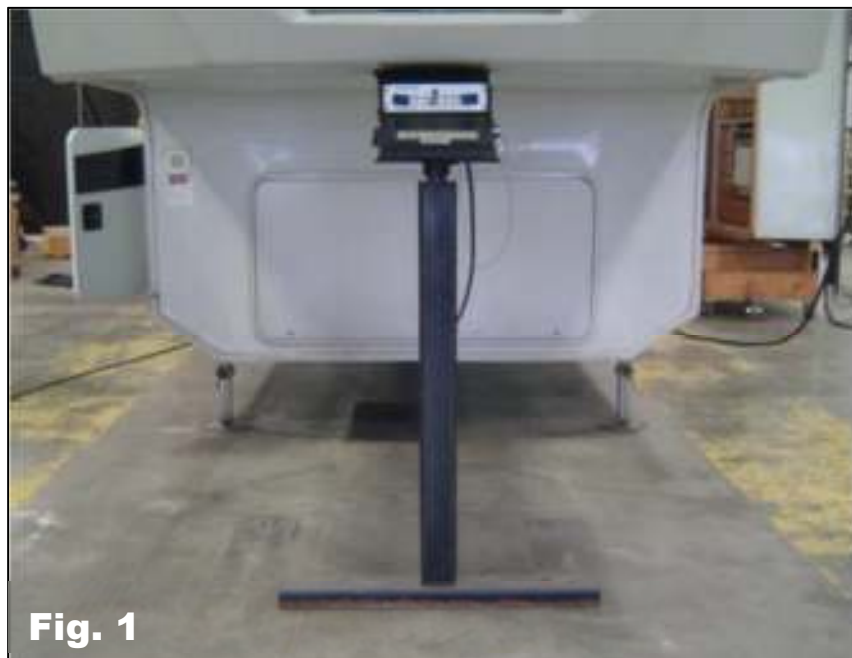
**VERY IMPORTANT! PLACE HITCH WEIGHT ON PIN, THEN LOWER FRONT LANDING LEGS TILL THEY TOUCH THE GROUND BUT DO NOT RAISE THE UNIT. LEAVE WEIGHT ON PIN FRAME THROUGHOUT REPAIR. See Figure 1.**

Locate the trailer on a level, flat, hard surface. Chock the wheels.

Inspect lower and upper welds for cracks. Using the landing legs remove weight from the pin box and inspect for any cracks. Take photos of all cracked/broken welds with weight on and off the hitch. Place weight back on the hitch as described in Step 1, Figure 1.

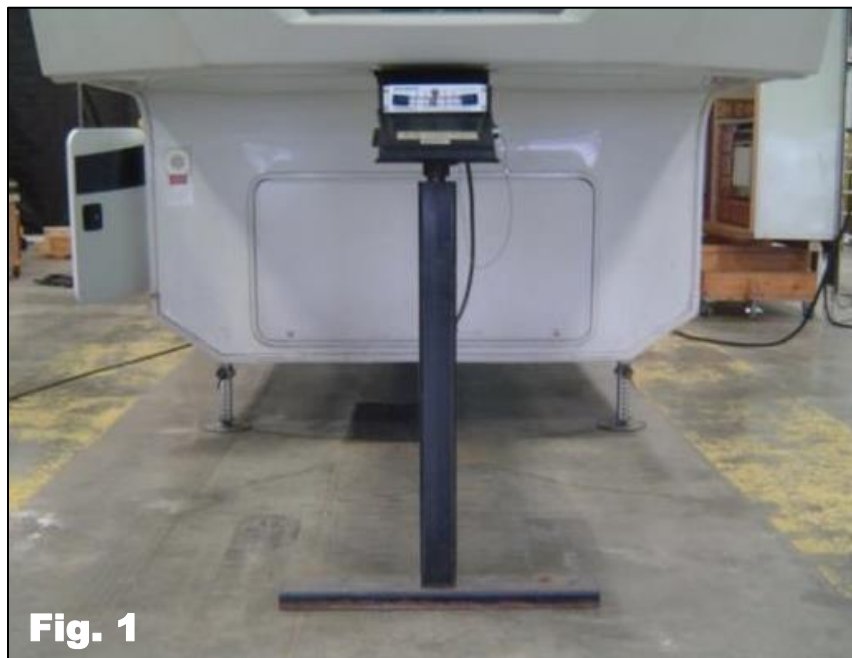
**VERY IMPORTANT! PLACE HITCH WEIGHT ON PIN, THEN LOWER FRONT LANDING LEGS TILL THEY TOUCH THE GROUND BUT DO NOT RAISE THE UNIT. LEAVE WEIGHT ON PIN FRAME THROUGHOUT REPAIR. See Figure 1.**

Locate the trailer on a level, flat, hard surface. Chock the wheels.
