JLRTB02071NAS1

TECHNICAL BULLETIN

Second Row Seat Backrest 'Sticking' Noise

MODEL:	MODEL YEAR:	VIN:	ASSEMBLY PLANT:	APPLICABILITY:
I-PACE (X590)	2021	605262-608633	Graz (Austria)	Vehicles With: 40/20/40 Split Seat

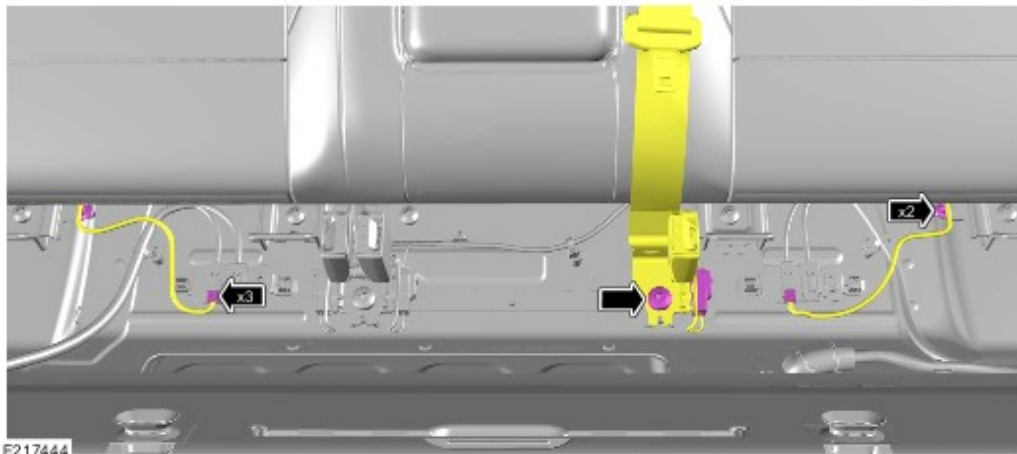
2.

Release the second row seat center seatbelt buckle.

- Remove the bolt.
 - Torque: **48 Nm**
- Disconnect the 3 electrical connectors.
- Remove the 2 wiring harness clips.

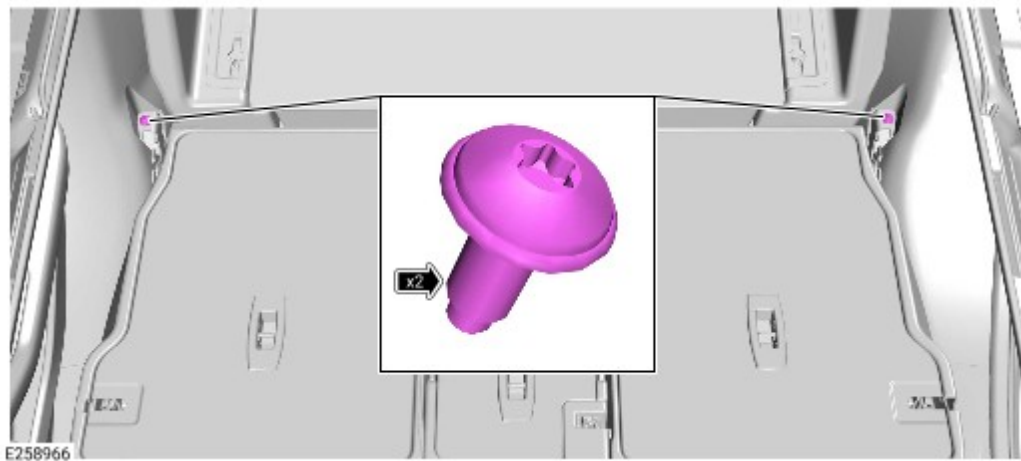
4.

Remove the 2 locking arm bolts.

- Torque: **22.5 Nm**

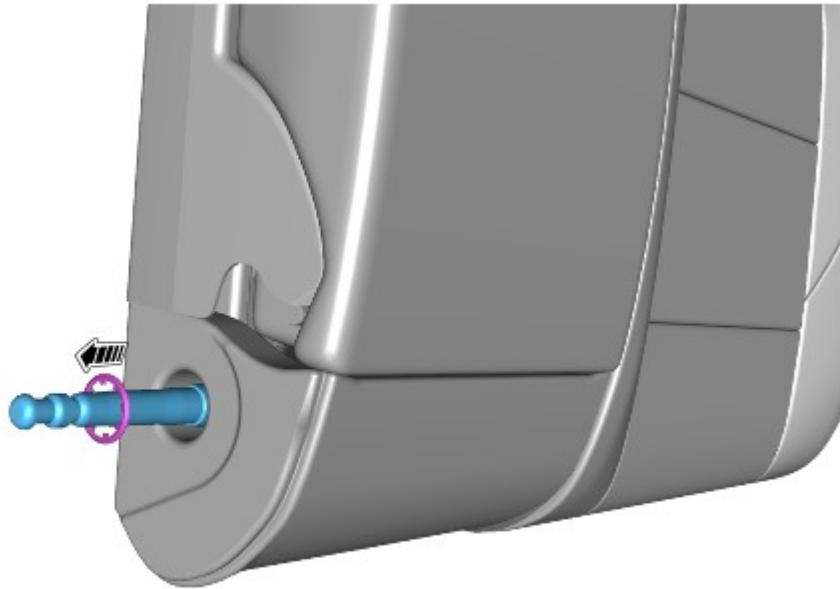
E278340

Using suitable tool, remove the self locking washer from the spindle.

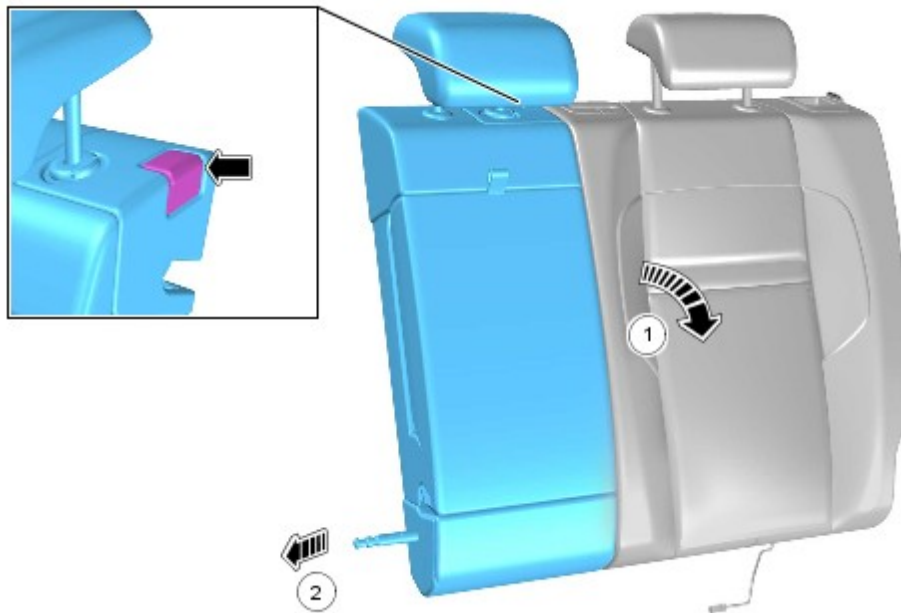
E233558

Remove the center armrest.

1. Fold down the center armrest.
2. Pull the center armrest away from the left second row seat backrest.

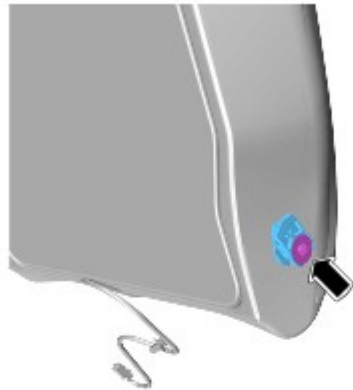
12.

Remove the bolt and the bush.

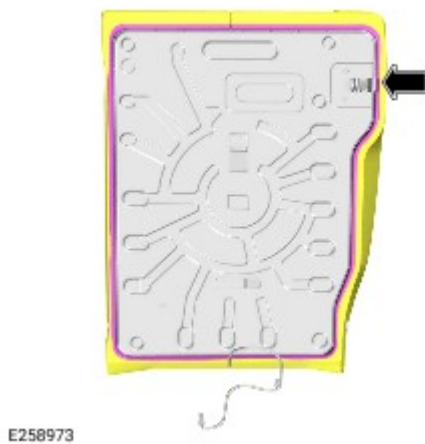
13.

Release the second row seat backrest cover from the frame.

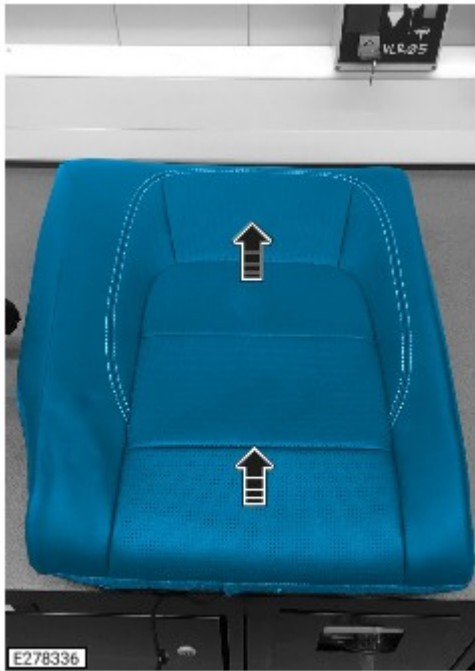
14.

Remove the second row seat backrest foam and cover from the frame.

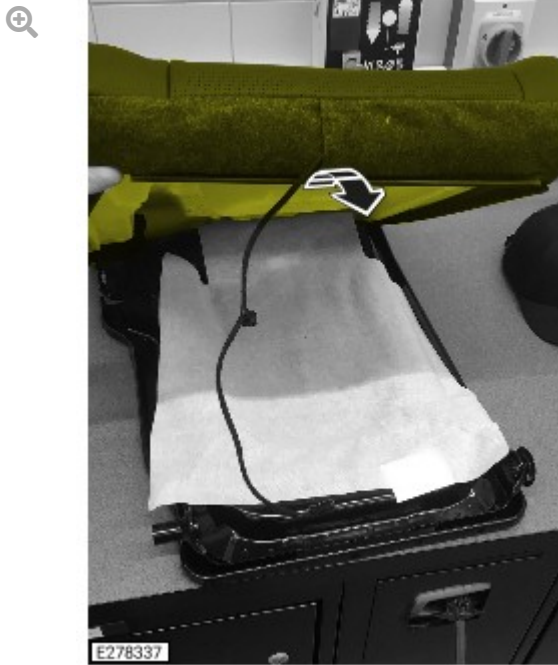
16.

Make sure the NVH cloth remains in position when positioning the second row backrest cushion and cover.

Reposition the second row backrest foam and cover onto the frame.

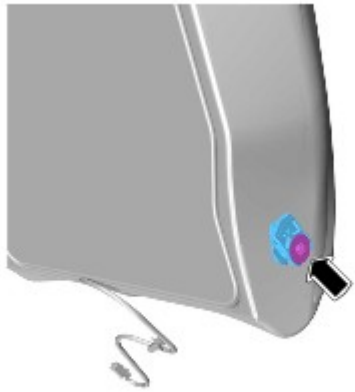
E258971

Install the bush.

- Install and tighten the bolt.
- Torque: **35 Nm**

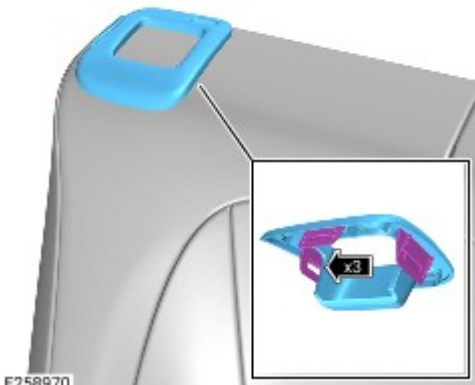
E258970

Install the second row seat latch cover.

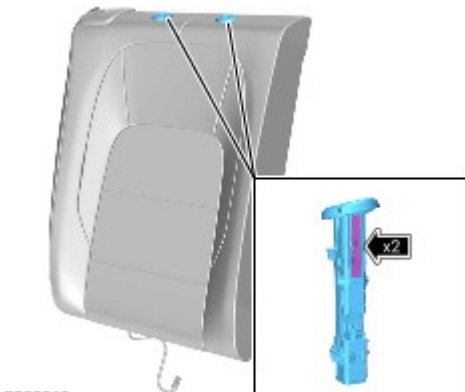
E258969

Install the second row seat head restraint guides.

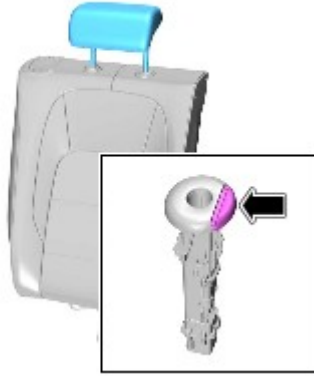
E258968

Install the head restraint.
