JLRTB02070NAS2
TECHNICAL BULLETIN
26 FEB 2021

Cloth Seat Staining - Cleaning Procedure

MODEL:	MODEL YEAR:	VIN:	ASSEMBLY PLANT:
Defender (LE)	2020 Onwards	000002 Onwards	Nitra (Slovakia)

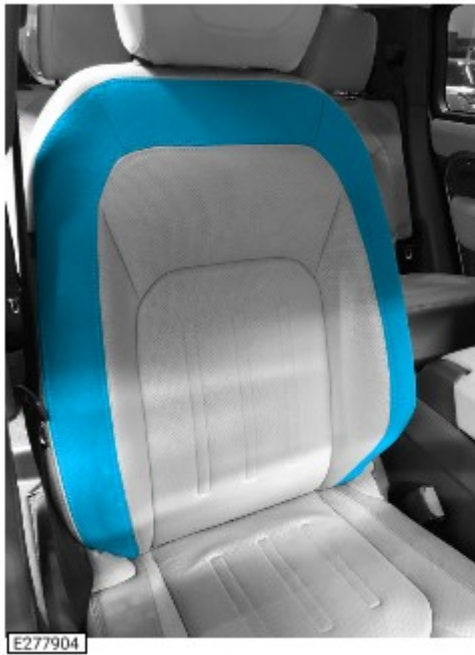
1.

Front backrest cover.

Only complete the Service Instruction on the area of the seats highlighted blue in the Service Information illustrations.

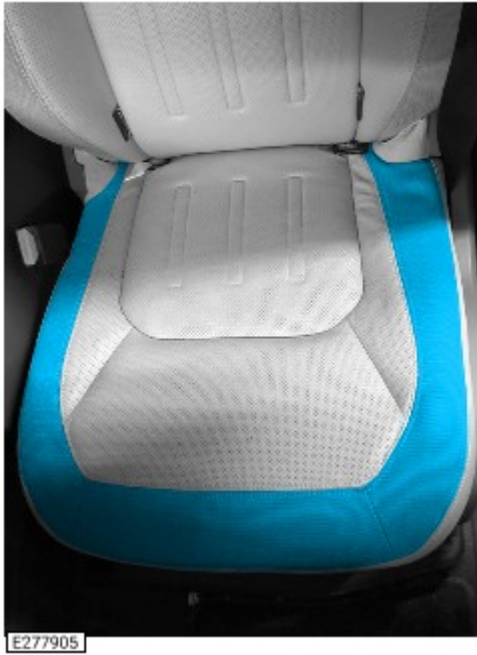
2.

Front cushion cover.

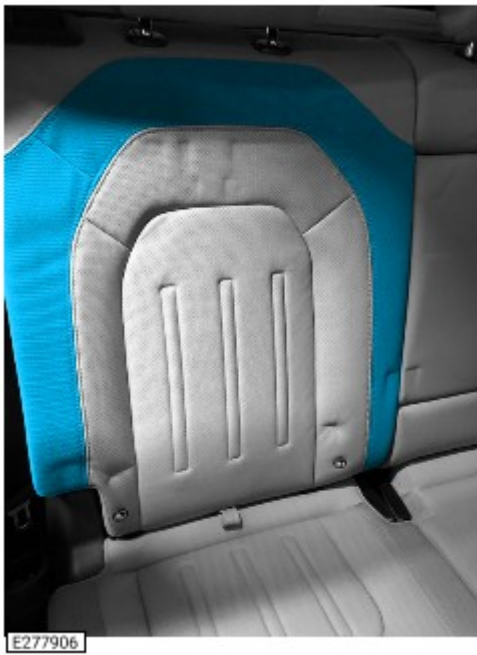
3.

Second row backrest cover.

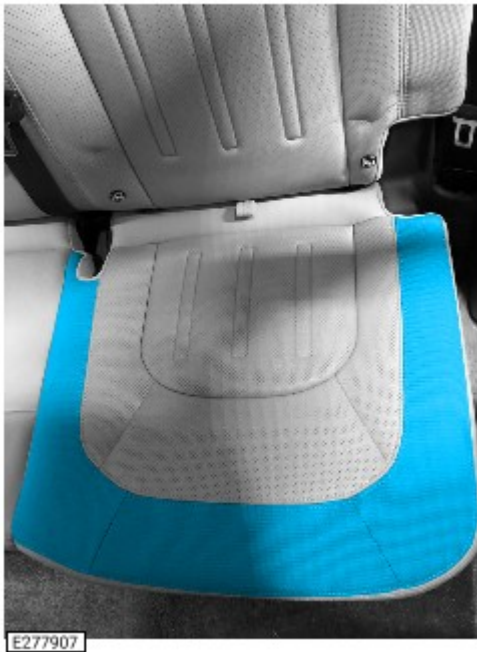
4.

Second row cushion cover.
