# Technical product information

| Topic | Bentayga front door trim - Alignment pin |

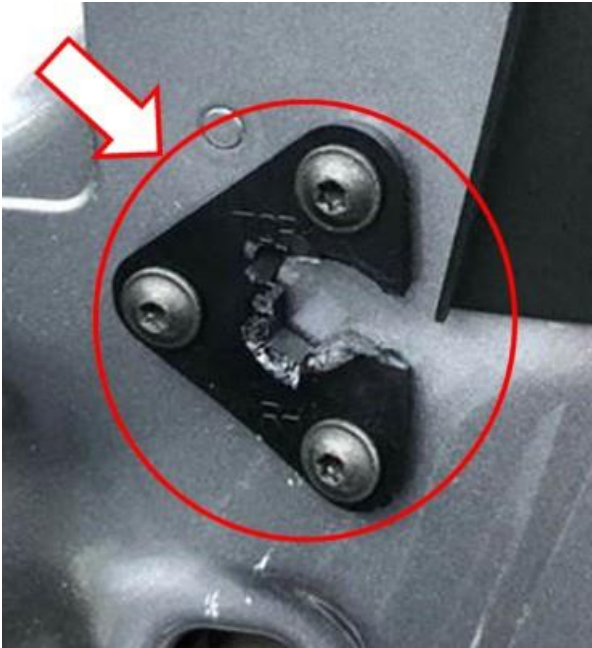
The alignment pin used to locate the front door trim panel is broken (Figure 1)

Referring to Figure 1 – Remove and discard the following:

- Broken alignment pin x1 (If evident)
- Fixings x3
- Alignment pin plate x1

TIP: Cover the area in which the plate was previously fixed using anti creak tape

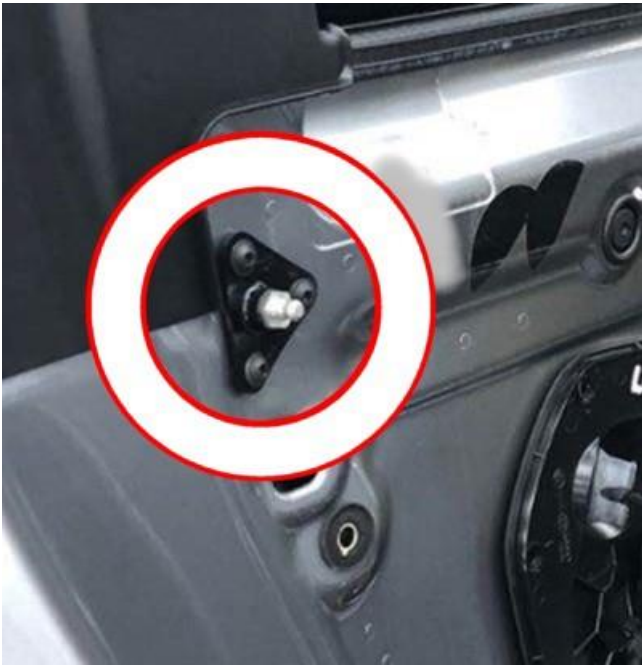
▪ If the condition is as shown in Figure 2 - The removal of the alignment pin/plate and fixings is not required unless broken
