## Technical Service Information Bulletin

### 2.0 Overhead Display Replacement Notification

**Bulletin Name:** FDM-TSIB-019

**Model:** Oshkosh S-Series

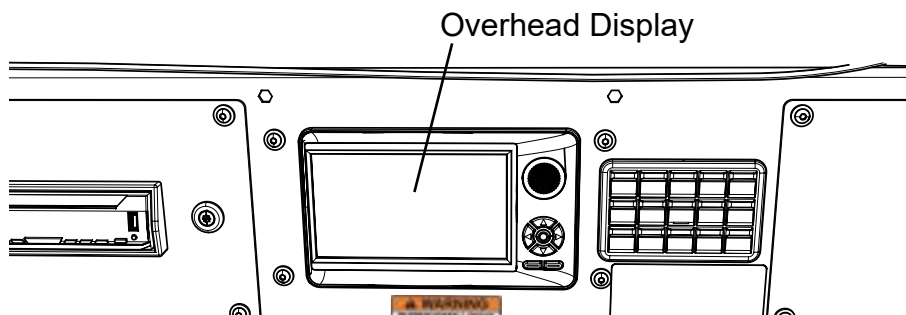
Figure 1 Overhead Display

When replacing/changing the overhead display in a vehicle the SIM card from the original device must be removed and inserted into the new/replacement display. Failure to transfer the SIM card that originally came with the vehicle's display will prevent ClearSky™ telematics from functioning.

Contact the ClearSky™ team at **920-204-1086** or email **clearskysupport@oshkoshcorp.com** for assistance on what action is needed before replacing/changing an overhead display.

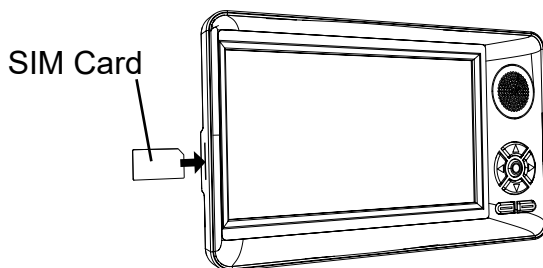
Figure 2 Overhead Display SIM Card

Swapping displays from vehicle-to-vehicle without changing SIM cards is not acceptable as the SIM card in the display is vehicle specific. Contacting the ClearSky™ team if swapping a display from vehicle-to-vehicle is a must, see contact information above.
