Technical Service Bulletin

GROUP Campaign	NUMBER 21-01-004H
DATE February, 2021	MODEL(S) Elantra (AD/ADa)

SUBJECT: HEADLAMP HIGH BEAM REPAIR (SERVICE CAMPAIGN T5G)

Description: This bulletin describes the procedure to repair a headlamp that has an inoperable high beam function.

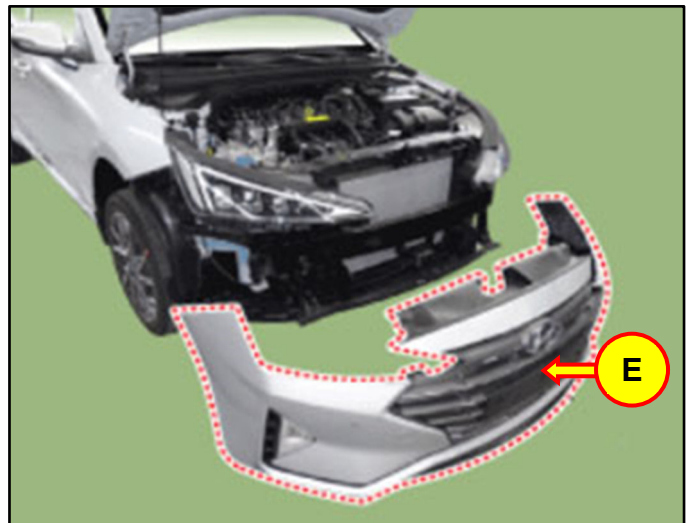
5. Remove the front bumper cover (E).

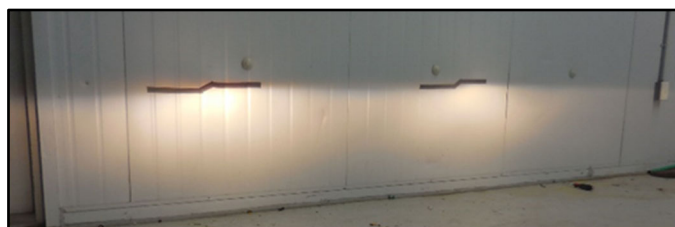
7. Turn on the headlamps.
- Mark the height of the headlamp illumination.

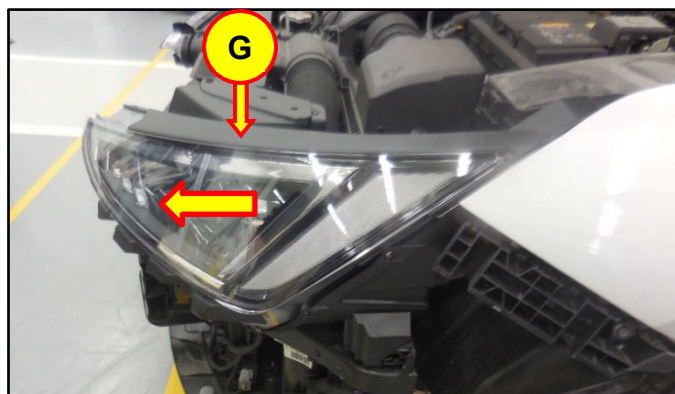
10. Remove the affected headlamp(s) (G).

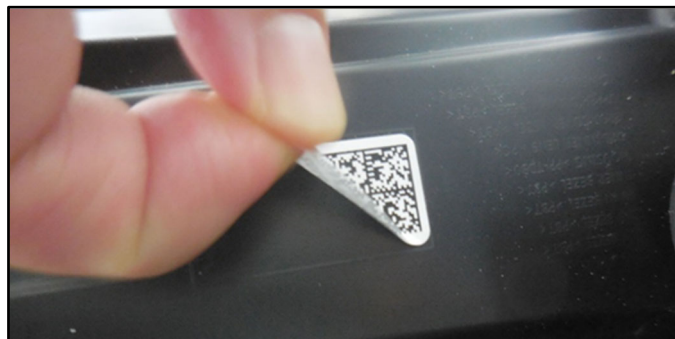
2. Remove the headlamp production label.

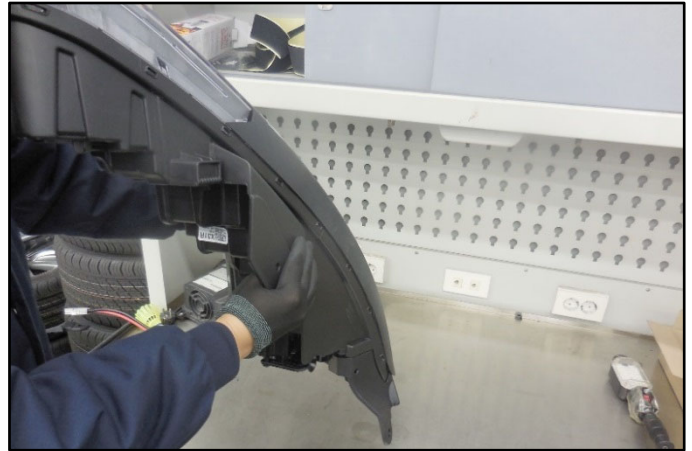
9. Shake the headlamp to remove the debris through the dust cover.

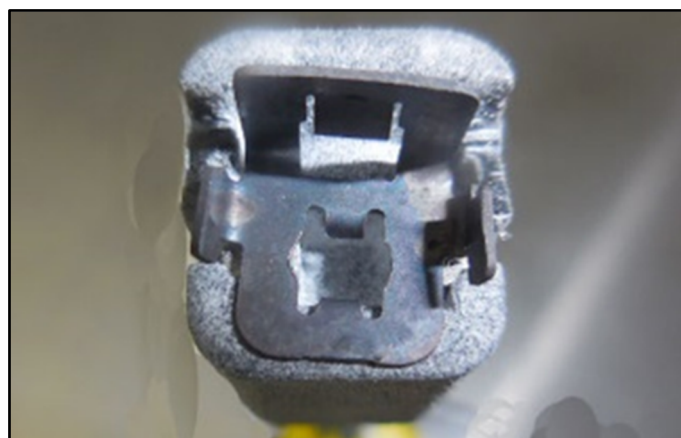
12. Install the clip (N) onto the clip installation tool (O).

Verify that the clip is fully seated and held in place by the magnets on the clip installation tool.
