## **Service Bulletin**

### Subject: Information on Accessory All-Weather Floor Liners and Flat Mats Warped or Misshapen

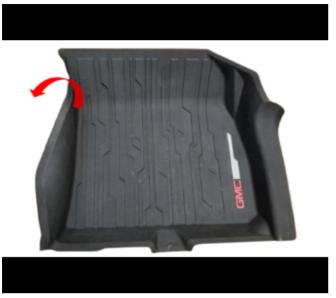
5721506

1. Remove the affected all-weather floor liner/flat mat(s) from the vehicle.

- 2. Roll the warped edge in the opposite direction, towards the gapped area, and hold it in that position for approximately 10 seconds.
- 3. Unroll and position the mat(s) in the vehicle, to re-evaluate the fit again.
