**Gurgling sound from Sunroof area, While driving in the rain**

<b>REF NO:</b> TJ 34532.2.0	<b>ISSUING DEPARTMENT:</b> Technical Service	<b>CAR MARKET:</b> United States and Canada	
<b>PARTNER:</b> 3 US 7510 Volvo Car USA		<b>ISSUE DATE:</b> 2021-01-28	<b>STATUS DATE:</b> 2021-01-28
<b>FUNC GROUP:</b> 8369	<b>FUNC DESC:</b> Miscellaneous	Page 1 of 7

TJ Instruction VCC-516846-1

<b>Title</b>	Sunroof draining hose	<b>Page</b>	1 ( 5 )
<b>Action</b>	Adjustment	<b>Operation number:</b>	98728-2

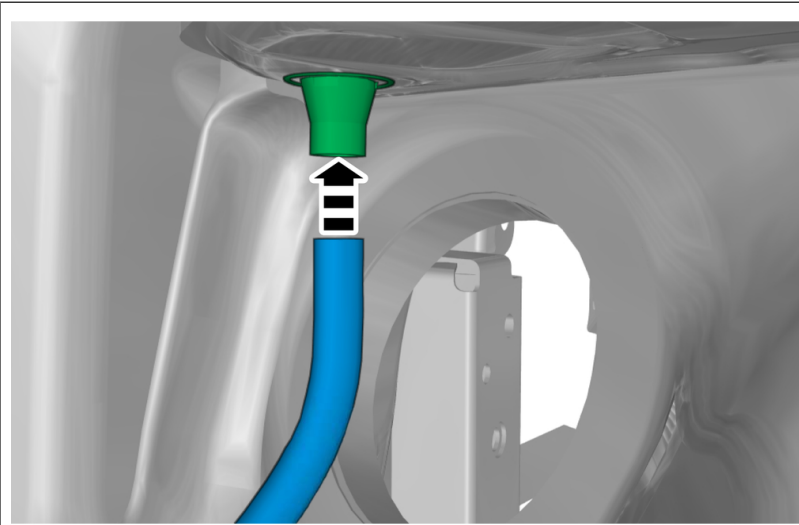
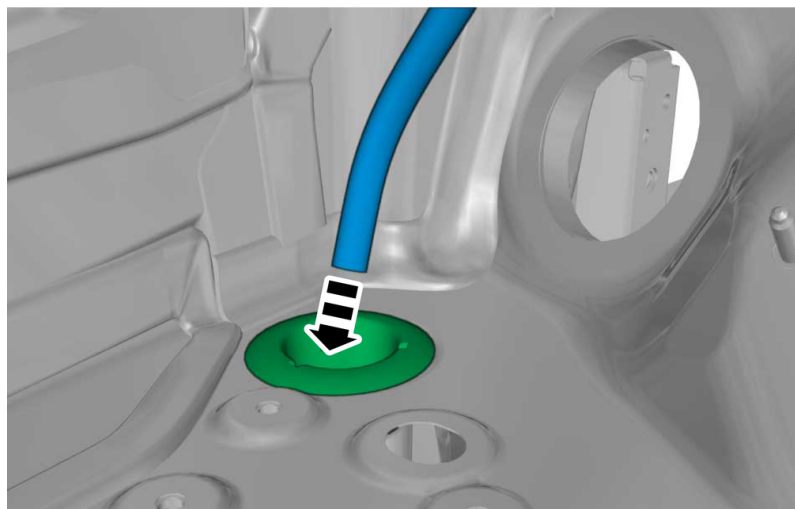
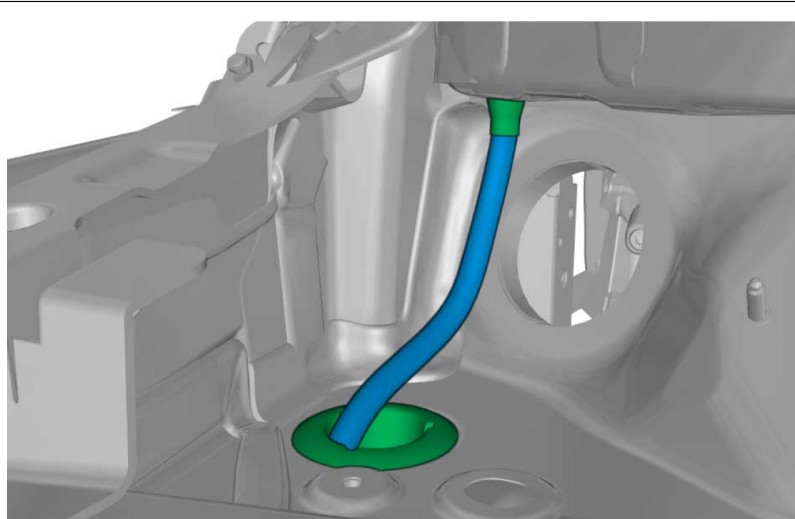
Left-hand side

In certain conditions, wind turbulence may prevent the water in the front drain hoses to drain properly. Extend the sunroof front drain hoses by following the attached method.

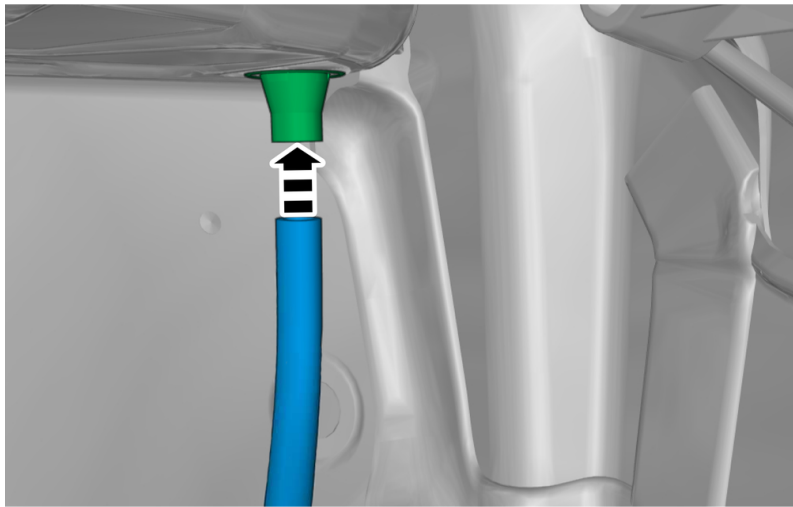
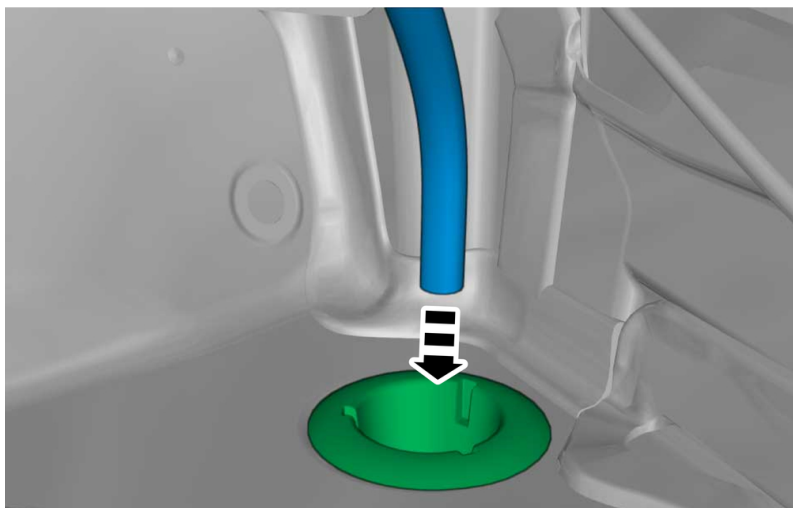
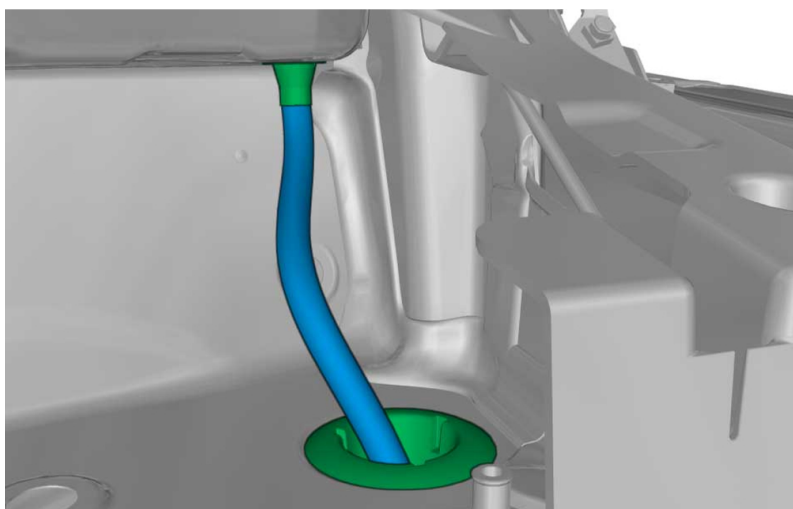
Right-hand side
