## Refrigerator not wired for 12Volt (DC)

| <b>Bulletin Type:</b> | Technical Service Bulletin<br>TSB | <b>Publication Date:</b> | March 9, 2021 |
| <b>Bulletin #:</b> | 21-002 | <b>Make(s):</b> | Entegra Class B |

| <b>Incident:</b> | Refrigerator wiring for 12 Volt omitted during manufacturing. |

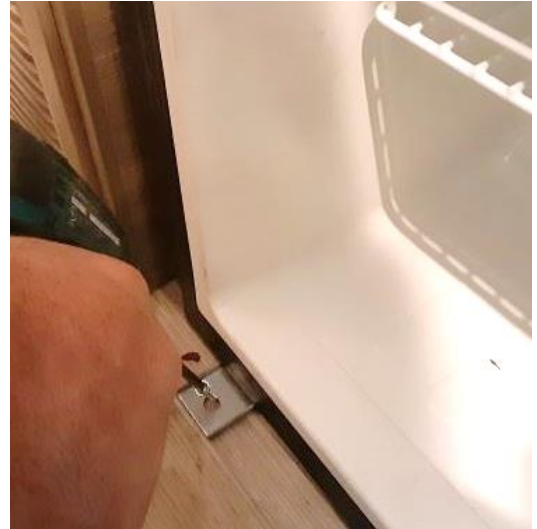
1. Remove the (2) screws from the bracket(s) that secure the refrigerator to the floor. Set the screws aside for re-use.

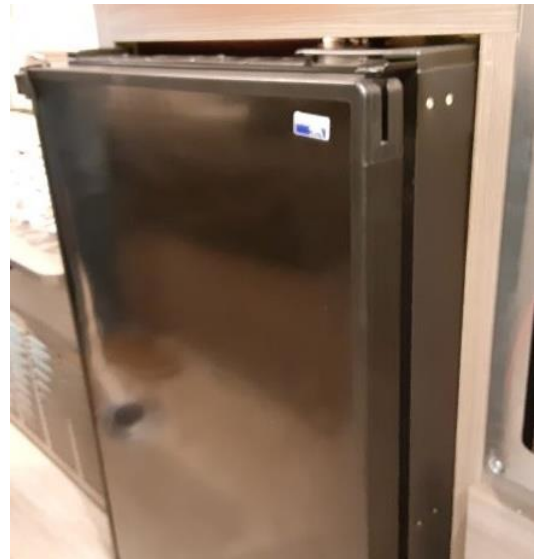
2. Pull the refrigerator from the cabinet.

**NOTE:** When moving the refrigerator out, hold on the sides of the refrigerator. Avoid adding pressure or stress to trims and molding on the refrigerator.

**CAUTION:** Take care not to damage the linoleum.

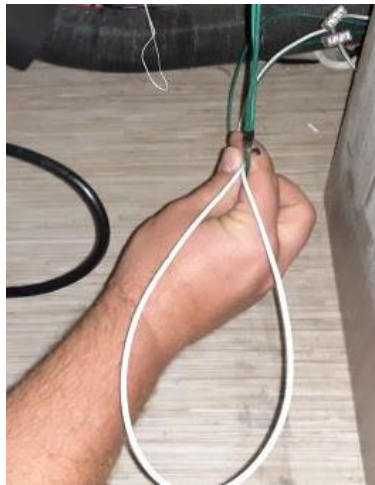
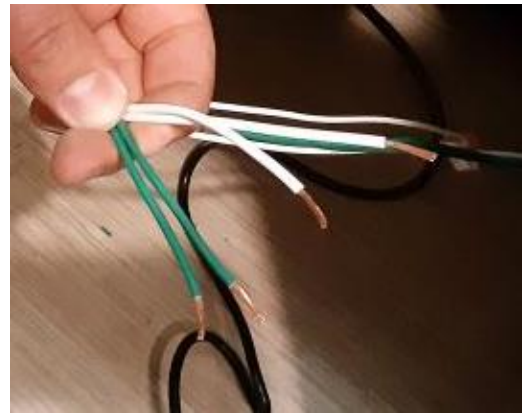
3. Unplug the refrigerator.
4. Locate the green and white wires. Cut both wires. Strip back the wires approximately 3/8".

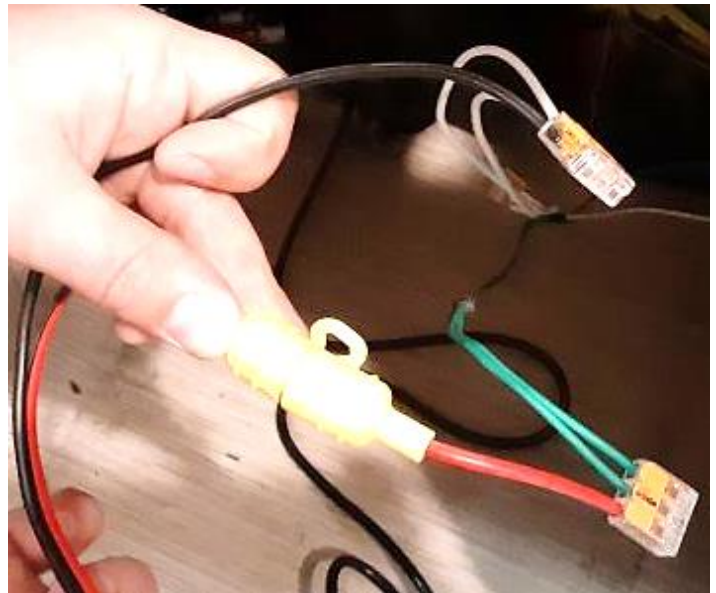
5. Using the 12v refrigerator connector and a wago connector, connect the (2) green wires to the red wire (2) white wires with the black.

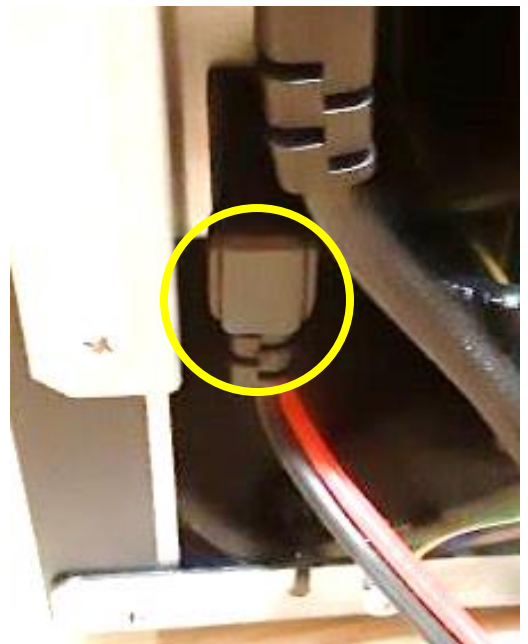
6. Plug the 12v connector into the port in the lower left (facing the back) of the refrigerator.
7. Plug the refrigerator back in.

**NOTE: When moving the refrigerator in, hold on the sides of the refrigerator. Avoid adding pressure or stress to trims and molding on the refrigerator.**

**CAUTION: Take care not to damage the linoleum.**

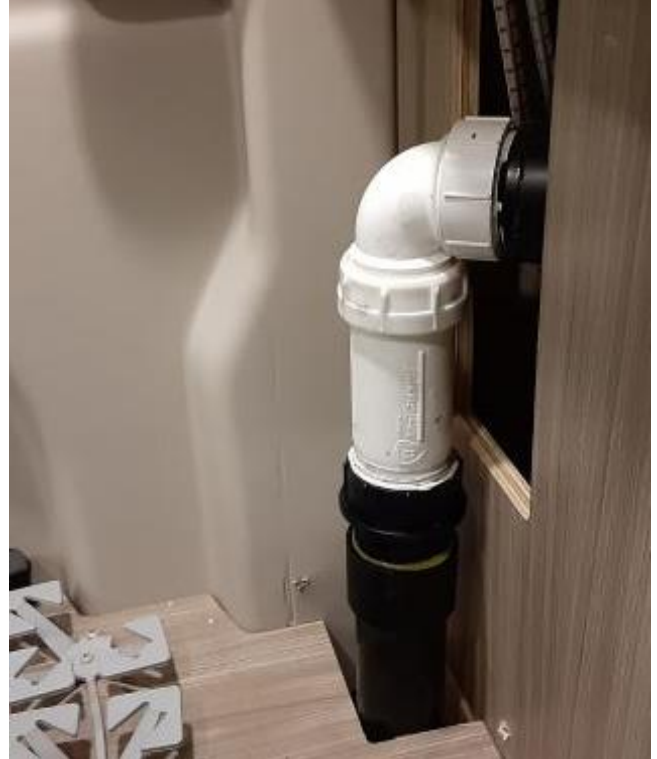
9. Remove the ABS pipe cover on the side of the cabinet (between the cabinet and the seat base). You will need to remove (4) square head screws. This will expose the pipe and give you access behind the refrigerator.
10. Have one person push the refrigerator back into place while a second person gently shifts the pipe allowing the refrigerator to be pushed back into place.
11. When back in place, re-install the screws to secure the refrigerator back into place.
12. Re-install the pipe cover.
