Technical Service Bulletin

34 Special diagnosis instructions: hydraulic pump checking

34 21 51 2050725/2 March 8, 2021. Supersedes Technical Service Bulletin Group 34 number 18-33 dated June 27, 2018 for reasons listed below.

Model(s)	Year	VIN Range	Vehicle-Specific Equipment
A3	2017	All	0GC 7 speed S-tronic transmissions
A3	2018	000001 - 022977	0GC 7 speed S-tronic transmissions

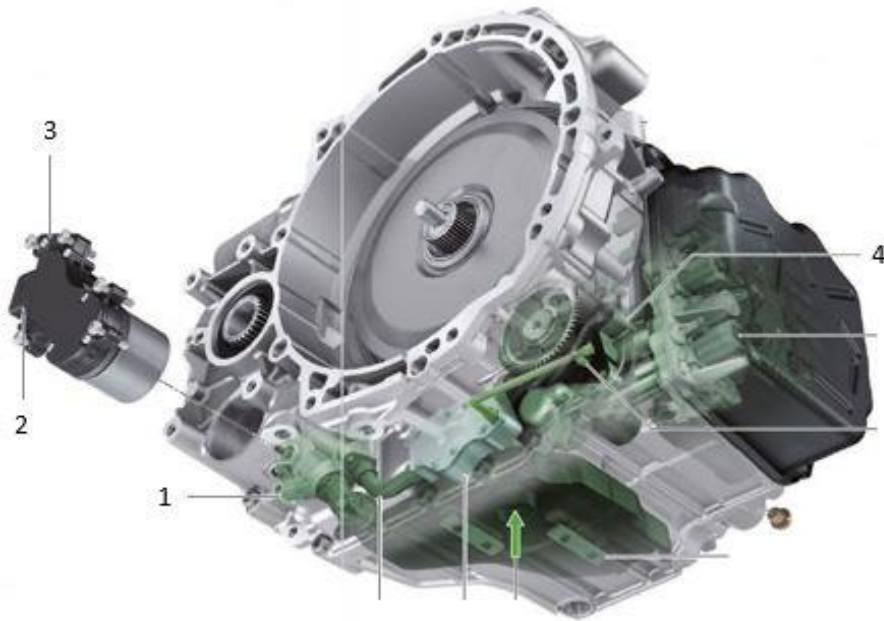
Figure 1. OGC gearbox parts.

Position 1: Auxiliary mechanical hydraulic pump (driven by V475).

Position 2: Electrical connection of Transmission Fluid Auxiliary Hydraulic Pump 1 V475.

Position 3: Transmission Fluid Auxiliary Hydraulic Pump 1 V475.

Position 4: Main ATF pump (driven by the transmission input shaft).

To see the drive shaft of the auxiliary hydraulic pump, the pump motor (Figure 1, position 3) has to be removed. The depth of the drive shaft can be used to check the cover position.

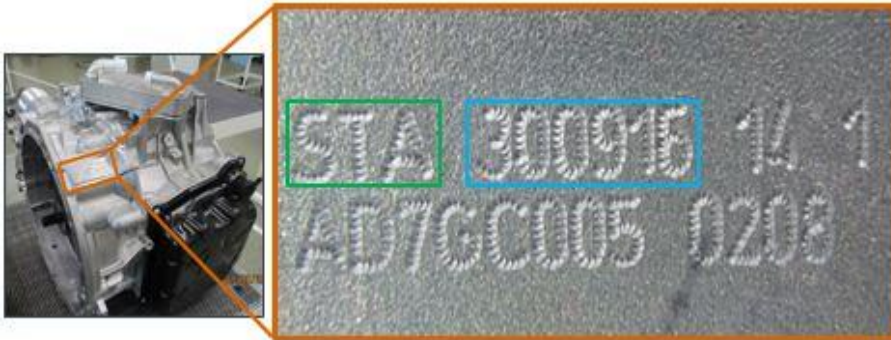
Figure 2. Transmission code and identification.

The transmission code and identification information are engraved on the transmission (Figure 2). In the example of Figure 2:

- Transmission code = STA.

- The transmission build date format is Day-Month-Year.
- The transmission production date: 300916 = 30.09.2016 or September 30th. 2016.

If you have not already provided the transmission code and identification information (Figure 2) to the Audi Technical Assistance Center please enter the information into the contact. The procedure is only for transmissions built before a certain date. The Audi Technical Assistance Center needs this information before this TSB can be performed.

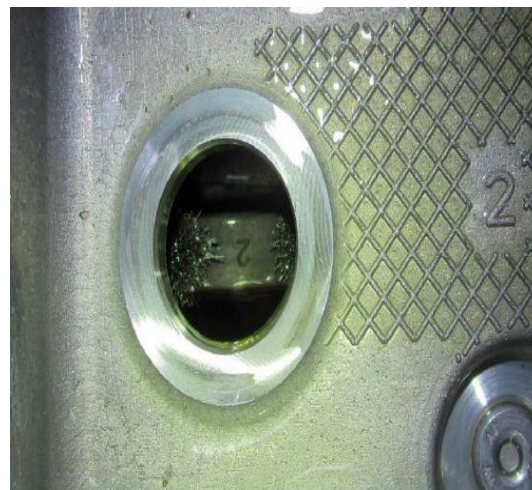
Figure 3. Selector magnet for gear actuator 2/6.

1. Check for metal shavings in the transmission:
 - a. Remove the mechatronic unit according to the repair manual.
 - b. Check the magnet for gear actuator 2/6 for metallic deposits. Look through the lower hole closest to the bellhousing (Figure 3) to see the selector fork magnet. The example shows the selector fork magnet with metallic deposits.
 - c. Take a picture of the magnet and attach the picture to the Audi Technical Assistance Center Contact.

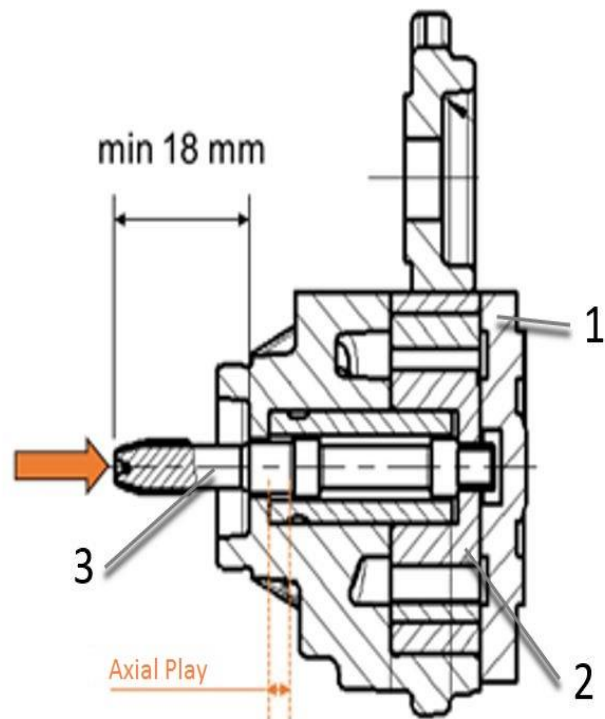
Figure 4. Structure of auxiliary hydraulic pump.

- c. Now you can see the drive shaft of the auxiliary hydraulic pump. The auxiliary hydraulic pump in the transmission is constructed as shown in the example (Figure 4):

Position 1: The cover of the auxiliary hydraulic pump.

Position 2: Pump impeller.

Position 3: Drive shaft.

The drive shaft has an axial play, which is normal and shown. If the drive shaft has too much play (in direction of the large arrow), the cover (pos. 1) is loose and the drive shaft moves with the pump impeller, (pos. 2) toward the inside of the gearbox.

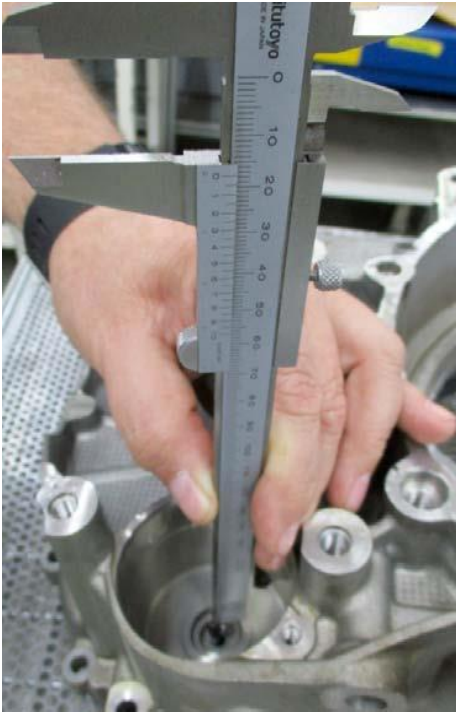
Figure 5. Caliper positioning (transmission removed for pictures).

- d. Check the axial clearance of the drive shaft with a dial caliper. Position the caliper as shown in the examples below (Figure 5 and 6):

- f. Record the measurement to the 2nd decimal place for example: 18.02 mm.
