STAR ONLINE PUBLICATION

Case Number: S2102000001

Symptom/Vehicle Issue: Service Air Suspension Message On Cluster With DTC's C15D9-00 C15A1-00

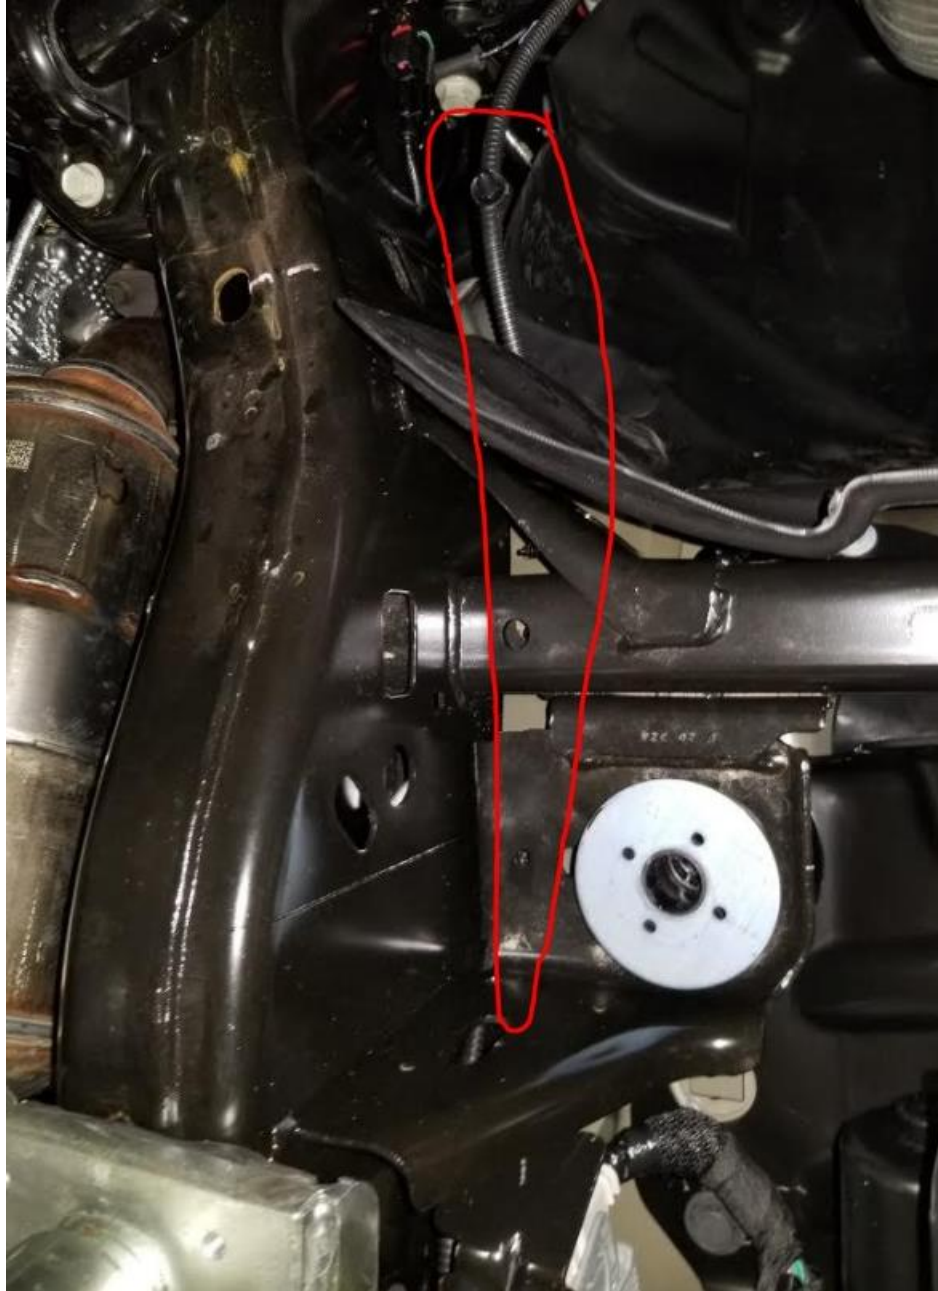
Discussion: Perform a visual inspection of air line routing. Gently tug on the air lines by hand to feel if the air line is trapped or pinched by the drivers A Pillar body mount. If the line is found to be pinched, inspect the line for being crushed (Fig 1). Voss line repair fitting 68084816AA can be used for small areas of damage.

LF air suspension line at A Pillar.
