#### **UPDATE FROM WARRANTY OPERATIONS**

# WARRANTY OPERATIONS NEWSLETTER VOLUME 7, ISSUE 2

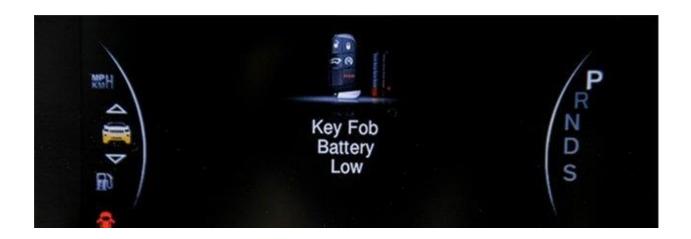
1. If the antenna is checked to be OK, check the vehicle cluster for the low battery message. (See screen shot below)

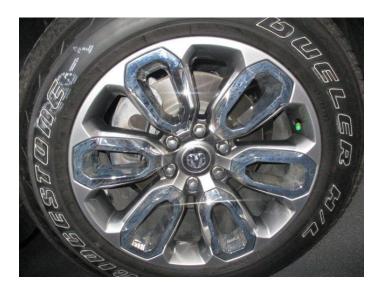
NOTE: Many aftermarket wheel cleaners contain strong acids or strong alkaline additives that can harm the wheel surface. Wheel staining from chemical contamination is not a defect in material or workmanship and is NOT a warrantable condition. (see example to the right of "MAG" wheel cleaner damage)

When cleaning extremely dirty wheels including excessive brake dust, care must be taken in the selection of tire and wheel cleaning chemicals and equipment to prevent damage to the wheels.

Mopar Wheel Treatment or Mopar Chrome Cleaner or their equivalent is recommended or select a non-abrasive, non-acidic cleaner for aluminum or chrome wheels.
