## Winterization of Fogatti Water Heater

| <b>Bulletin Type:</b> | Technical Service Bulletin | <b>Publication Date:</b> | March 19 , 2021 |
| <b>Bulletin #(s):</b> | 21-005 | <b>Make(s):</b> | Jayco |
| <b>Incident:</b> | Inadequate winterization of Fogatti on demand water heater. | | |

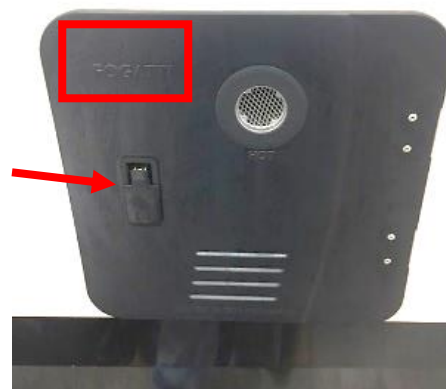
Determine if the Fogatti water heater is installed in the unit (it will say Fogatti in the upper left corner of the door). The water heater will be located on the off door side of the unit. If it is a Fogatti water heater, continue with the inspection.

The latch will allow you to open the water heater door for access to the water heater.

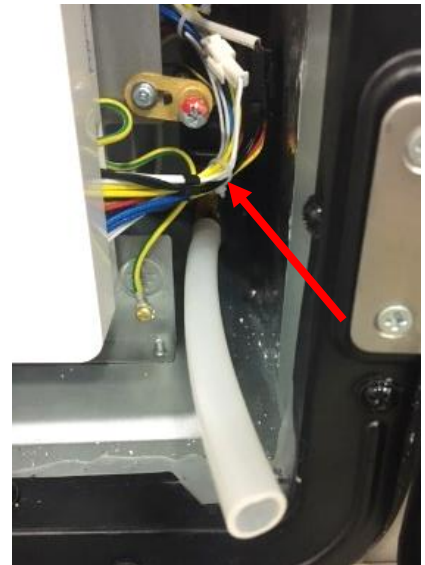
Locate the drain valve at the end of the clear hose on the right side of the water heater. Using pliers, turn the drain valve counter clockwise.

*If antifreeze drains from the hose, the water heater has been winterized and no further action is required.*

If **no** antifreeze drains from the hose, retighten the valve and **proceed with the following instructions.**

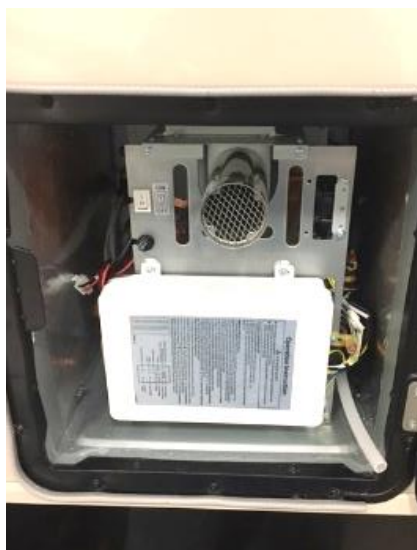
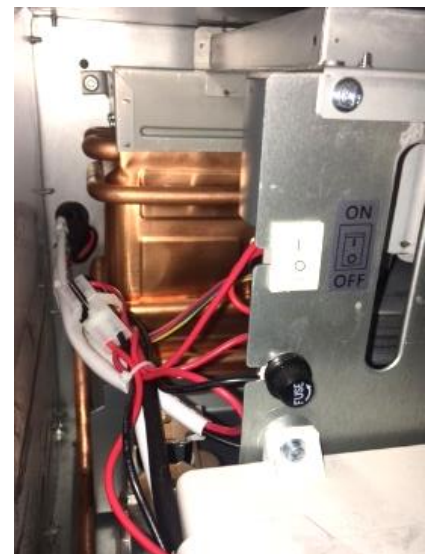
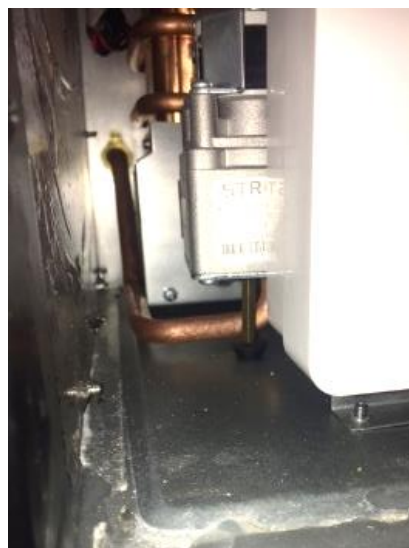
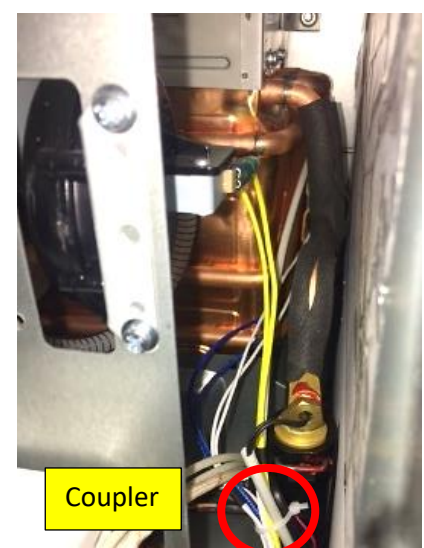
Coupler

1. Open the door to access the water heater. Visually inspect all of the **copper coils and the plastic coupler** for cracks.

**Replace the water heater when inspection notes damage. Authorization is required from Customer Service prior to ordering a new water heater.**

Proceed with the winterization process when Inspection does not find damage.

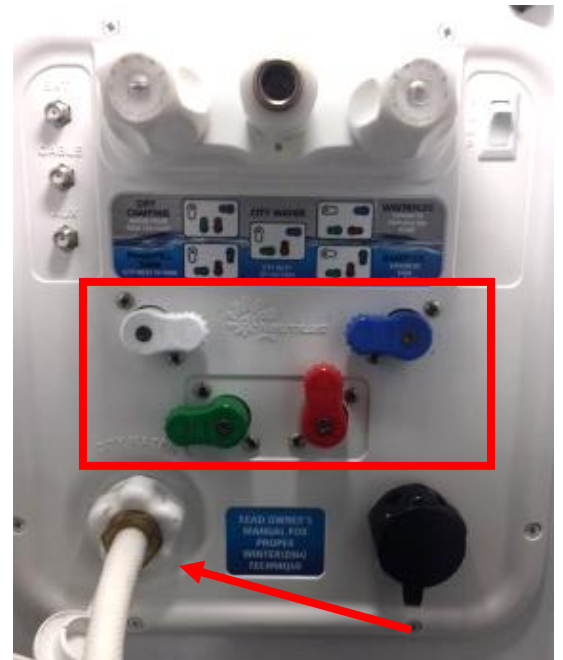
2. To winterize, attach a siphon hose to the city water connection. The winterization setting on the docking station **will not be used**.
3. Turn the red lever on the docking station up. This setting will siphon from the hose through the water heater and then through the system.

NOTE: There is no configuration label on the docking station for this configuration.

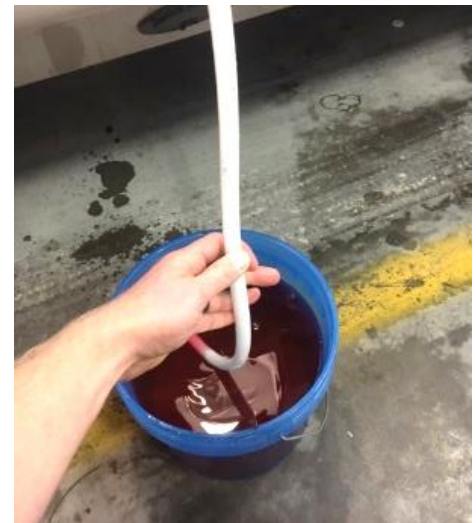
4. Put the siphon hose in a bucket of antifreeze and proceed to the normal winterization process (reference the owner's manual for detail information on the winterization process).
