GLOBAL SAFETY FIELD INVESTIGATIONS
DCS5688
URGENT - DISTRIBUTE IMMEDIATELY

Subject: A202321370 - Service Update
AWD Nameplate Missing From Tailgate

Models: 2020-2021 Chevrolet Trax Redline

A202321370 AWD Nameplate Missing From Tailgate

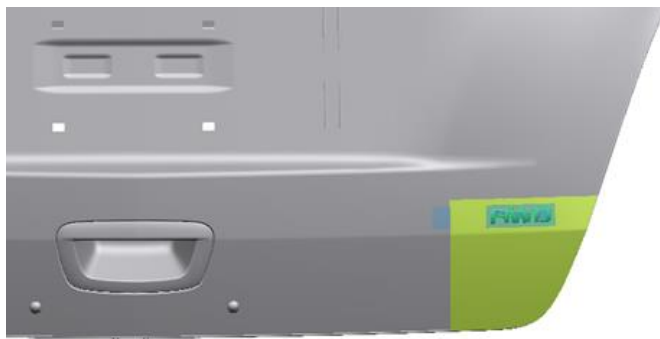
5733133

1. The part and surface should be 21°C (70°F) prior to installation. The vehicle should remain 21°C (70°F) for one hour after assembly to allow adhesive to develop sufficient bond strength.
2. Wipe the surface dry with a clean lint-free towel prior to installing the new name plate.
3. Wipe the vehicle surface area with a 50/50 solution by volume of isopropyl alcohol and clean drinkable water.
4. When removing protective liners from the adhesive tape, be careful not to touch tape with hands and do not allow tape to come in contact with dirt or any foreign matter prior to adhesion.
5. Use the alignment template or witness marks to position liftgate vehicle name plate.

6. Using the palm of the hand, wet out the liftgate vehicle name plate to the liftgate to ensure full adhesion is made.

Condition	On certain 2020-2021 model year Chevrolet Trax Redline vehicles, the AWD nameplate may be missing from the right side of the tailgate.
Correction	Dealers are to install the AWD nameplate on the right side of the tailgate.
