Technical Service Bulletin

Subject: Glued-In Windows

Applies To: Certain 2020 Rosenbauer Commanders and Warriors chassis with Manufacturer Coach Glass.

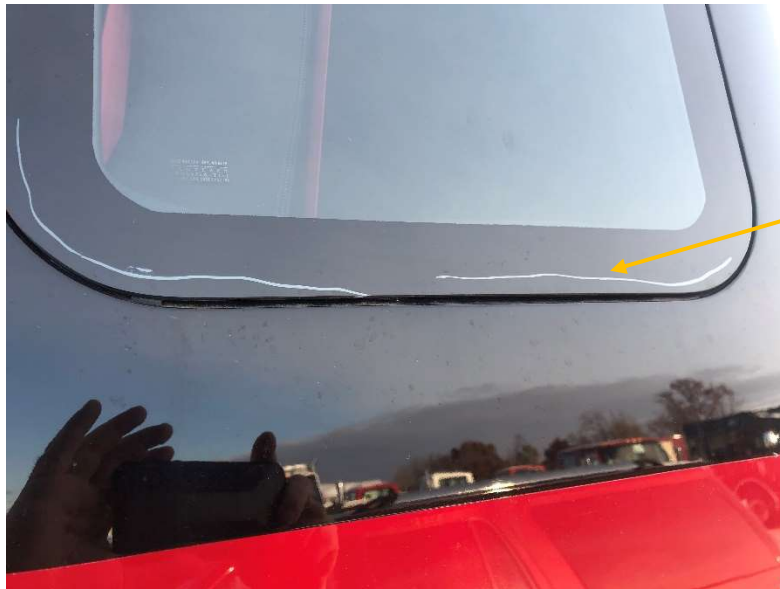
See the separation.

Correction: Follow these steps to determine if you have faulty glass. Then work with your Rosenbauer Dealer to arrange for a replacement window through an approved automotive glass installation company.

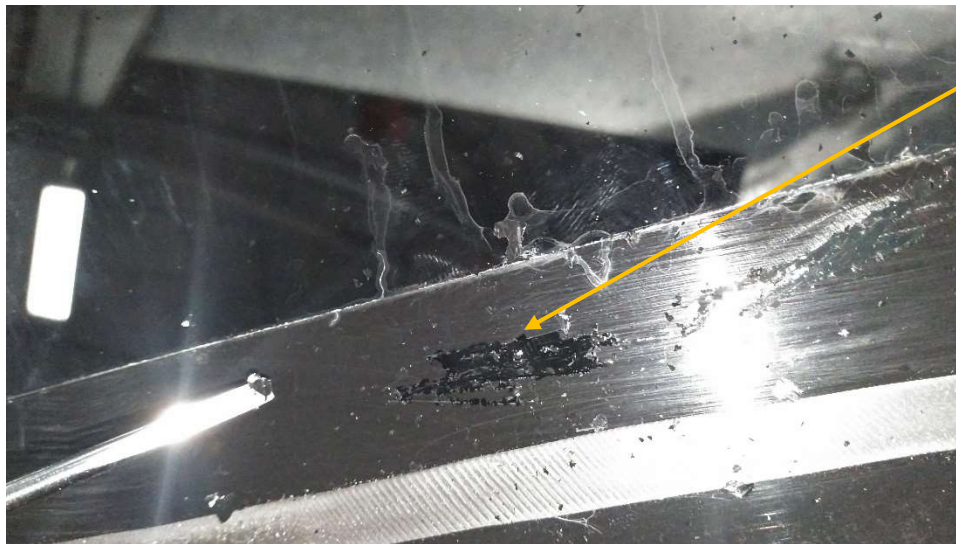
See the flaking on the frit which shows when LIGHTLY using a screwdriver to scratch at the frit.
