GROUP ELE	MODEL 2011-2014MY Sedona (VQ) w/PSD
	NUMBER 232	DATE March 2020
<b>TECHNICAL SERVICE BULLETIN</b>		
<b>SUBJECT: POWER SLIDING DOOR (PSD) OPERATION INSPECTION AND REPAIR</b>

## POWER SLIDING DOOR (PSD) OPERATION INSPECTION AND REPAIR

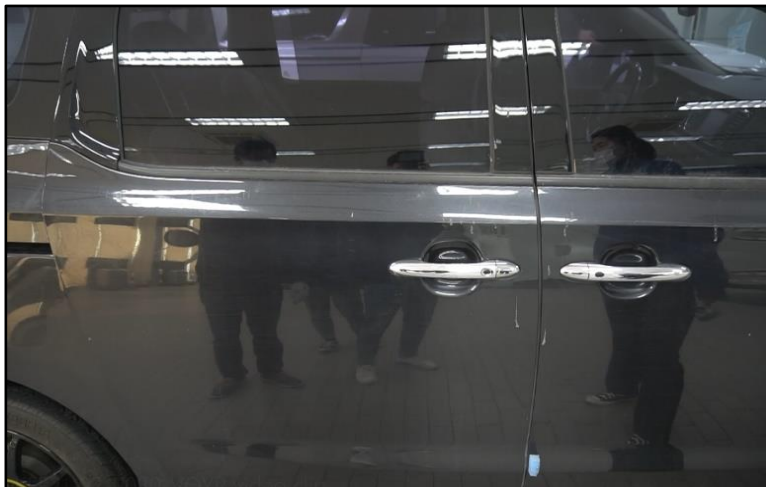
**Note:** The PSD features a '2-stage latching mechanism'. In stage one (1), the door may appear to be fully closed (1st latching), however, only in stage two (2), the PSD will actually be fully closed/secured (2nd latching).

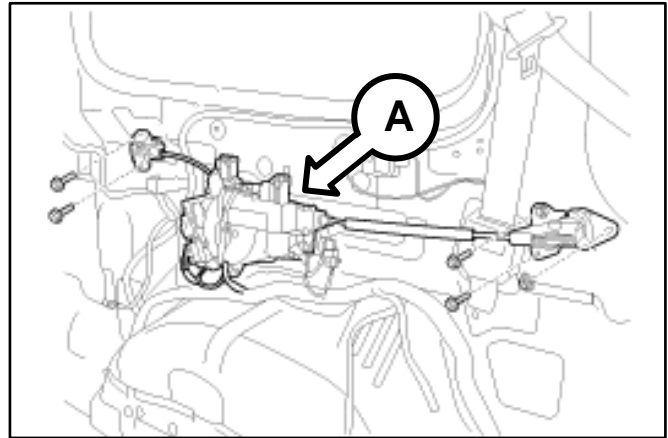
- 1a. The PSD (Left or Right Side) will not closed fully and/or is secured on the 2nd stage latching after closing in auto-mode.
- 1b. **Repeat closing of the PSD in auto-mode after four warning alerts.**
- 2a. **Do not replace the PSD drive unit/motor (A),** instead it is recommended that if the **PSD does NOT close normally,** proceed to diagnose by referring to the shop manual on KGIS to replace the Rear Door Latch Assembly or Rear Door Actuator.

- 2b. Replace the Rear Door Latch Assembly (B) or Rear Door Actuator (C) as needed.

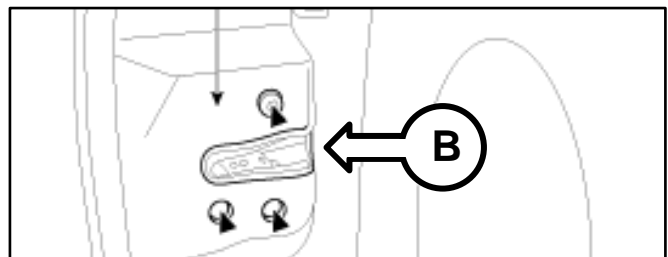
**Note:** Check if the PSD latch is fixed (Hold Open Lock) at the back when the door fully opens.

Replace the PSD rear door latch assembly (B) by referring to the “Body (Interior Exterior) → Exterior → Rear Door → Repair procedures” chapter in the applicable Shop Manual on KGIS.
