# **Service Action Code: 19P5**

Subject	Cooling Sys	stem Flush & C	oolant Replace	ement			
Release Date	March 18, 2021						
Affected Vehicles	Country	Beginning Model Year	Ending Model Year	Vehicle	Vehicle Count		
	USA	2019	2019	E-TRON QUATTRO	12		
	Check Campaigns/Actions screen in Elsa on the day of repair to verify that a VIN qualifies for repair under this action. Elsa is the <u>only</u> valid campaign inquiry & verification source. ✓ Campaign status must show "open." ✓ If Elsa shows other open action(s), inform your customer so that the work can also be completed at						
Problem Description	the same time the vehicle is in the workshop for this campaign. G13 coolant was mistakenly filled into the affected vehicles instead of G12evo coolant during a workshop visit. In certain circumstances, this could result in a cooling system leak.						
<b>Corrective Action</b>	Flush cooling system and replace coolant with the proper type.

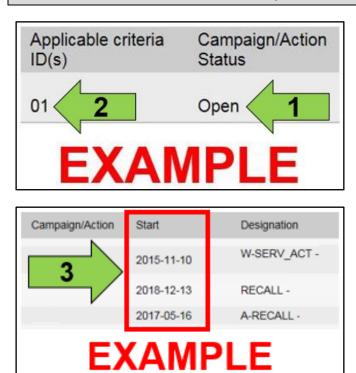
Enter the VIN in Elsa and proceed to the "Campaign/Action" screen.

- Confirm the Campaign/Action is open <arrow • 1>. If the status is closed, no further work is required.
- Note the Applicable Criteria ID <arrow 2> for use in determining the correct work to be done and corresponding parts associated.

If multiple software update Campaign/Actions are open, they must be performed in order of the Start date <arrow 3>. The oldest should be performed first.

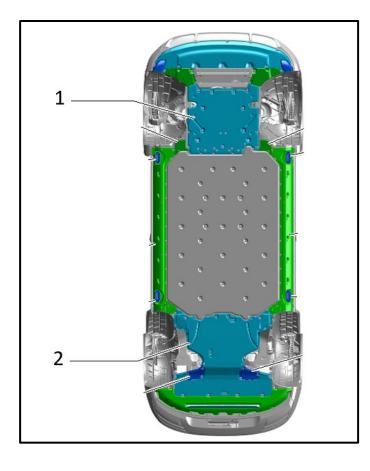
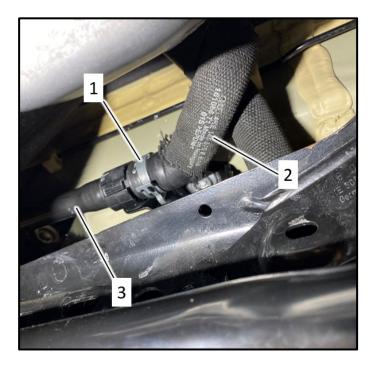
#### Disconnect rear coolant hose:

- Place a drip tray under the vehicle to capture • coolant.
- Locate the coolant connection at the rear of the high voltage battery.
- Loosen clamp <1> and remove coolant hose • <2> from coolant pipe <3>.

Attaching a scrap length of hose to the coolant hose <2> and coolant pipe <3> will prevent escaping coolant from pooling on top of the high voltage battery and other vehicle components.

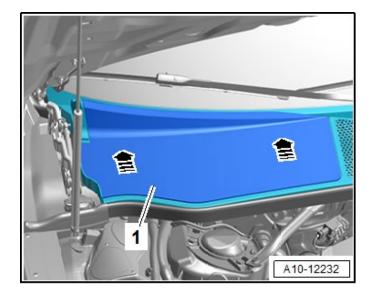
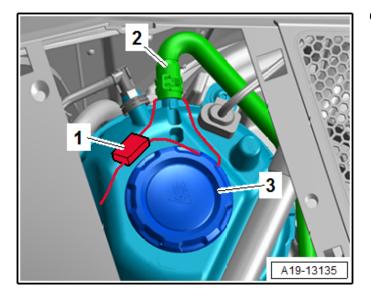
#### Access coolant reservoir:

Remove the cover <1> toward the rear in • direction of <arrows> and remove.

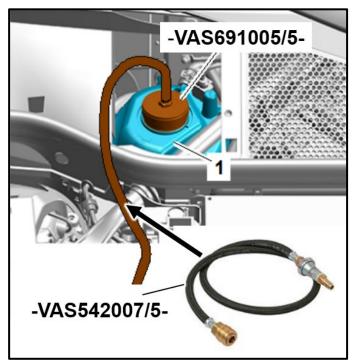
#### Open coolant expansion tank:

Open the coolant expansion tank cap <3> by • cutting the seal loop <1>.

- Connect adapter -VAS691005/5- with black • pressure hose -VAS542007/5- to the coolant expansion tank.
- Connect pressure hose -VAS542007/5- to an air supply and flush cooling system for approximately 5 minutes via the coolant expansion tank.
- Approximately 12 liters of coolant should be • flushed out.

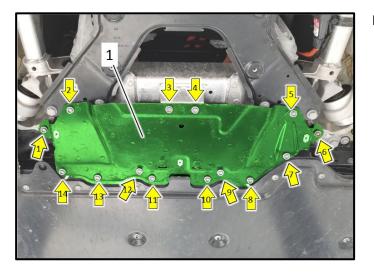
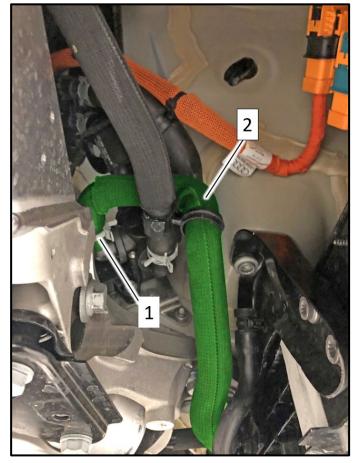
#### Remove front impact guard:

• Remove bolts <arrows> and remove impact guard <1>.

- Loosen clamp <1>.
- Remove hose <2> from valve.

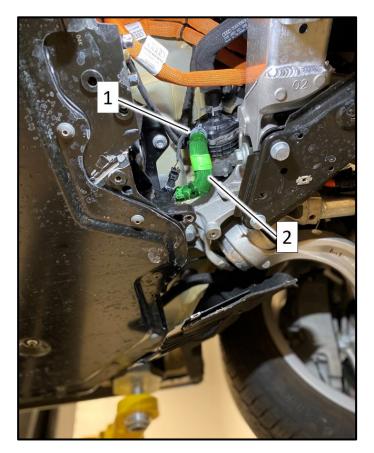
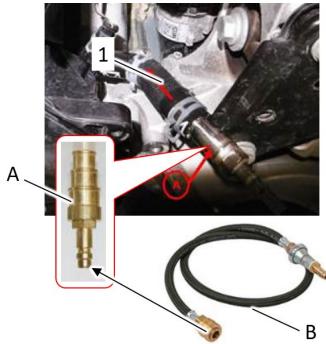
#### **Disconnect supply hose:**

- Loosen clamp <1>.
- Remove hose <2> from valve.

- Connect adapter -VAG1274B/14-3- <A> to • hose <1> and secure with clamp.
- Connect pressure hose -VAS542007/5- <B> • to adapter <A>.
- Connect pressure hose -VAS542007/5- <B> • to an air supply and flush cooling system for approximately 5 minutes.
- Approximately 3.5 liters of coolant should be • flushed out.

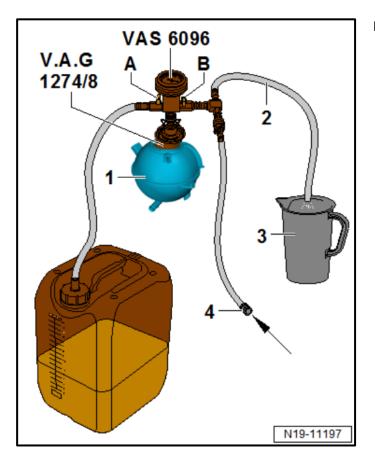
#### Fill cooling system:

- Restore the previous ODIS session.
- Fill and bleed the cooling system according to the ELSA Repair Manual and the ODIS tester.
  - ELSA Repair Manual: Repair manual 0 > Motor > Electric Drive Motor 0EF > System > Cooling 19 Cooling System/Coolant > Filling and Bleeding the Coolant
- After the "Fill Cooling System" test plan is • completed in GFF, the remaining relevant test plans will populate:
  - "Stop fill coolant circuit" 0
  - "Bleed cooling circuit" 0
- Complete the populated test plans.
- ONLY use G12 EVO coolant!
